CITY OF EVANSTON
REQUEST FOR PROPOSAL

NUMBER: 25-29

Sherman Plaza Parking Garage Structural Assessment

May 15, 2025

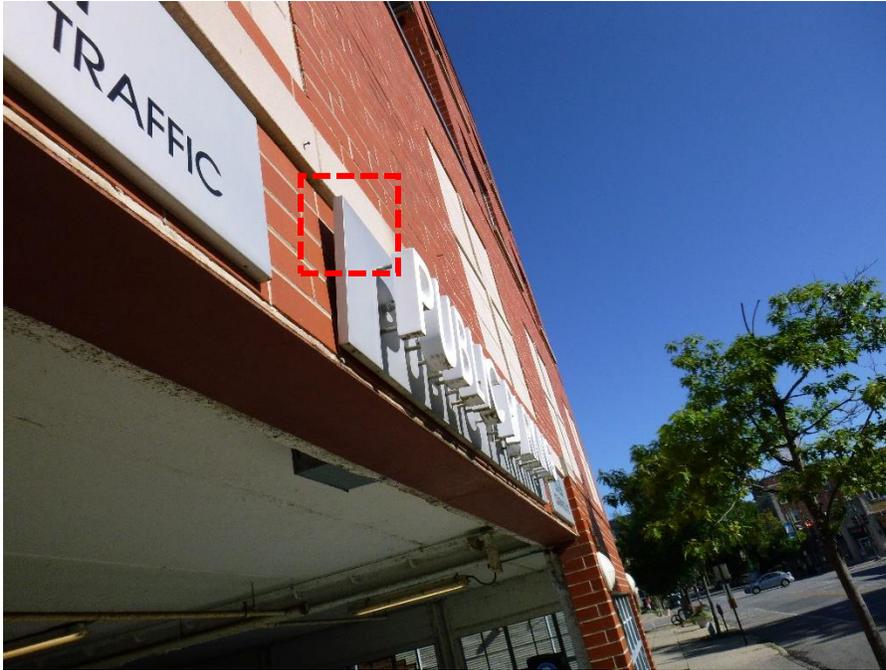
Figure 2.2. Sign anchor failed above entrance from Chicago Avenue, highlighted in red box

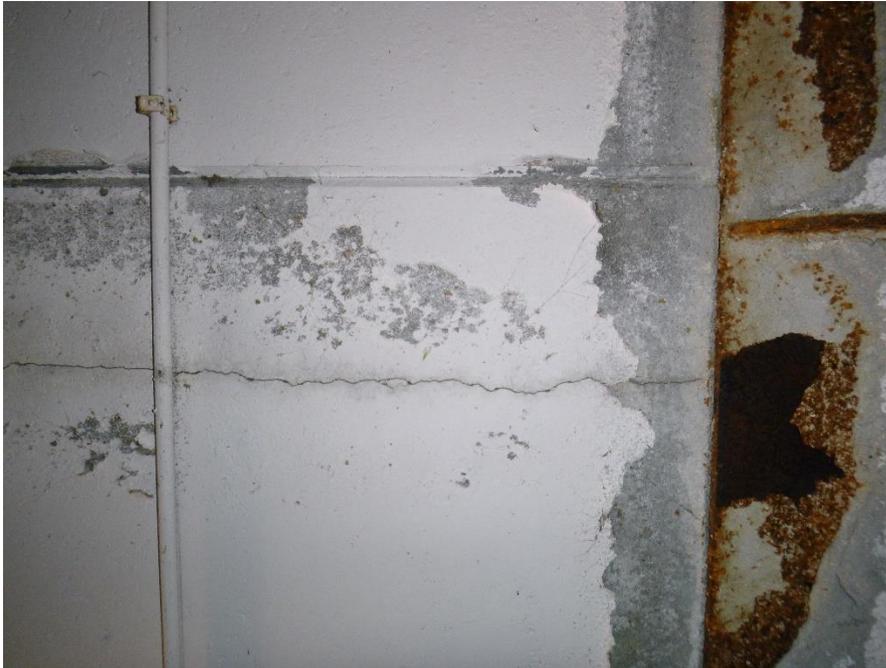
Figure 2.4. Leak through the second floor deck

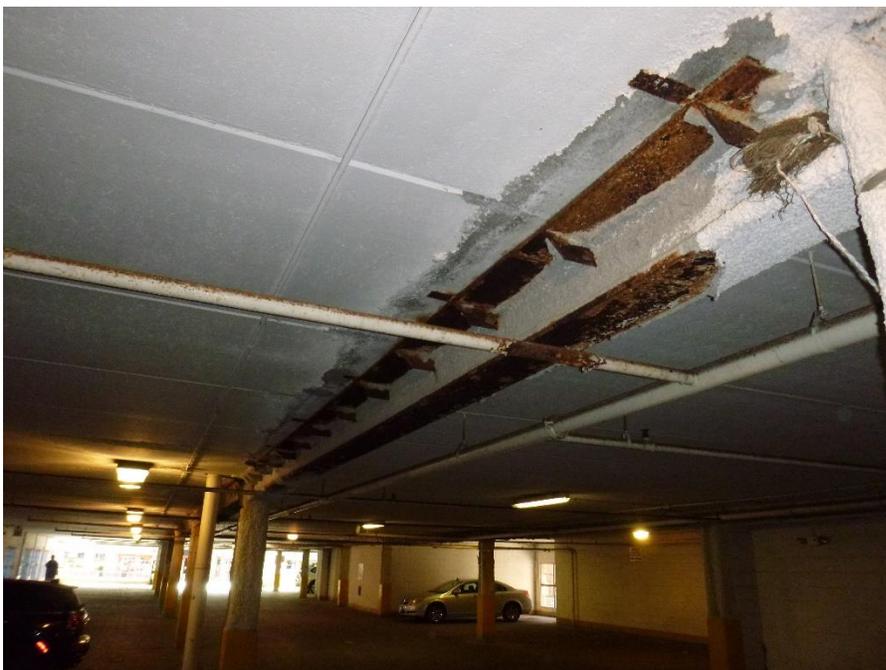
Figure 2.5. Failed fireproofing on a second floor steel beam, exposing a corroded section of steel

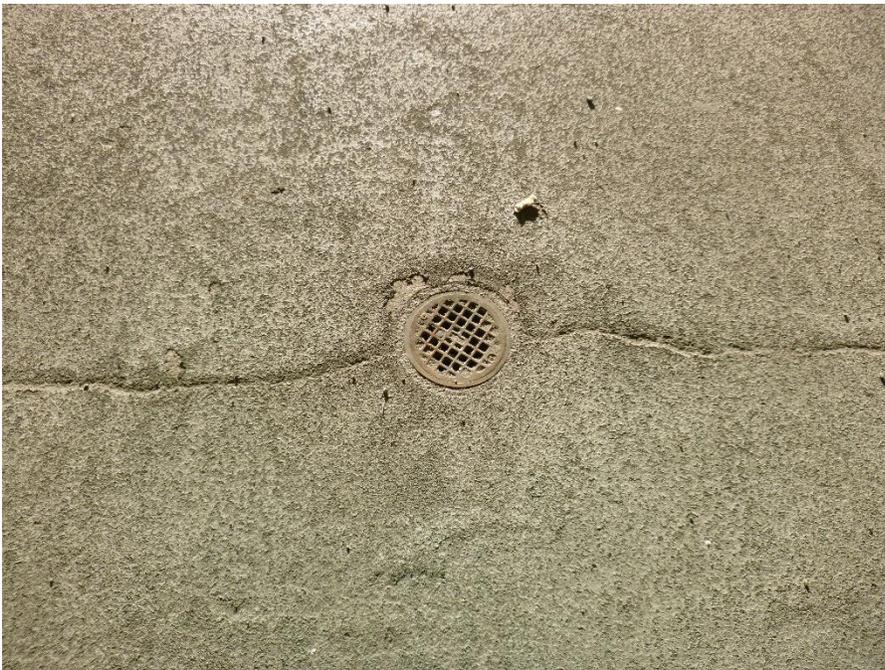
Figure 2.7. Debonded and failed membrane at a floor drain on the ground floor

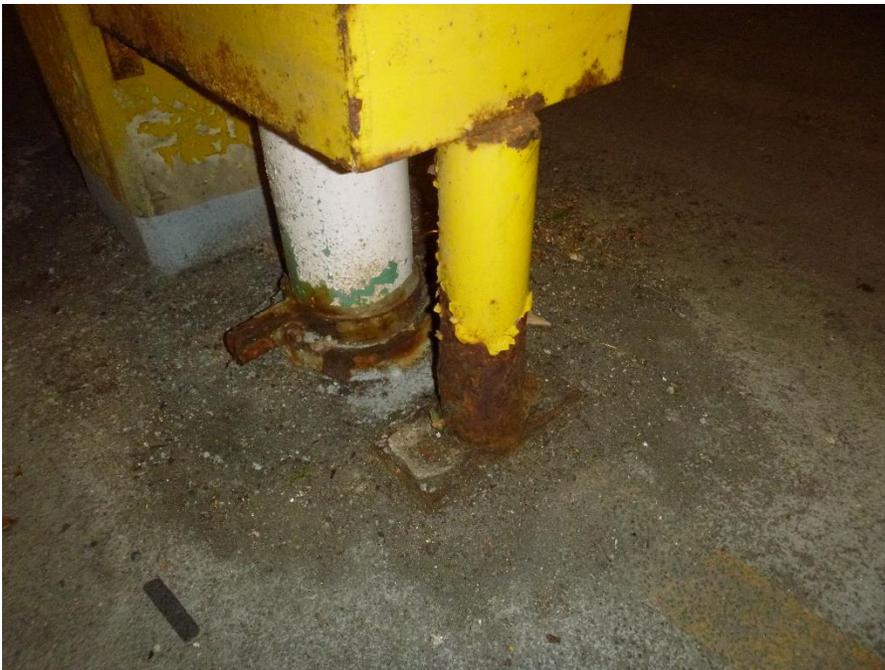
Figure 2.9. Corroded steel pipe guard

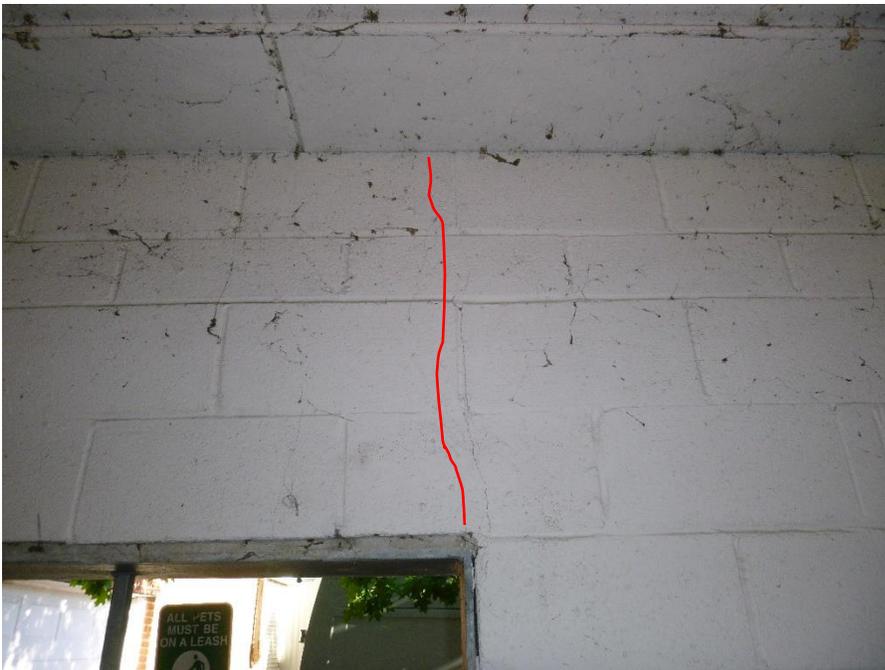
Figure 2.11. Cracks in CMU wall at exterior window frame, highlighted in red

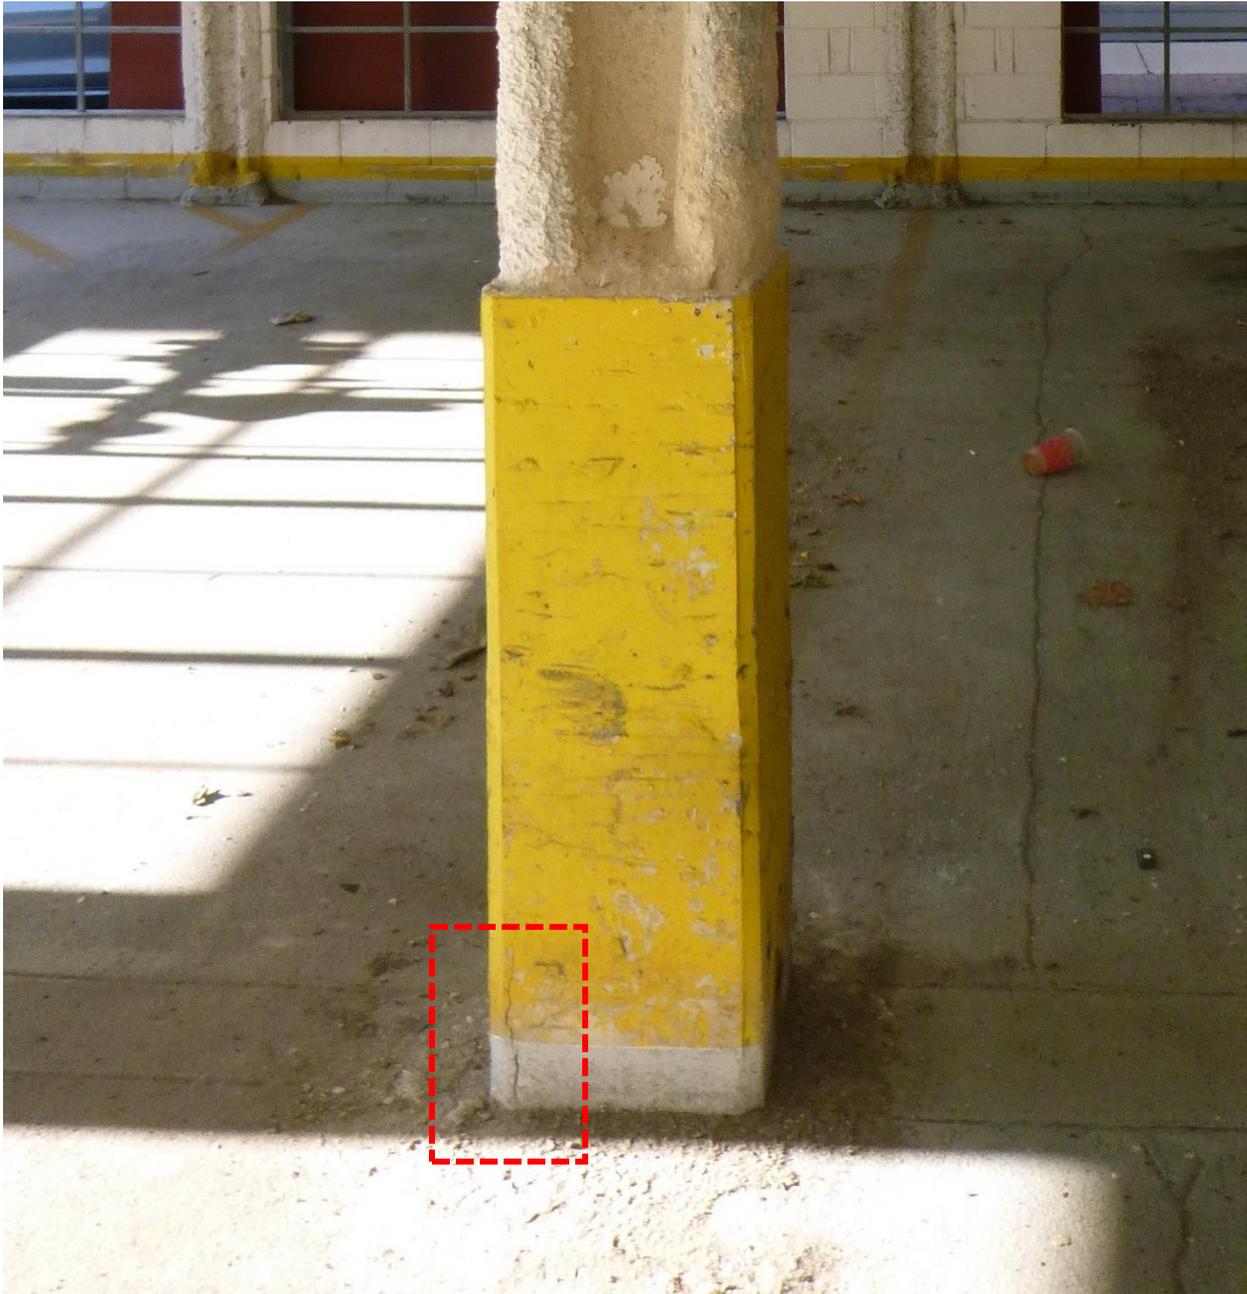
Figure 2.13. Delamination of concrete encasement at the base of a column above the ground floor, highlighted in red box

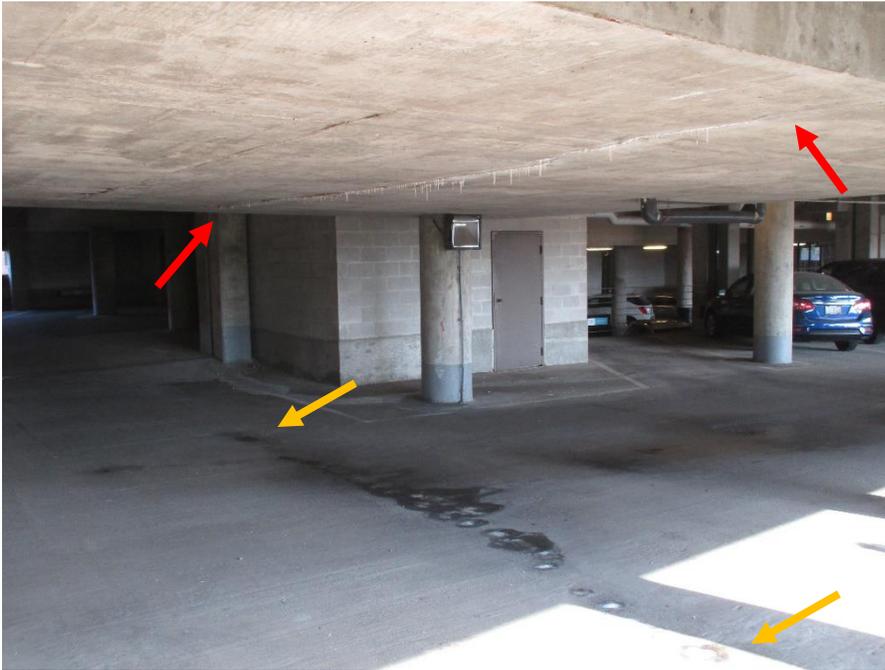
Figure 3.4. Crack with mineral deposits (indicated between red arrows) on underside of Level 6 swimming pool, with moisture and mineral deposits visible on the Level 5 deck below (indicated between orange arrows).

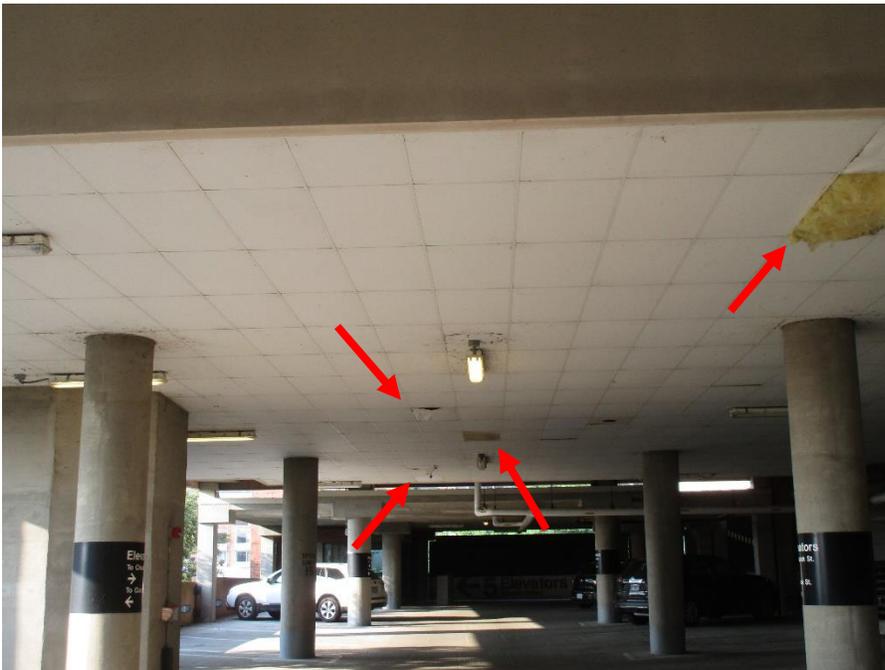
Figure 3.5. Four locations of apparent leaking above Level 5 (indicated by red arrows), as evidenced by failed or discolored soffit panels.

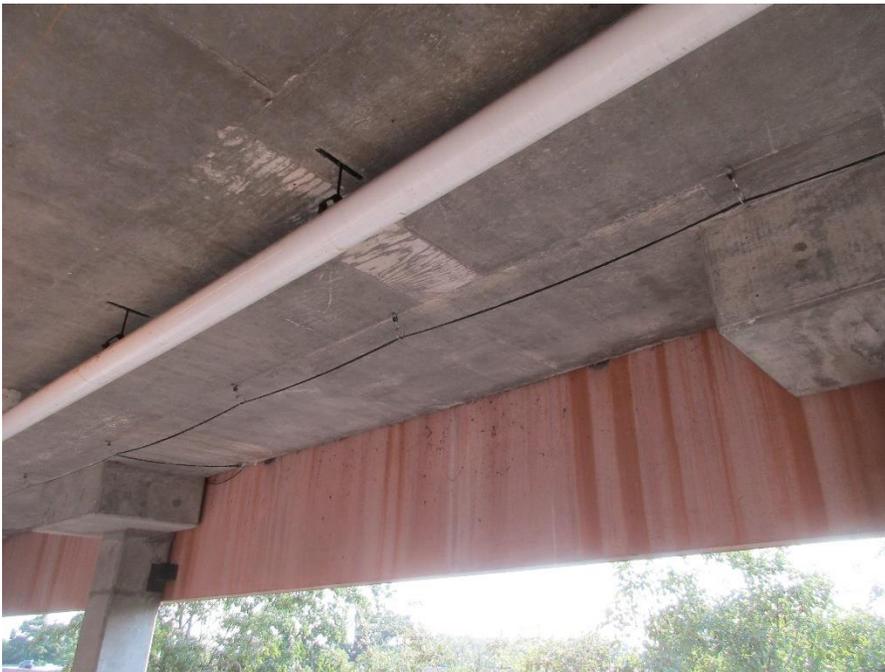
Figure 3.7. Staining on interior of facade panels due to water leaking at the joint between the facade panel and the Level 6 slab.

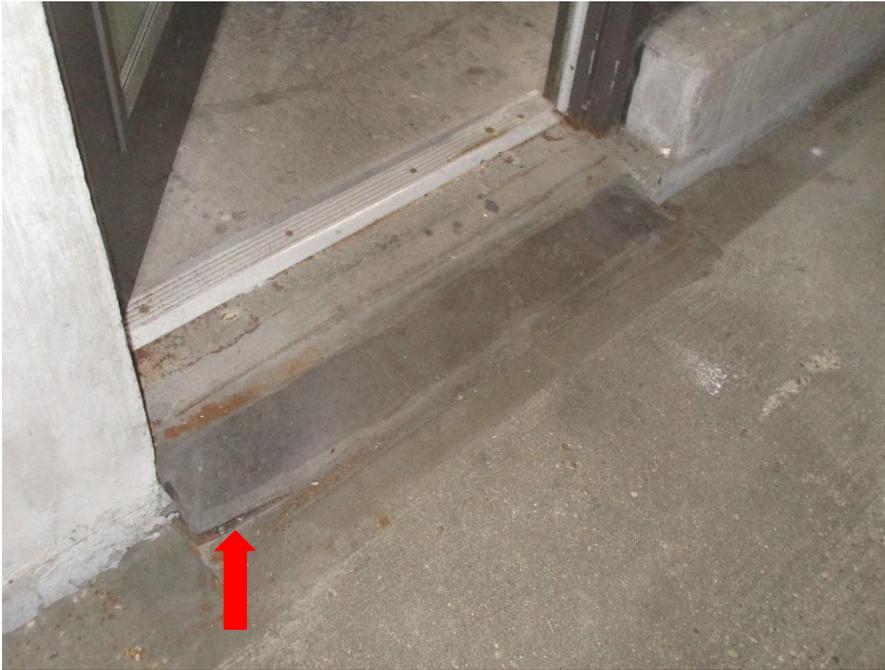
Figure 3.8. Failure of polyurethane expansion joint seal between stair tower door (upper left) and parking garage deck (lower right).

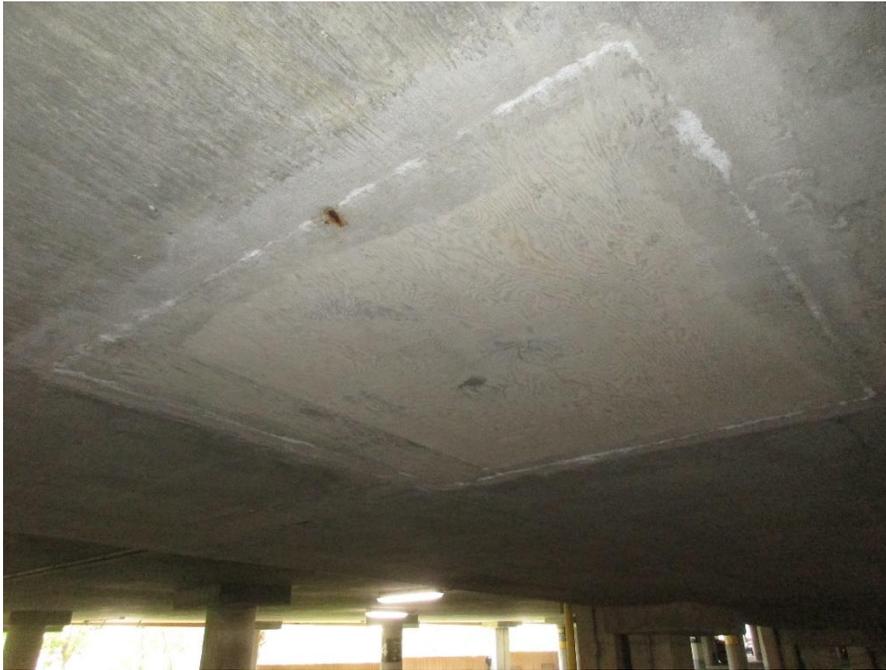
Figure 3.10. Underside of typical block-out for stressing of slab post-tensioning tendons showing signs of efflorescence and corrosion staining.

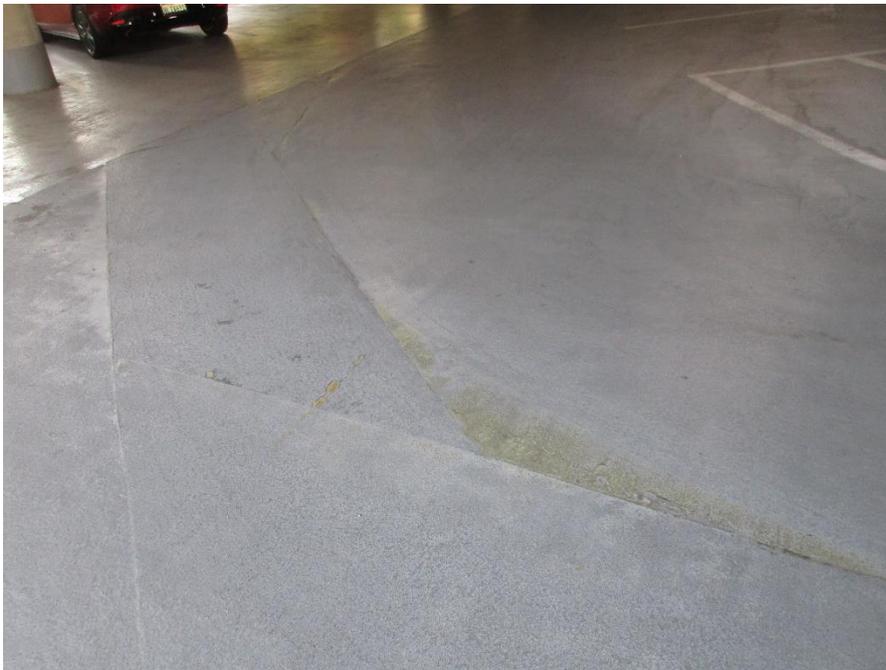
Figure 3.11. Waterproofing membrane showing signs of wear through the top coat at the turn at the north end of Level 2.

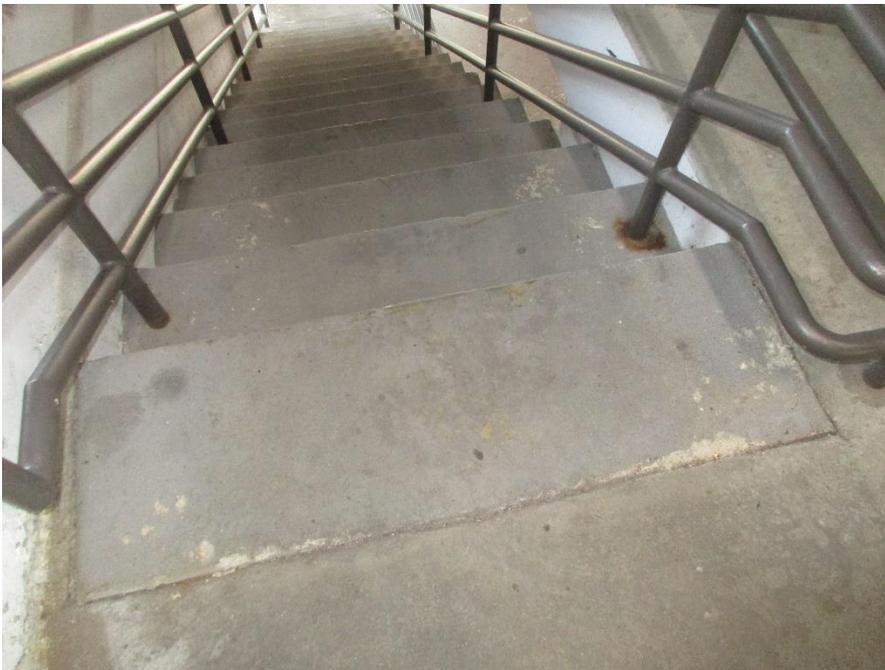
Figure 3.13. Worn membrane on the stair treads between Levels 1 and 2 in the southeast stairwell.

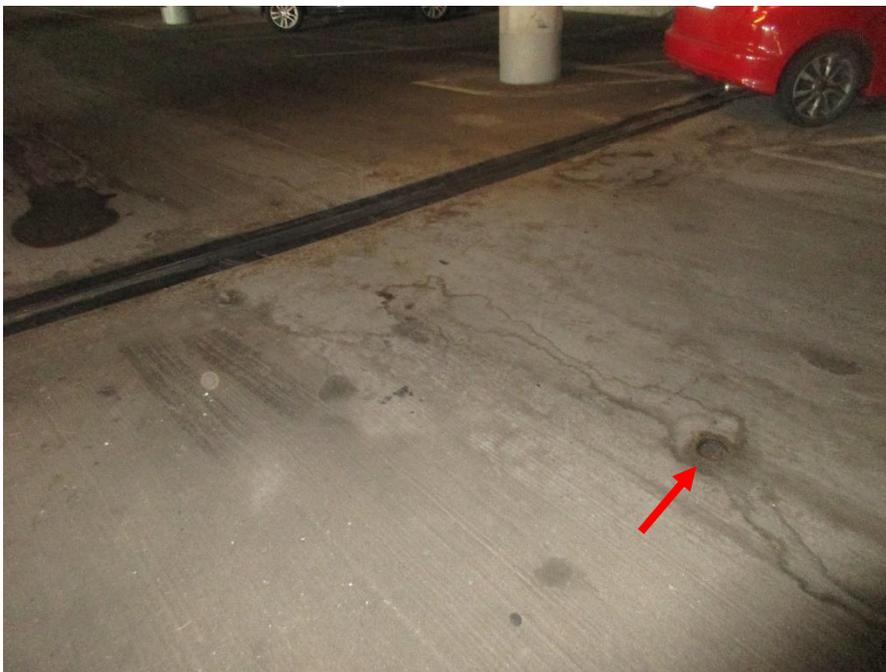
Figure 3.15. Failed patch at core hole (indicated by red arrow) over Level 5 expansion joint retrofit.

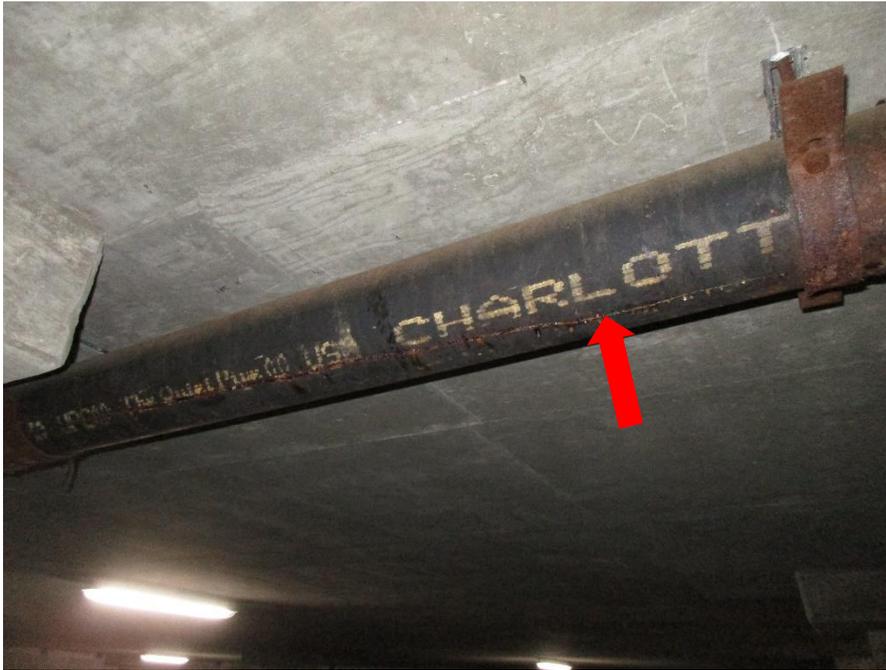
Figure 3.18. Failed drain pipe with water and corrosion along crack.

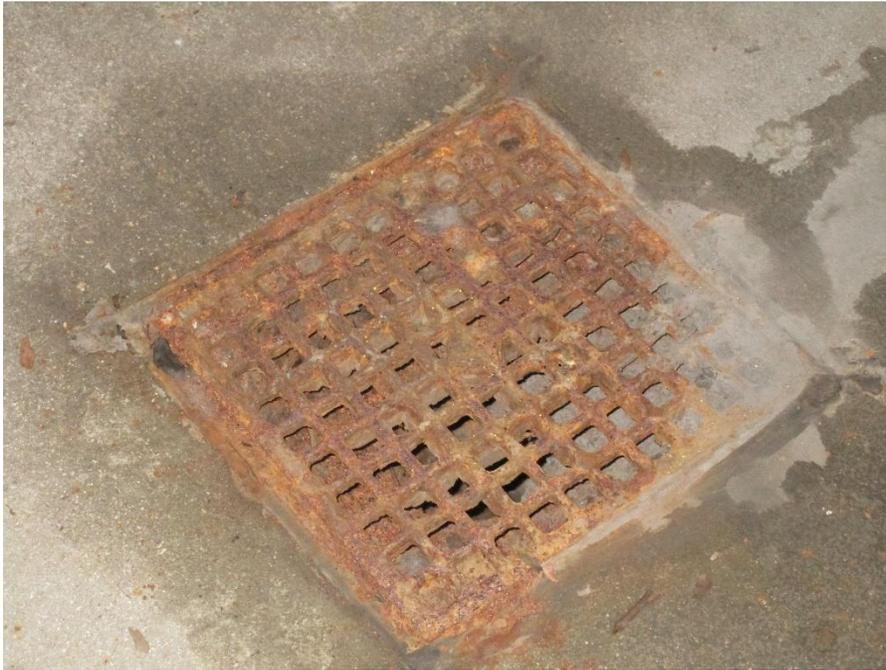
Figure 3.20. Corroded floor drain grating.

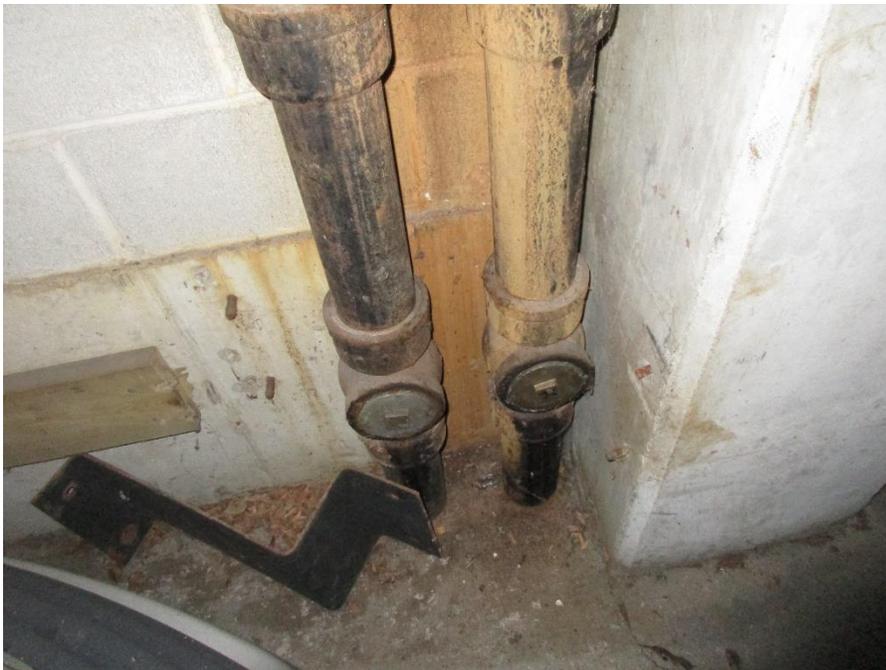
Figure 3.21. Disconnected drain pipe guard.

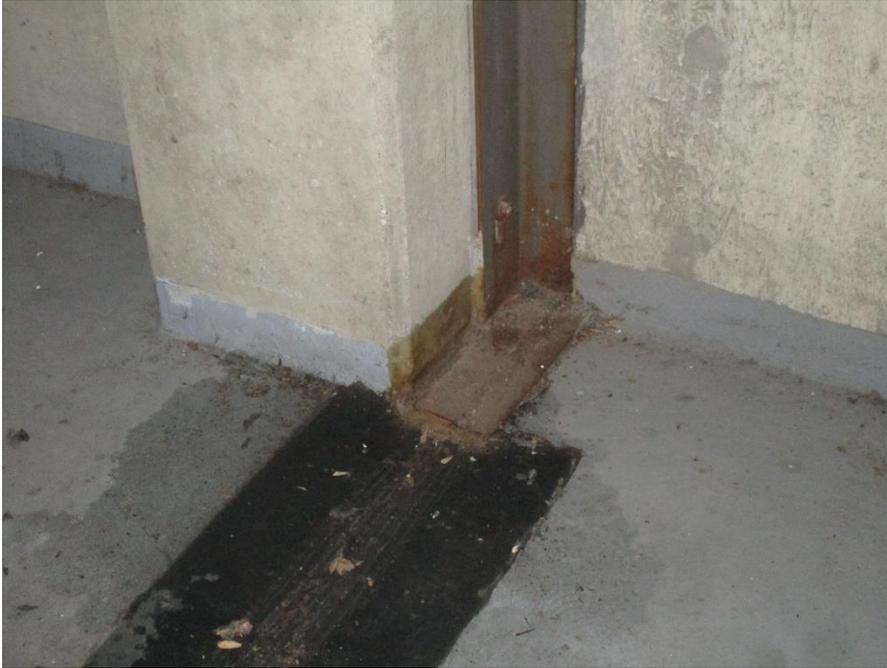
Figure 3.22. Corroded steel cover plate over expansion joint of Level 2 deck.

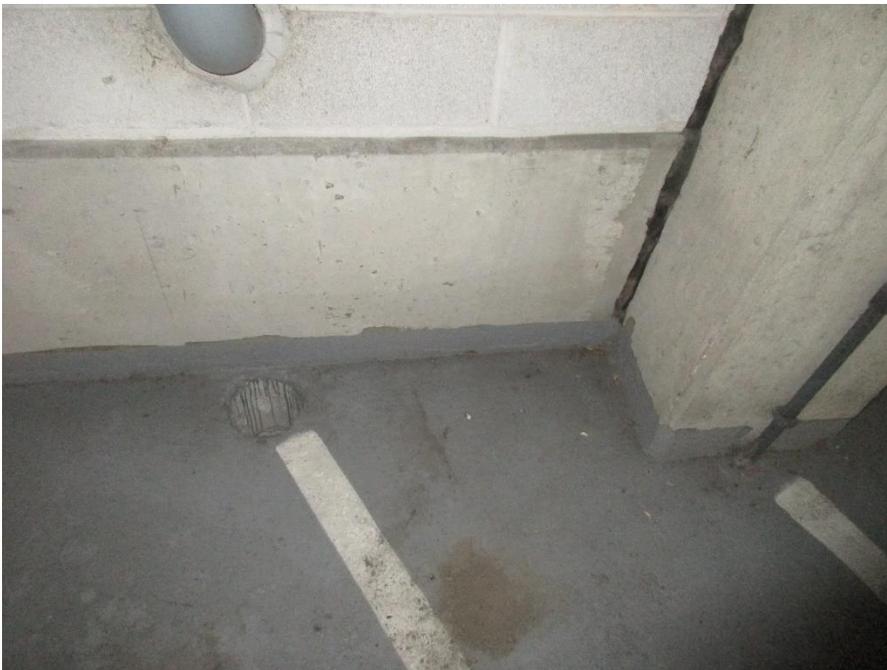
Figure 3.23. Open core hole through the Level 2 deck near Column PK/P11.

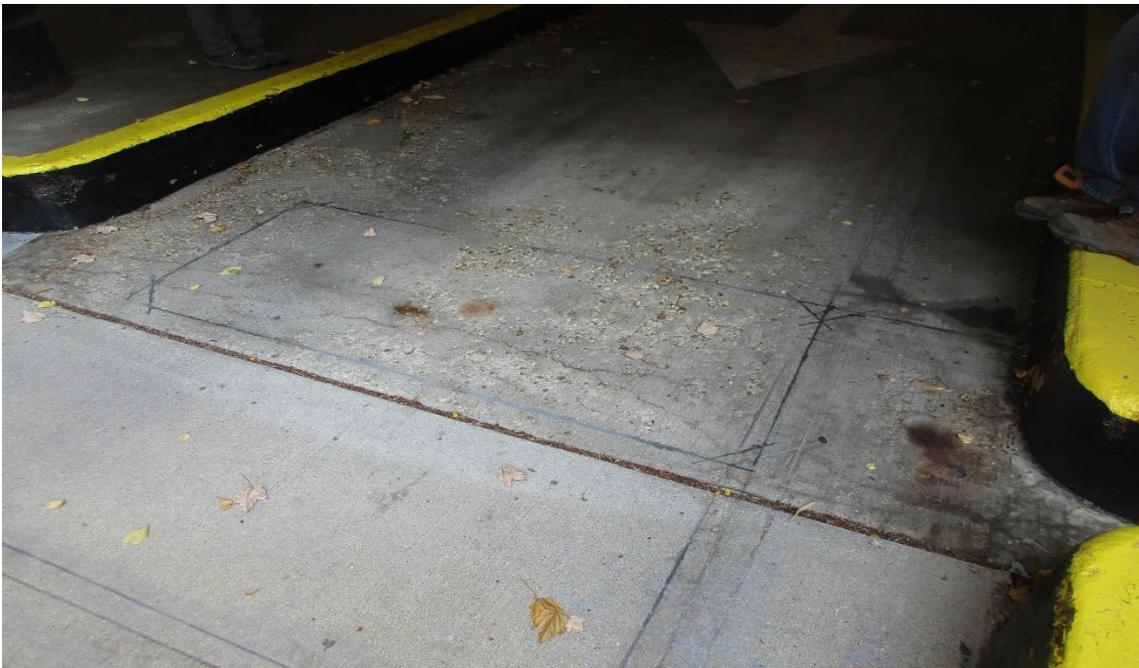
Figure 3.25. Concrete scaling at the south exit.

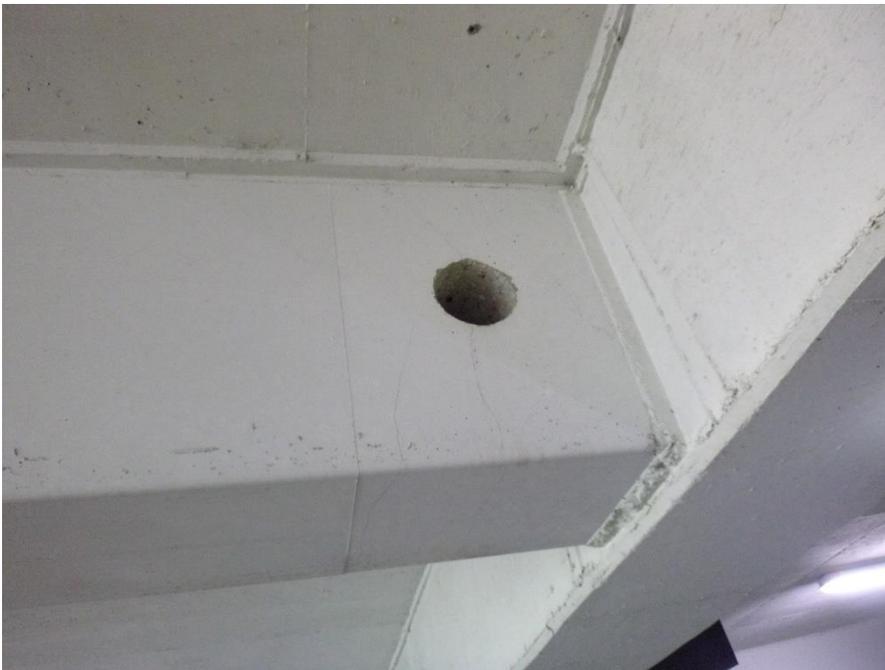
Figure 4.3. Core hole through beam with cut shear reinforcement

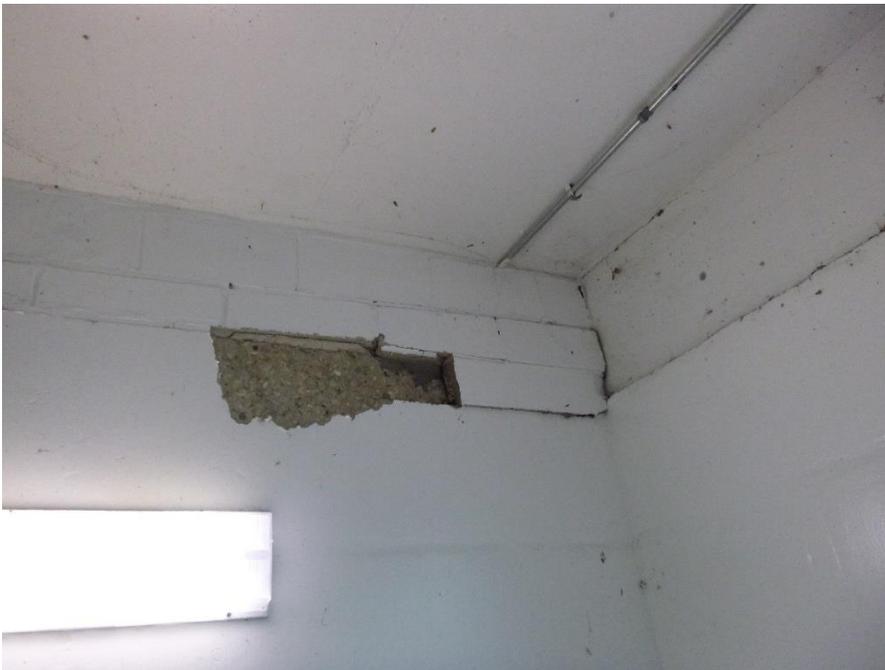
Figure 4.7. Spalled concrete requiring repair at west wall of northwest stairway

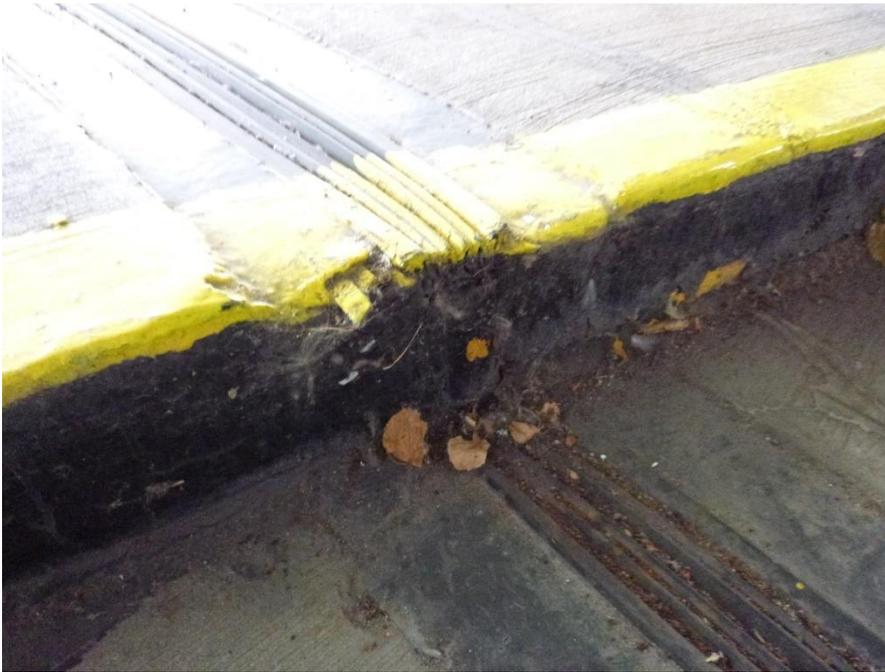
Figure 4.8. Discontinuity in expansion joint seal due to improper detailing at a change in elevation

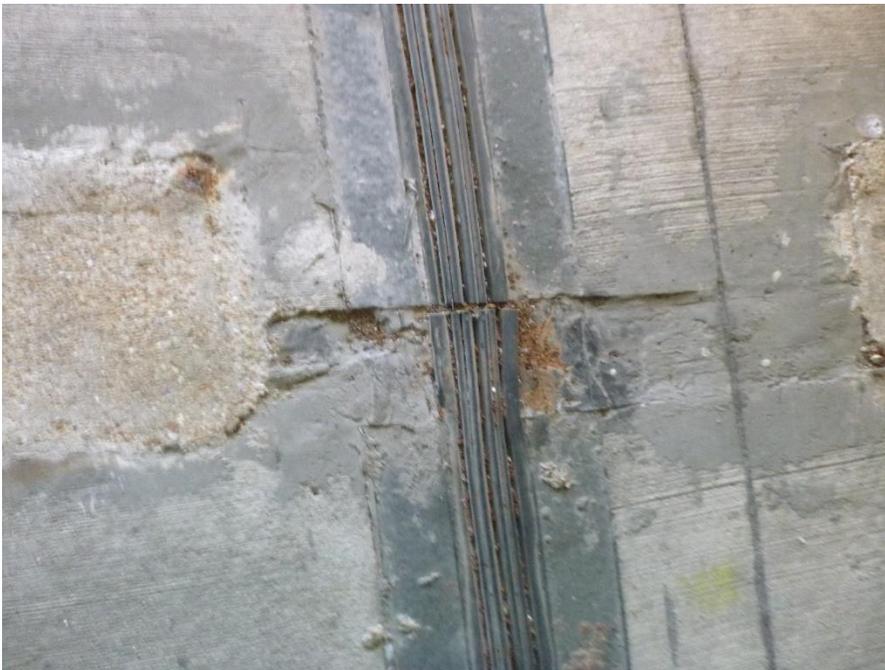
Figure 4.9. Damage to expansion joint seal due to sawcutting

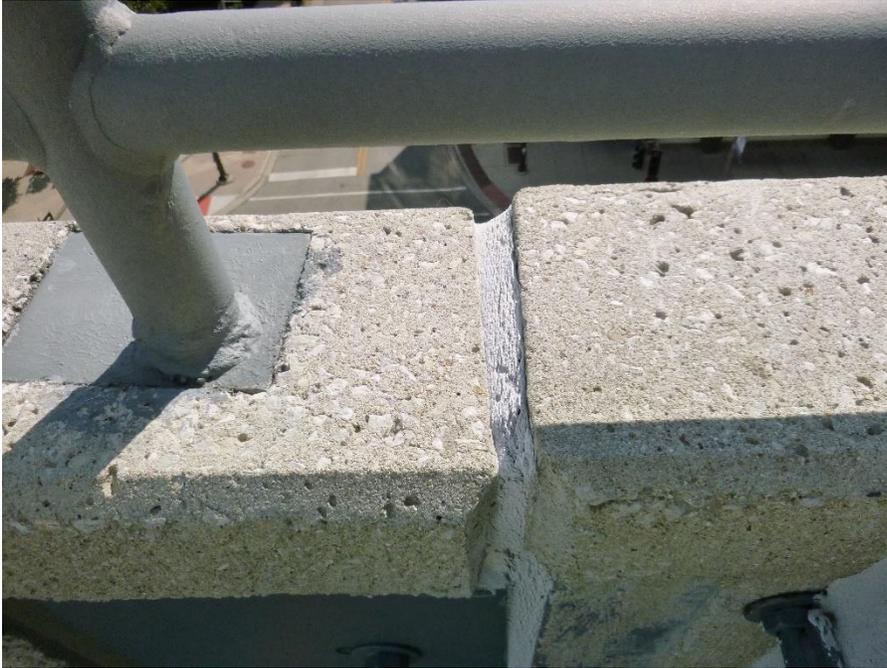
Figure 4.12. Failed sealed requiring repair

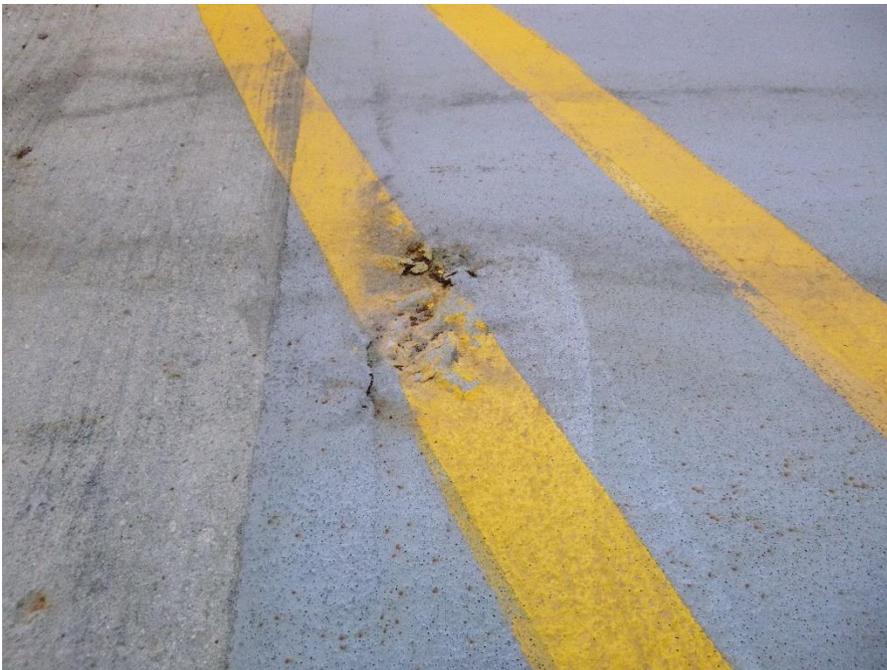
Figure 4.13. Localized failure of traffic-bearing waterproofing membrane

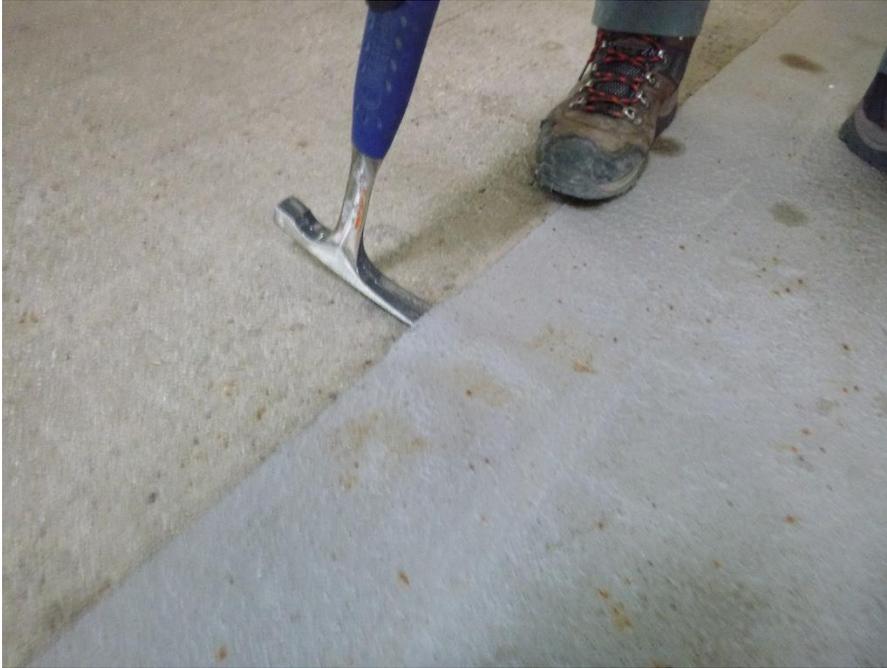
Figure 4.14. Debonding of traffic-bearing waterproofing membrane

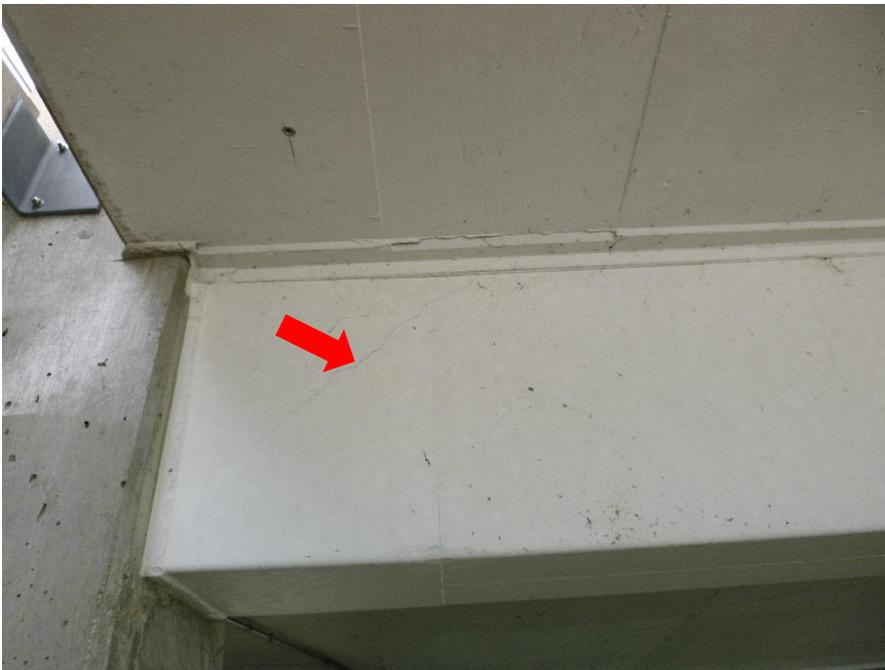
Figure 4.19. Shear cracks in beams

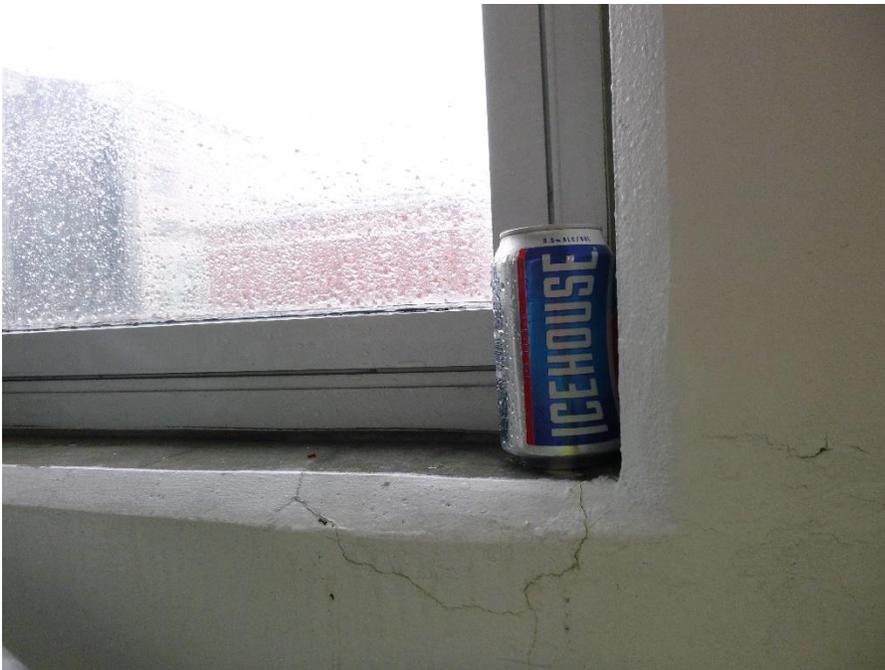
Figure 4.21. Leaking storefront in southeast stairwell

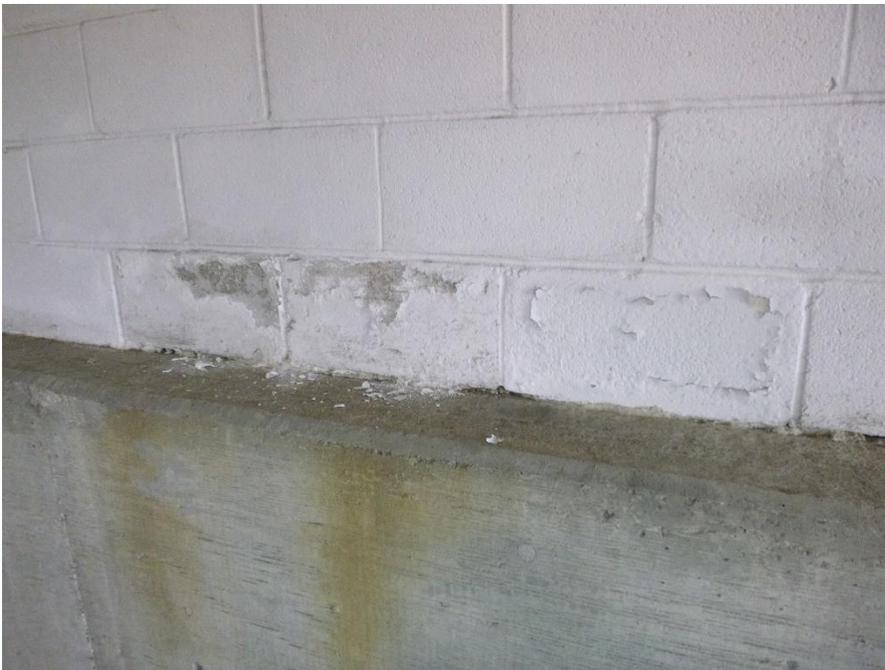
Figure 4.23. Peeling paint at south CMU infill wall

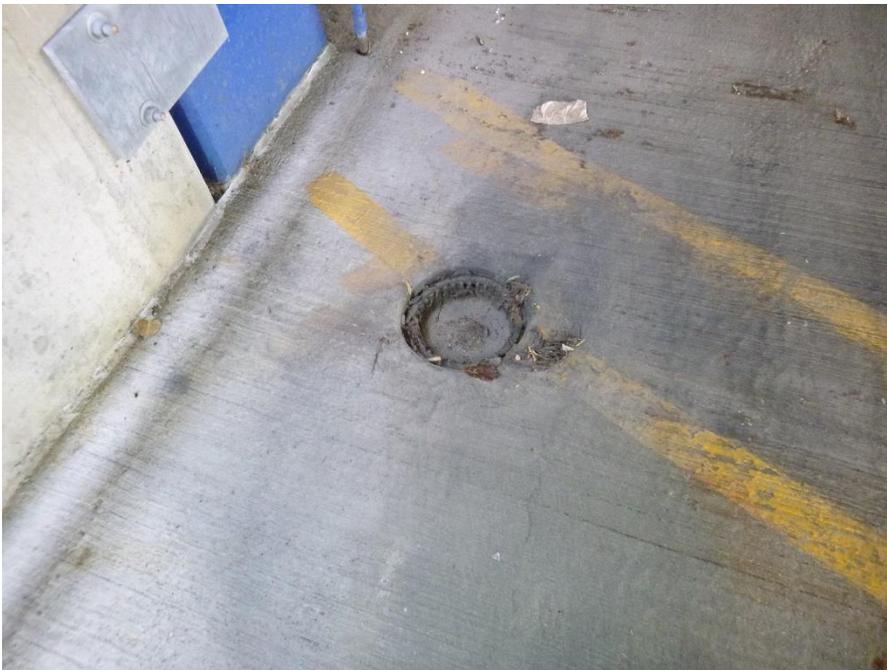
Figure 4.25. Missing or broken drain grate

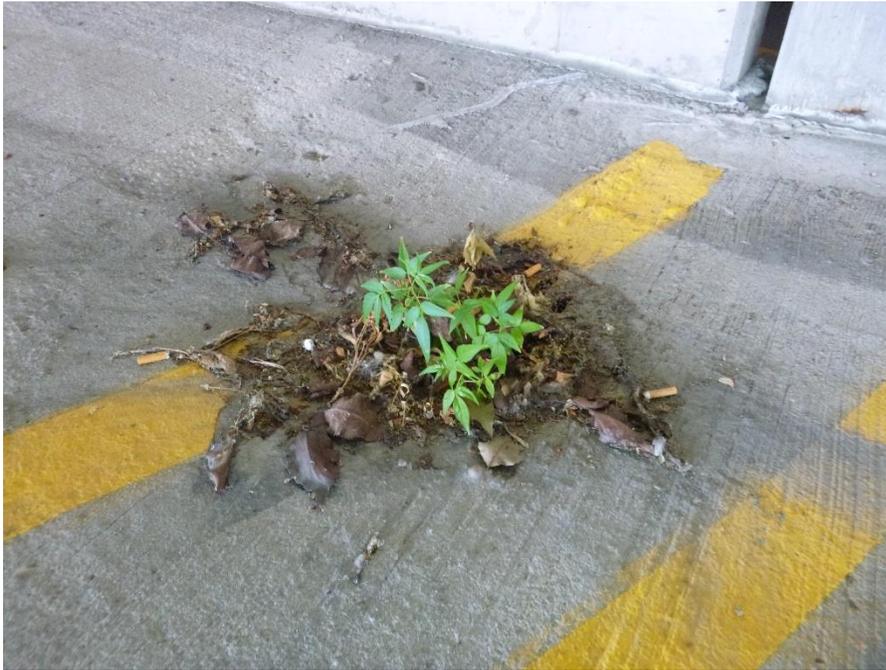
Figure 4.26. Vegetative growth and debris at drain

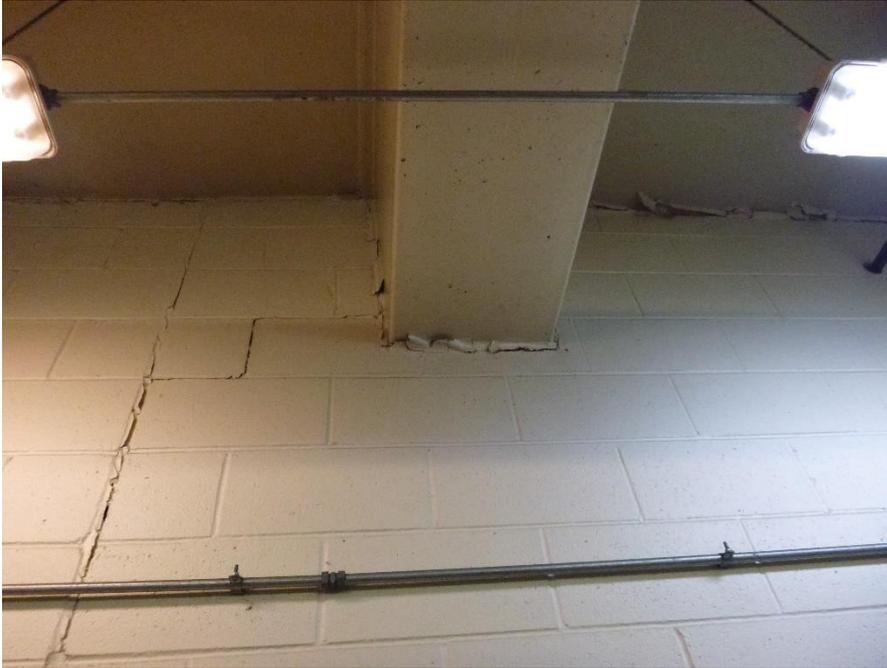
Figure 4.30. Cracked mortar joints requiring tuck pointing

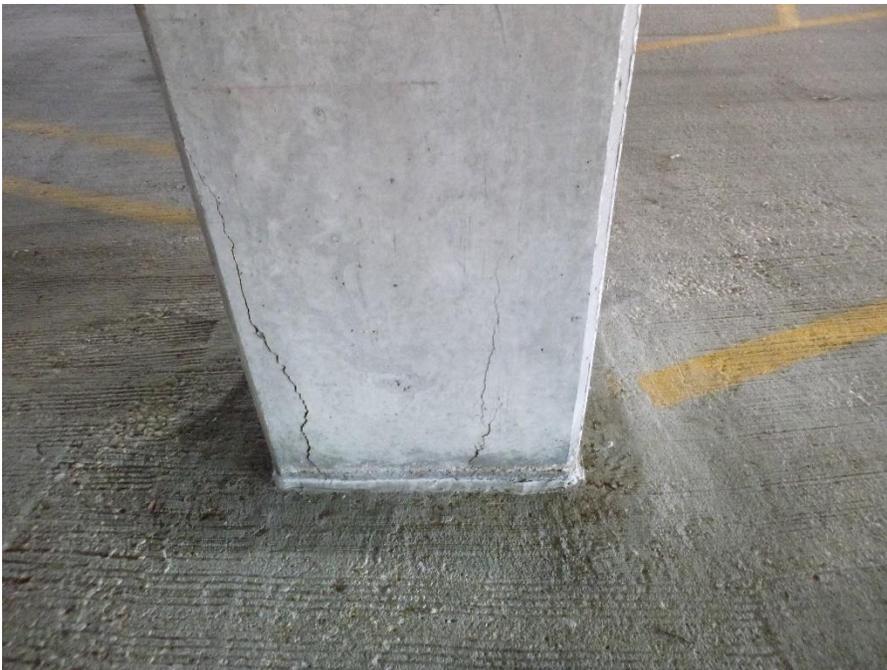
Figure 4.31. Cracking and delamination of a column base
