CITY OF EVANSTON
REQUEST FOR PROPOSAL

NUMBER: 25-29

Sherman Plaza Parking Garage Structural Assessment

May 15, 2025

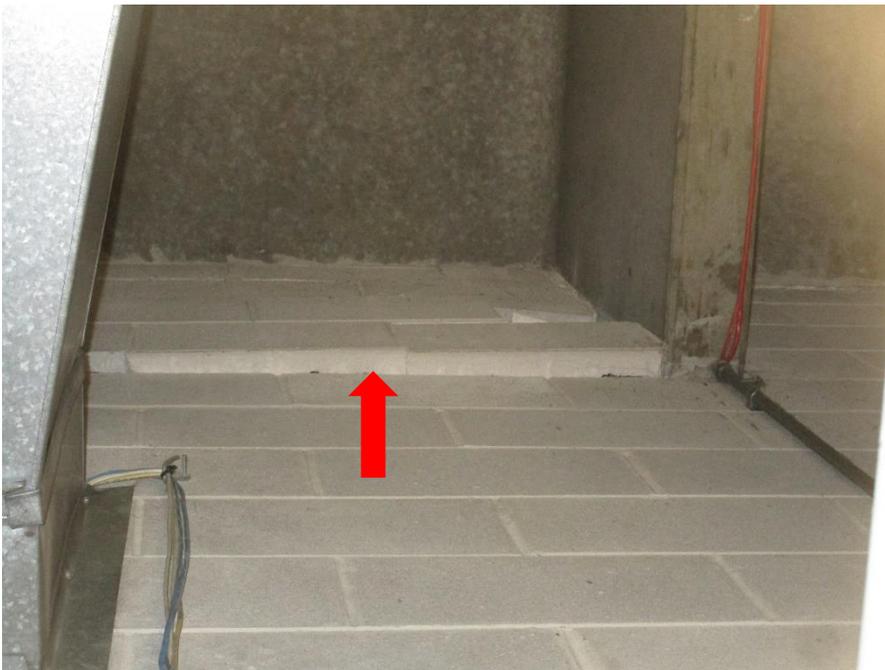
Figure 5.2. Shifting of the top three courses of the CMU partition wall over the interior door of the Electrical Room near Column C/D2.

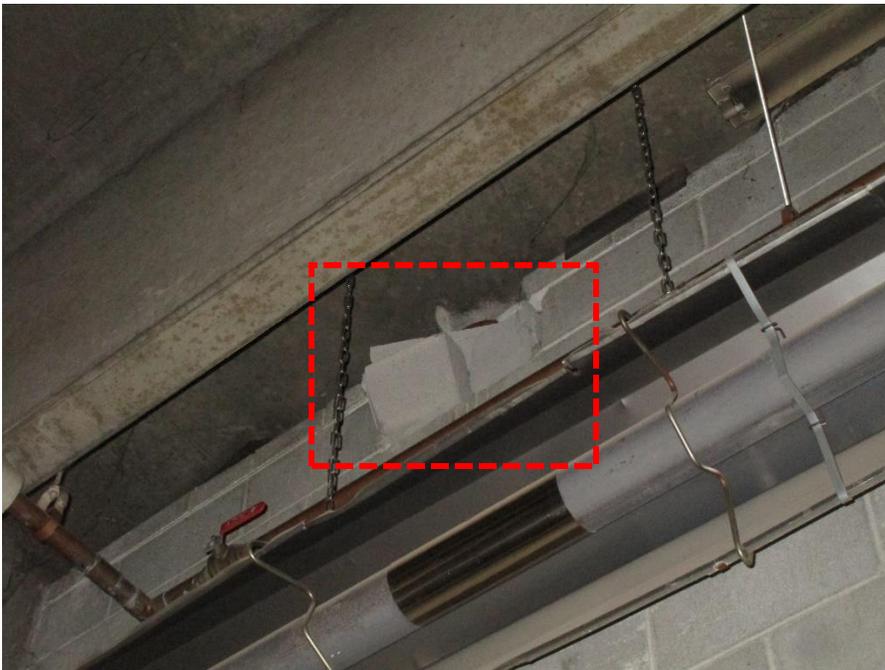
Figure 5.4. Face shell failure (highlighted in red box) in CMU partition wall near Column F/15.

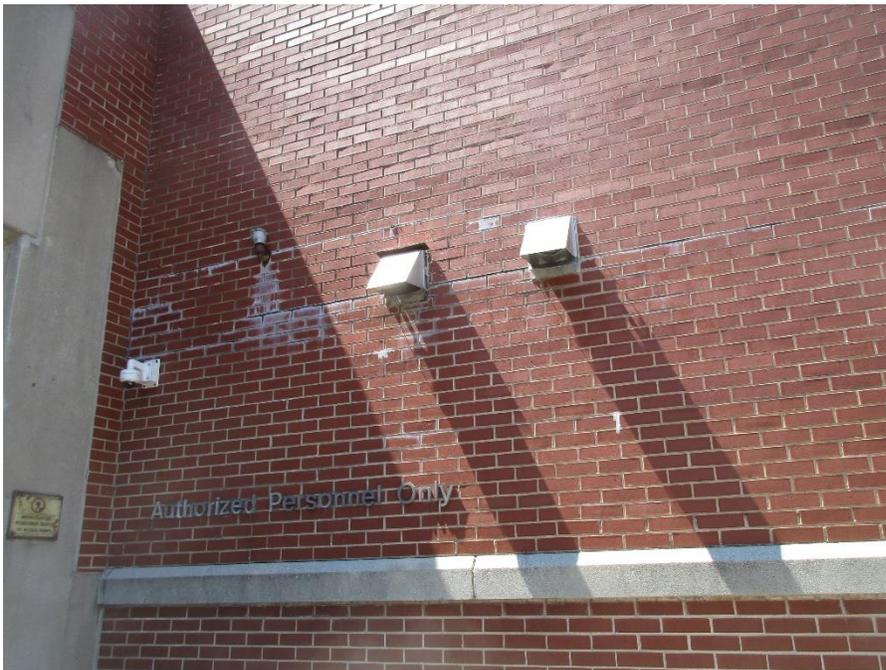
Figure 5.8. Efflorescence through the joints of the brick masonry facade adjacent to the base of the ramp on the north exterior of the structure.

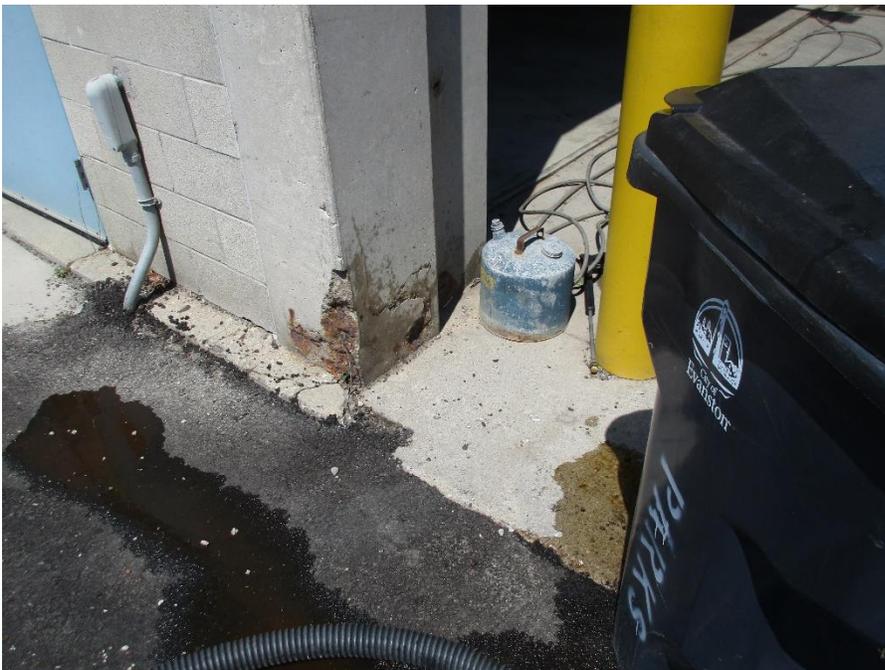
Figure 5.12. Typical example of column base spalling at Column H/D16.

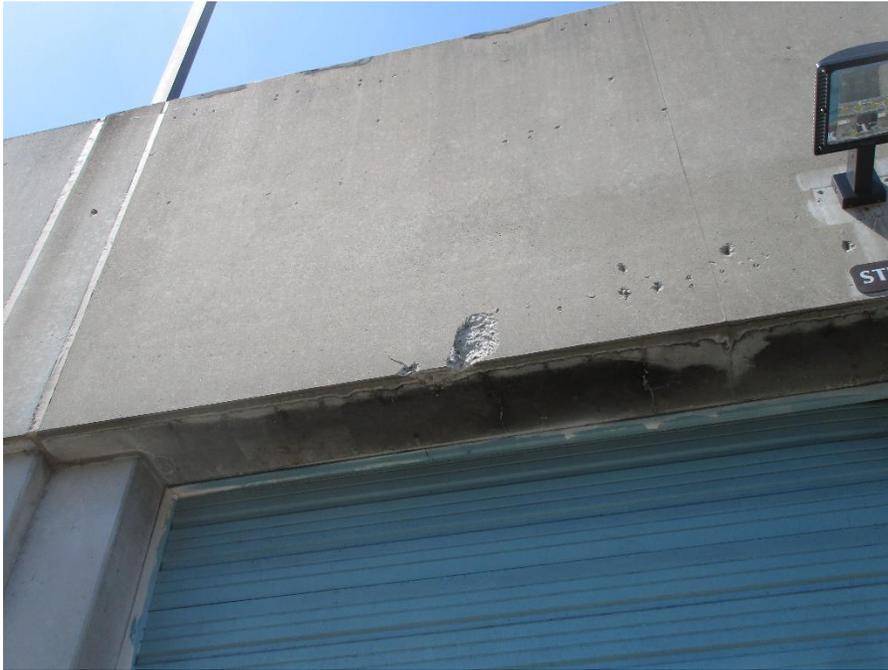
Figure 5.13. Spall on exterior of spandrel panel near Column H/D11.

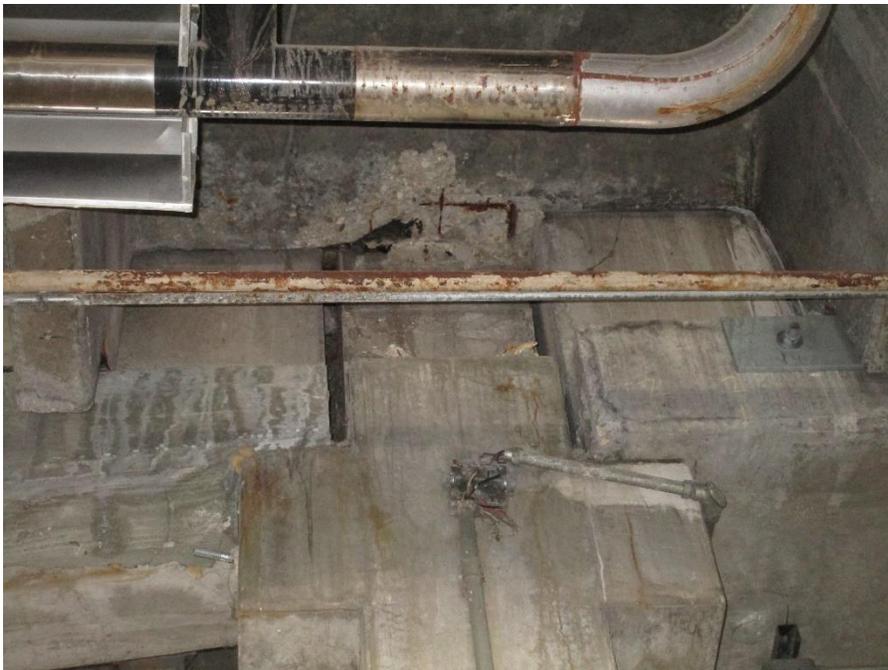
Figure 5.14. Overhead spall at Column E/D7, which appeared unchanged since WJE's inspection in June 2020.

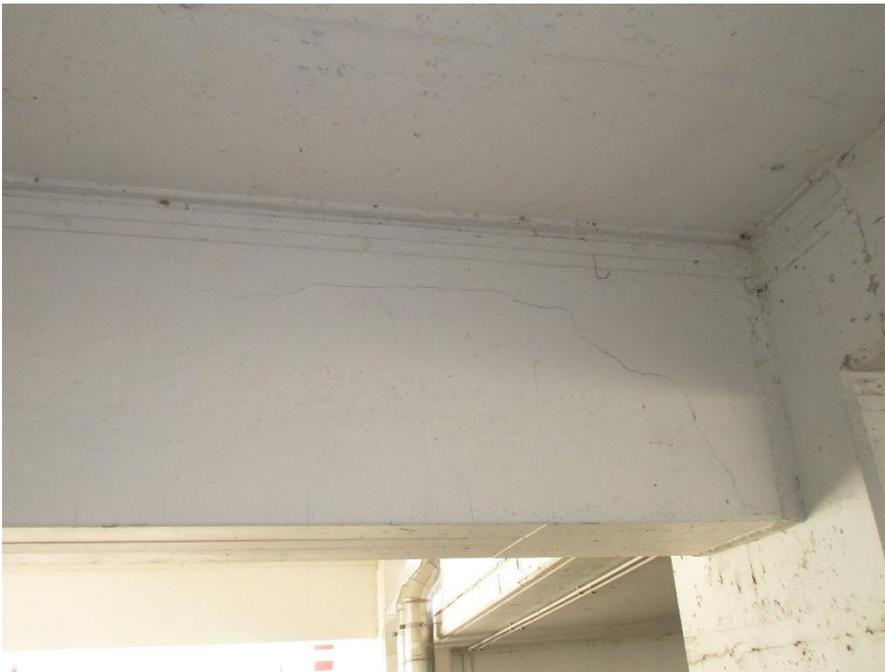
Figure 6.5. End cracking observed in post-tensioned beam framing into west face of Column PH/P7 below the rooftop cross-over.

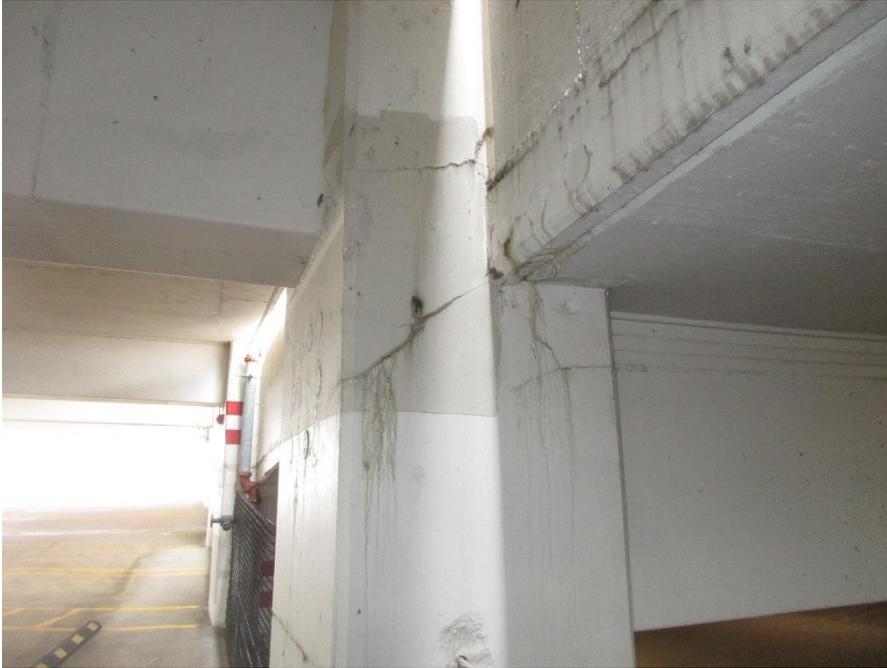
Figure 6.6. Cracking at beam/column junction beneath Level 12 at Column PE/P7.

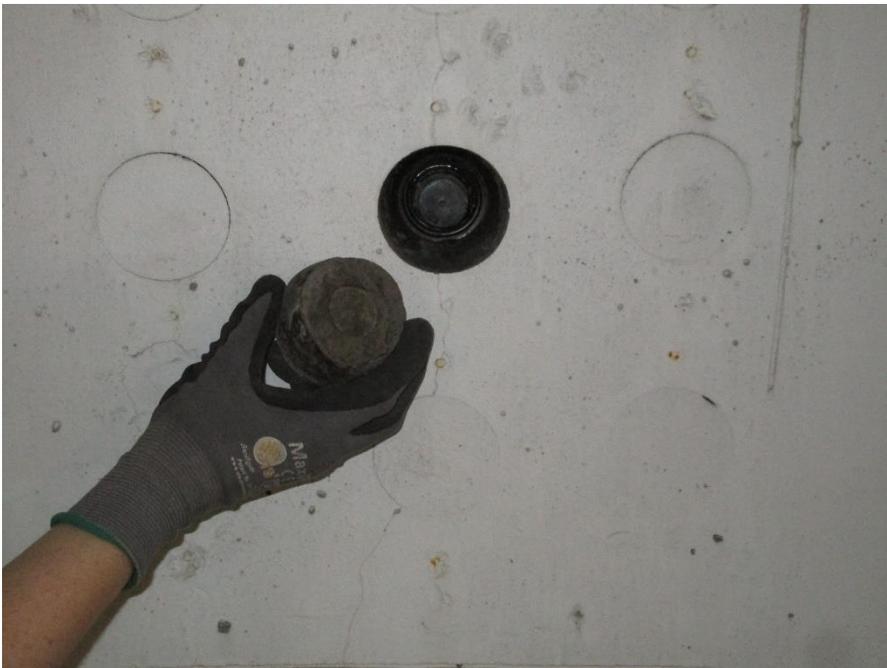
Figure 6.7. Loose grout pocket observed at Column PL/P7 on Level 11.

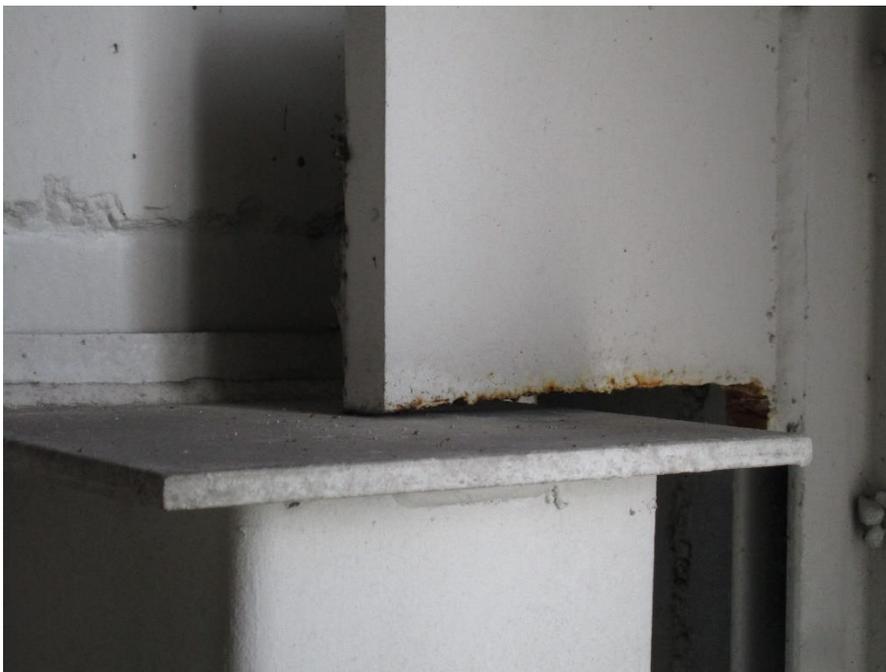
Figure 6.9. Facade panel bearing connection with point bearing at the end of the flame-cut bearing plate.

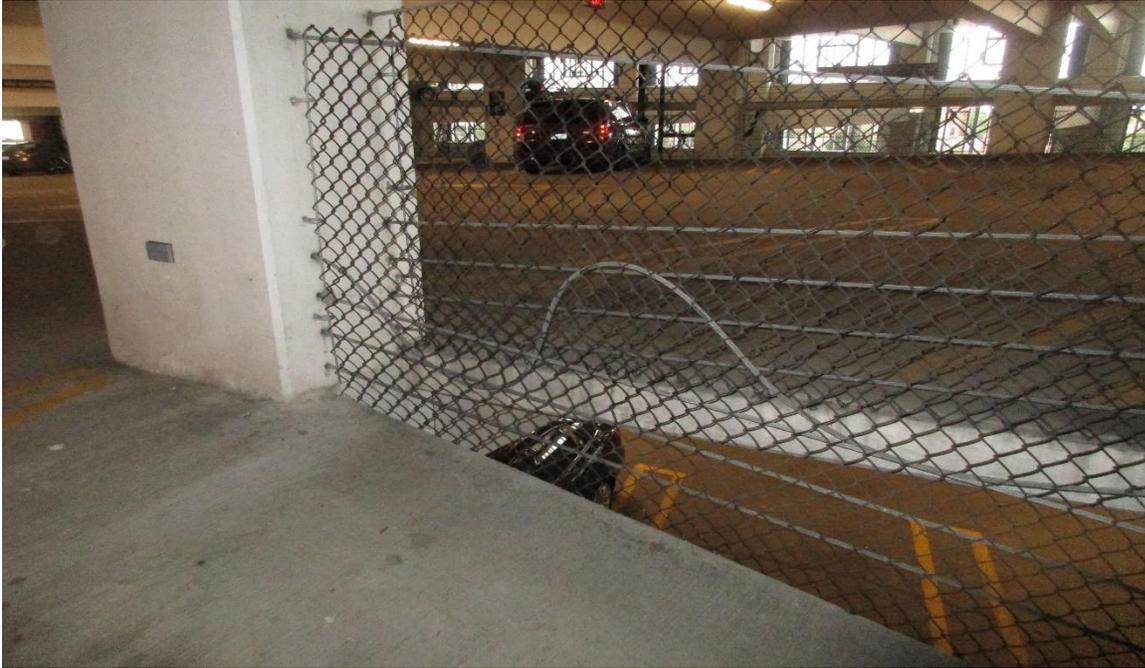
Figure 6.14. Failed barrier cable at Column PJ/P7 on Level 6.

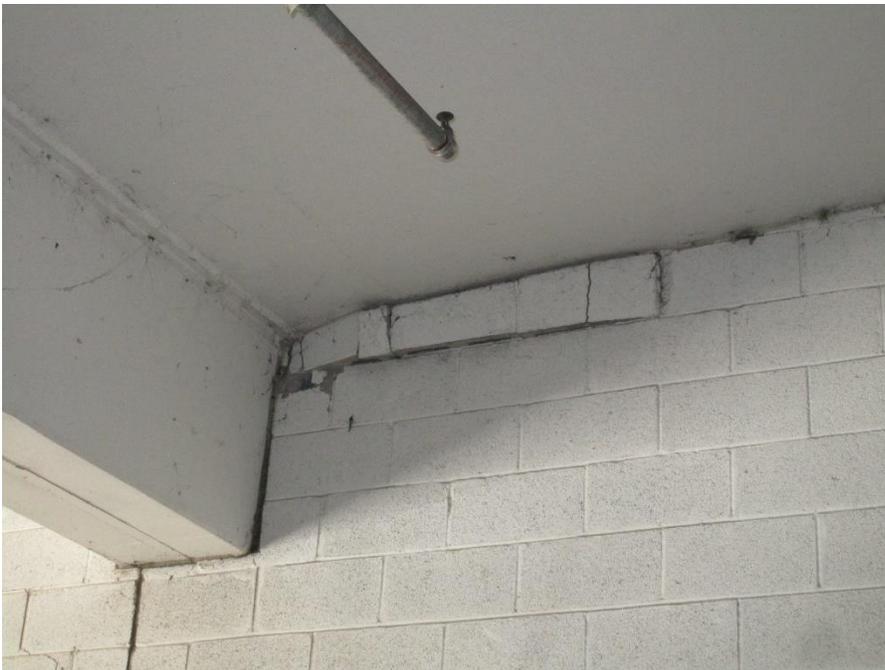
Figure 6.15. Dislodged and cracked CMU in the partition wall adjacent to the Davis Street exit ramp.

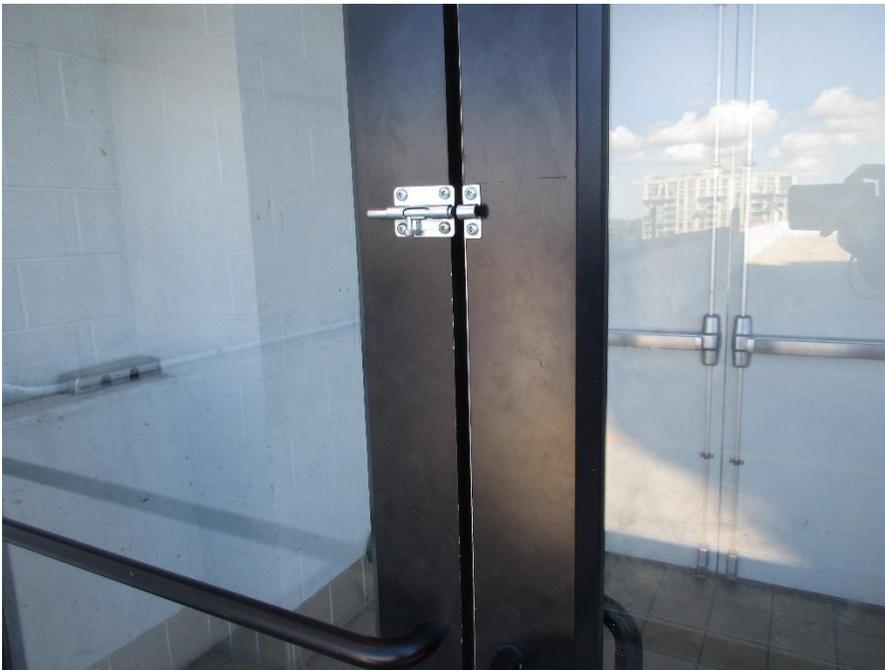
Figure 6.17. Sliding deadbolt affixed to exterior of the Level 12 vestibule in front of the northeast elevator bank.

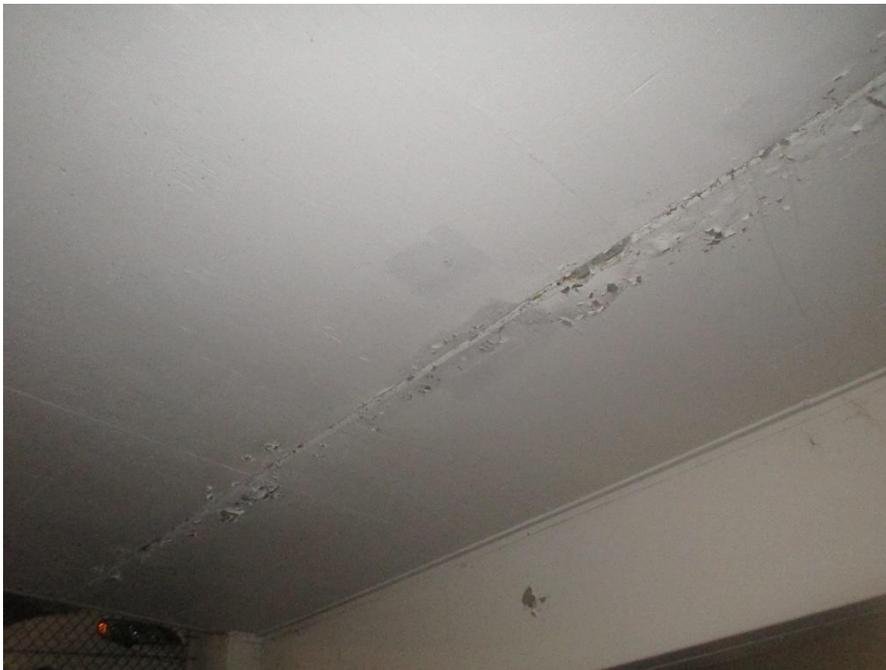
Figure 6.19. Joint in the East Bay of Level 5 presenting signs of moisture penetration, including moisture staining, corrosion staining and peeling paint.

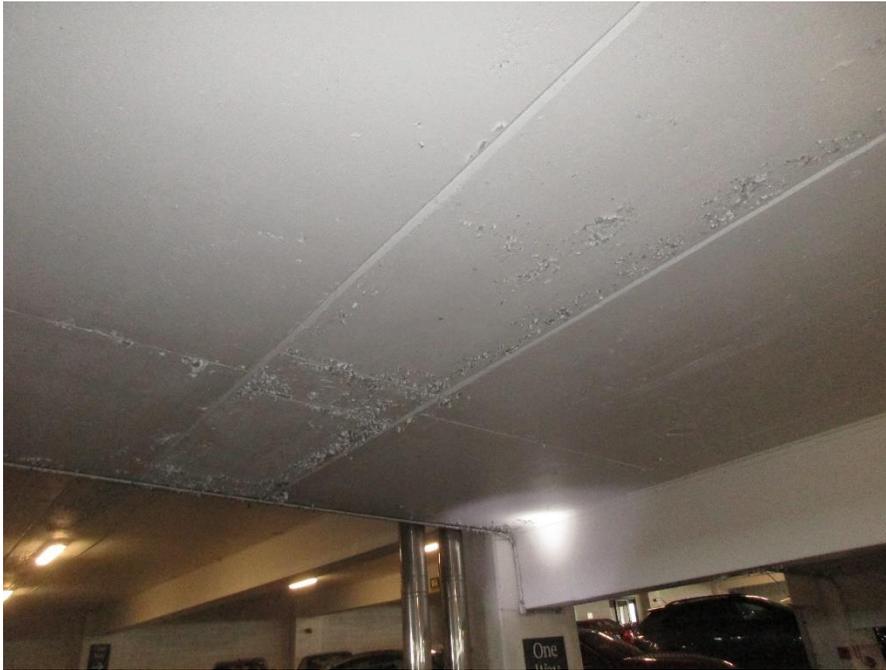
Figure 6.20. Paint peeling beneath the pour strip in the Middle Bay of the Level 7 deck.

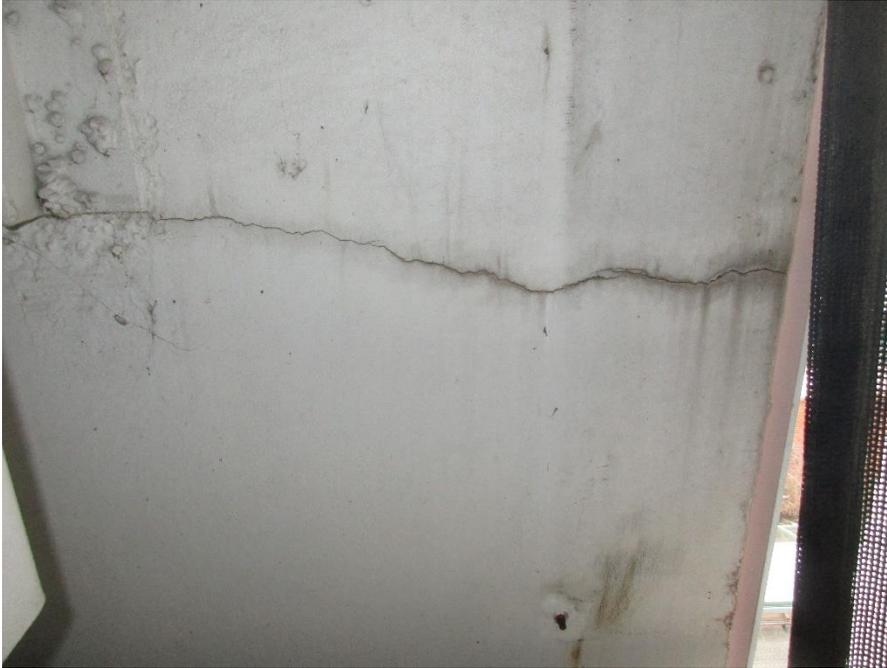
Figure 6.22. Crack in the facade panel anchored at Column PJ/P1 above the Level 5 slab with a maximum measured opening of 0.025 inches.

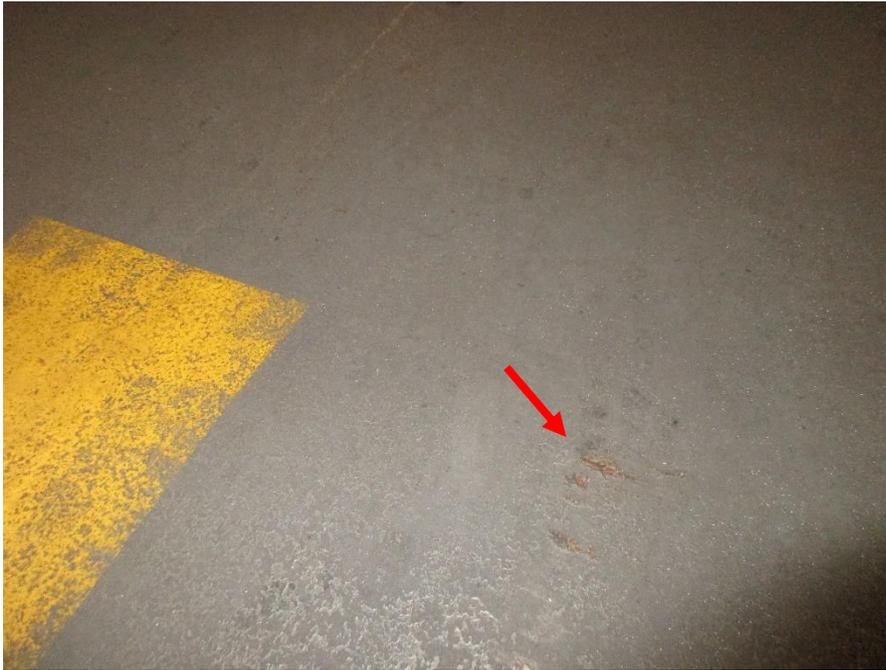
Figure 6.24. Worn waterproofing membrane on the Middle Bay slab ramping up from Level 2 to Level 3 near Column Line PK, with region worn through to the deck indicated with red arrow.

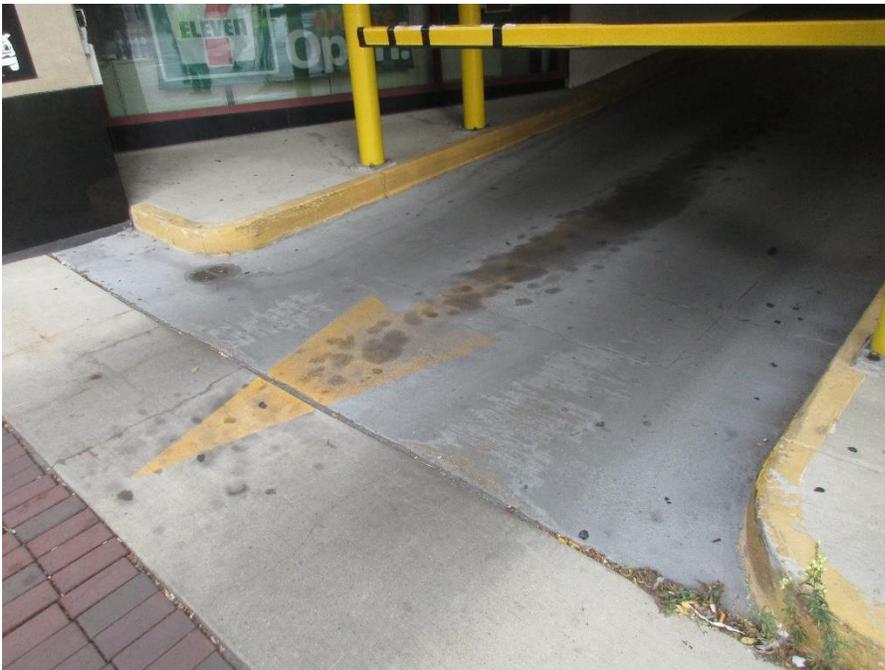
Figure 6.27. Davis Street exit ramp, showing membrane wear through to the concrete deck.

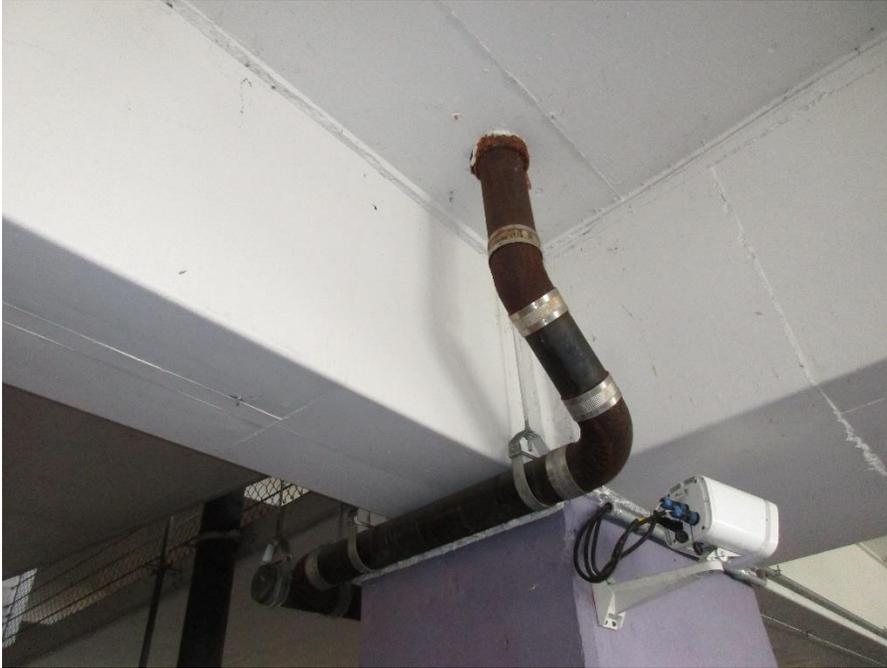
Figure 6.28. Moderate drain pipe corrosion near Column PN/P7 beneath the Level 7 slab.

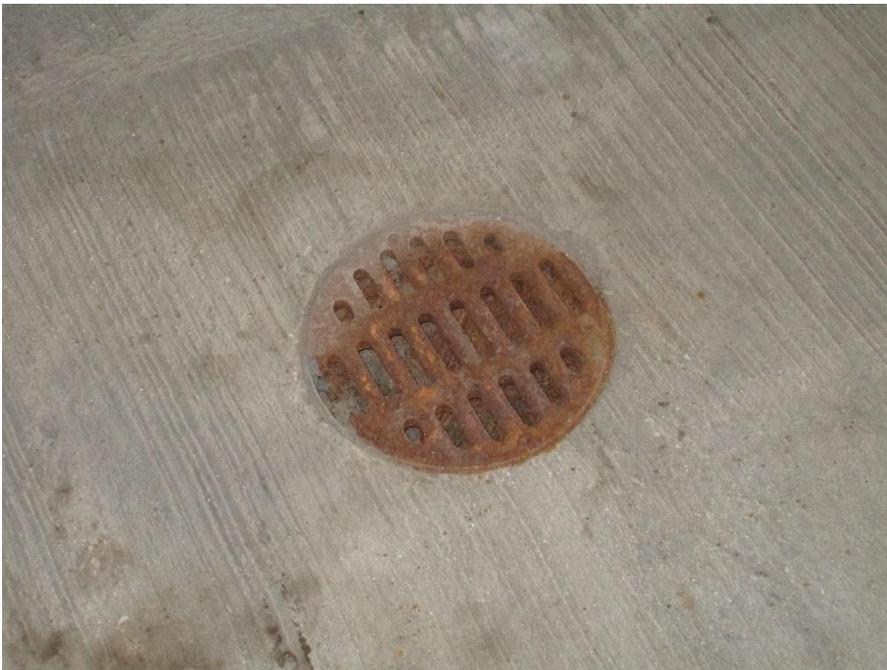
Figure 6.29. Corroded drain grate near Column PC/P4 on Level 10.

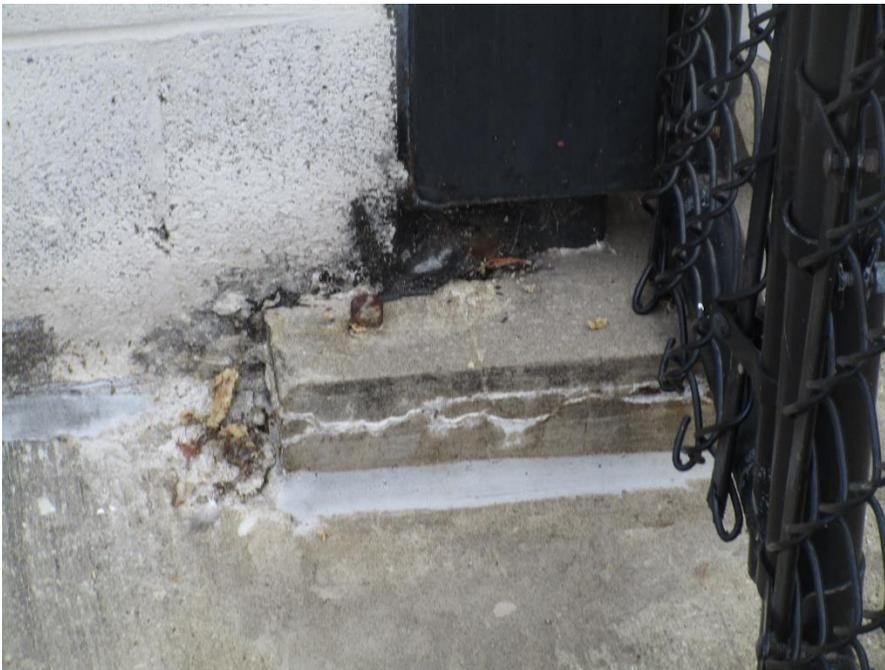
Figure 6.31. Freeze-thaw deterioration of concrete encasement over the steel column baseplate at the Level 12 vestibule in the northeast corner of the garage.

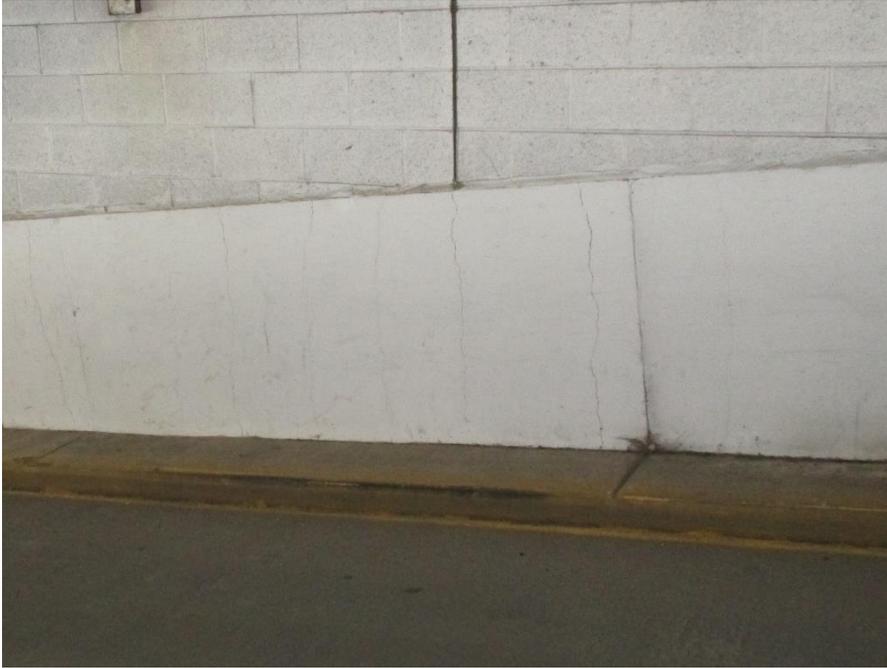
Figure 6.32. Regularly-spaced vertical cracking in the concrete edge wall along the west side of the Davis Street exit ramp.

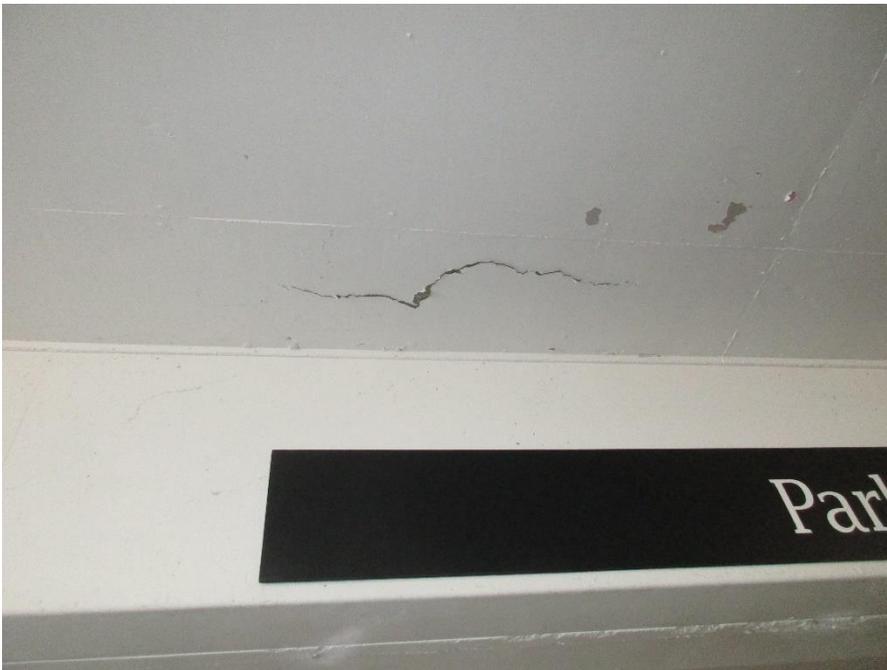
Figure 6.33. Overhead concrete delamination observed beneath the Level 4 deck.

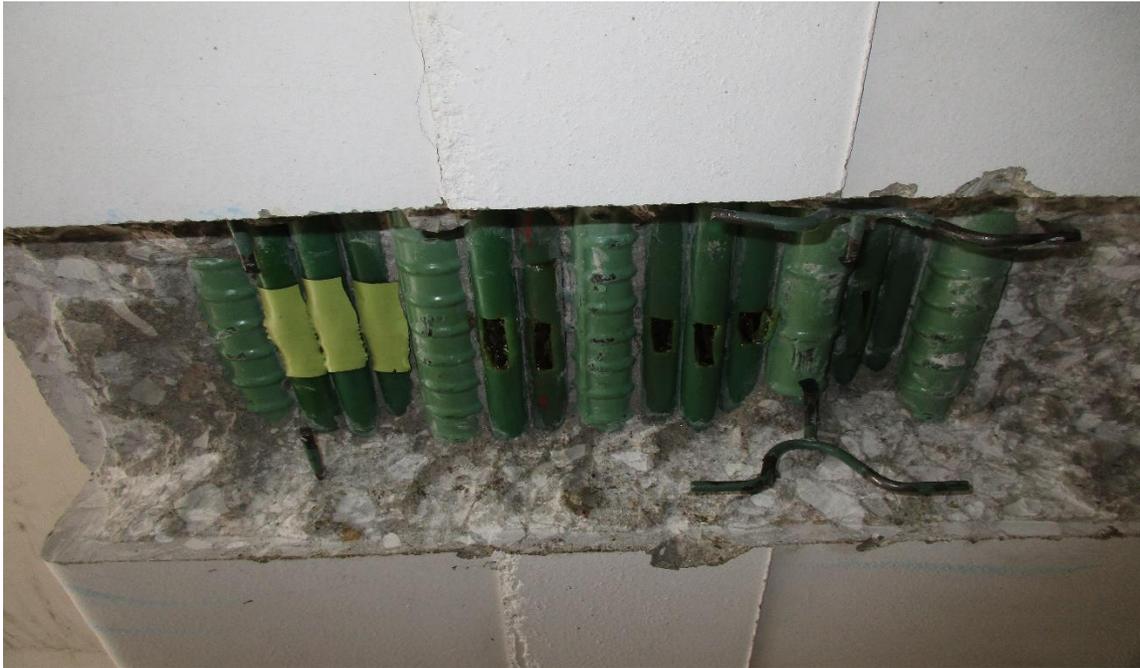
Figure 6.40. Post-tensioning strands and conventional reinforcing steel visible in the inspection opening made on the underside of Level 12 Beam PJ/P7-P10. The openings in the sheathing of the three strands at left are covered with sheathing repair tape.

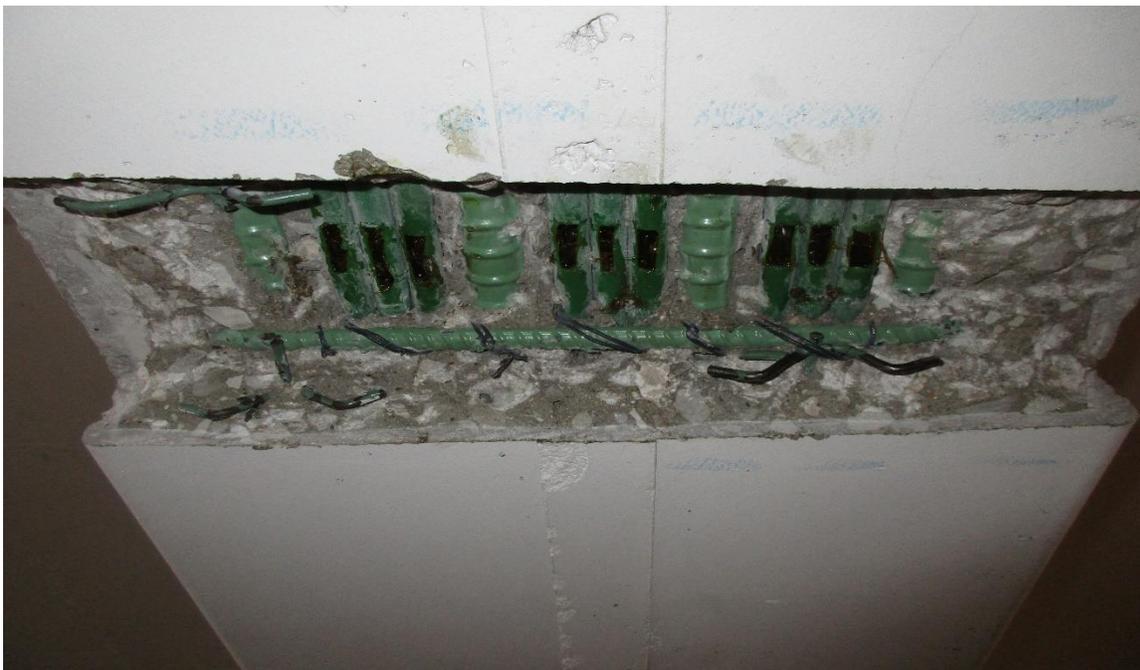
Figure 6.41. Post-tensioning strands and conventional reinforcing steel visible in the inspection opening made on the underside of Level 12 Beam PP/P7-P10.
