## Roof Evaluation - Various City Facilities

### Recycling Center

Location: 2222 Oakton Year Built: 1990 Rehabbed: N/A Overall rating: Fair

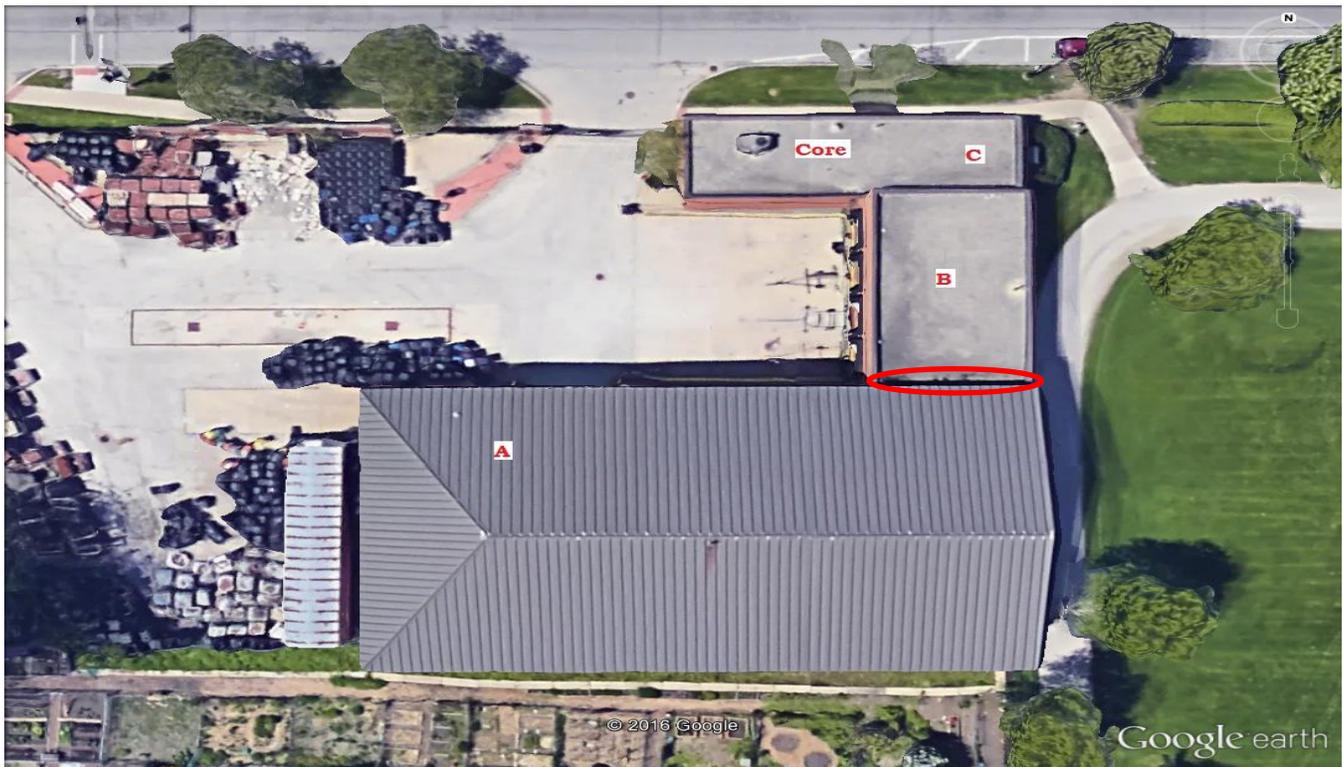
**Current condition:** Per observation, the coping and flashing appeared to be in good condition. However, vegetation was present and this needs to be removed, to prevent further growth and existence of unwanted material.

Area where vegetation was located.

**Recommended Strategy:** Maintenance
