| # | DESCRIPTION | DATE |
|---|---|---|
| 01 | HISTORIC TAX CREDIT | 2020.06.05 |

REVIVE  
ARCHITECTURE

CLIENT/OWNER  
CELADON CONSTRUCTION CORPORATION NFP

ARCHITECT OF RECORD  
ASSEMBLE DESIGN WORKSHOP PLLC

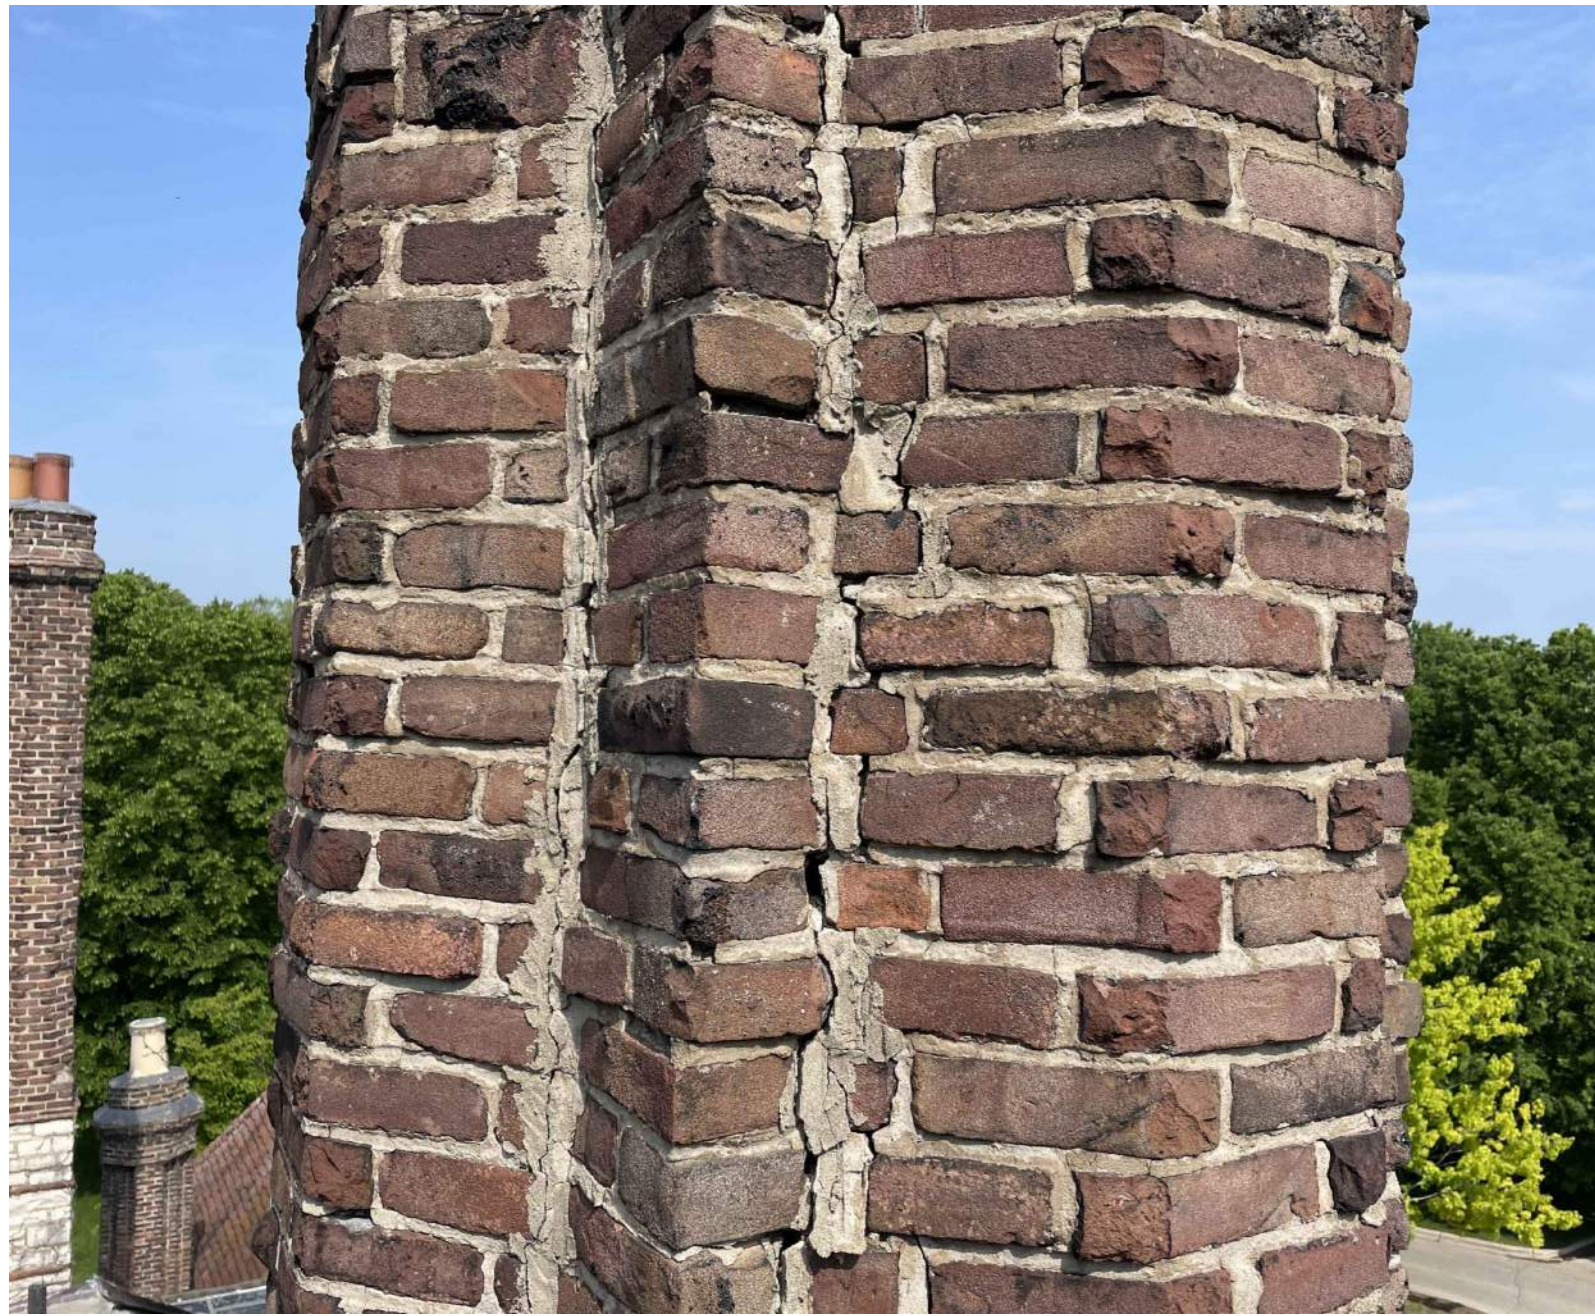
13 CRACKED CORNER AT CHIMNEY  
SCALE: NONE

| BUILDING ENVELOPE REHABILITATION<br>Harley Clarke Mansion - 2603 Sheridan Rd, Evanston, IL. (DATED 06-01-2026) | | | | | |
|---|---|---|---|---|---|
| | ii. Rebuild corner of brick masonry at vertical cracking on southwest and northeast chimneys. Stabilize surrounding areas as required | 150 | SF | \$ - | \$ - |

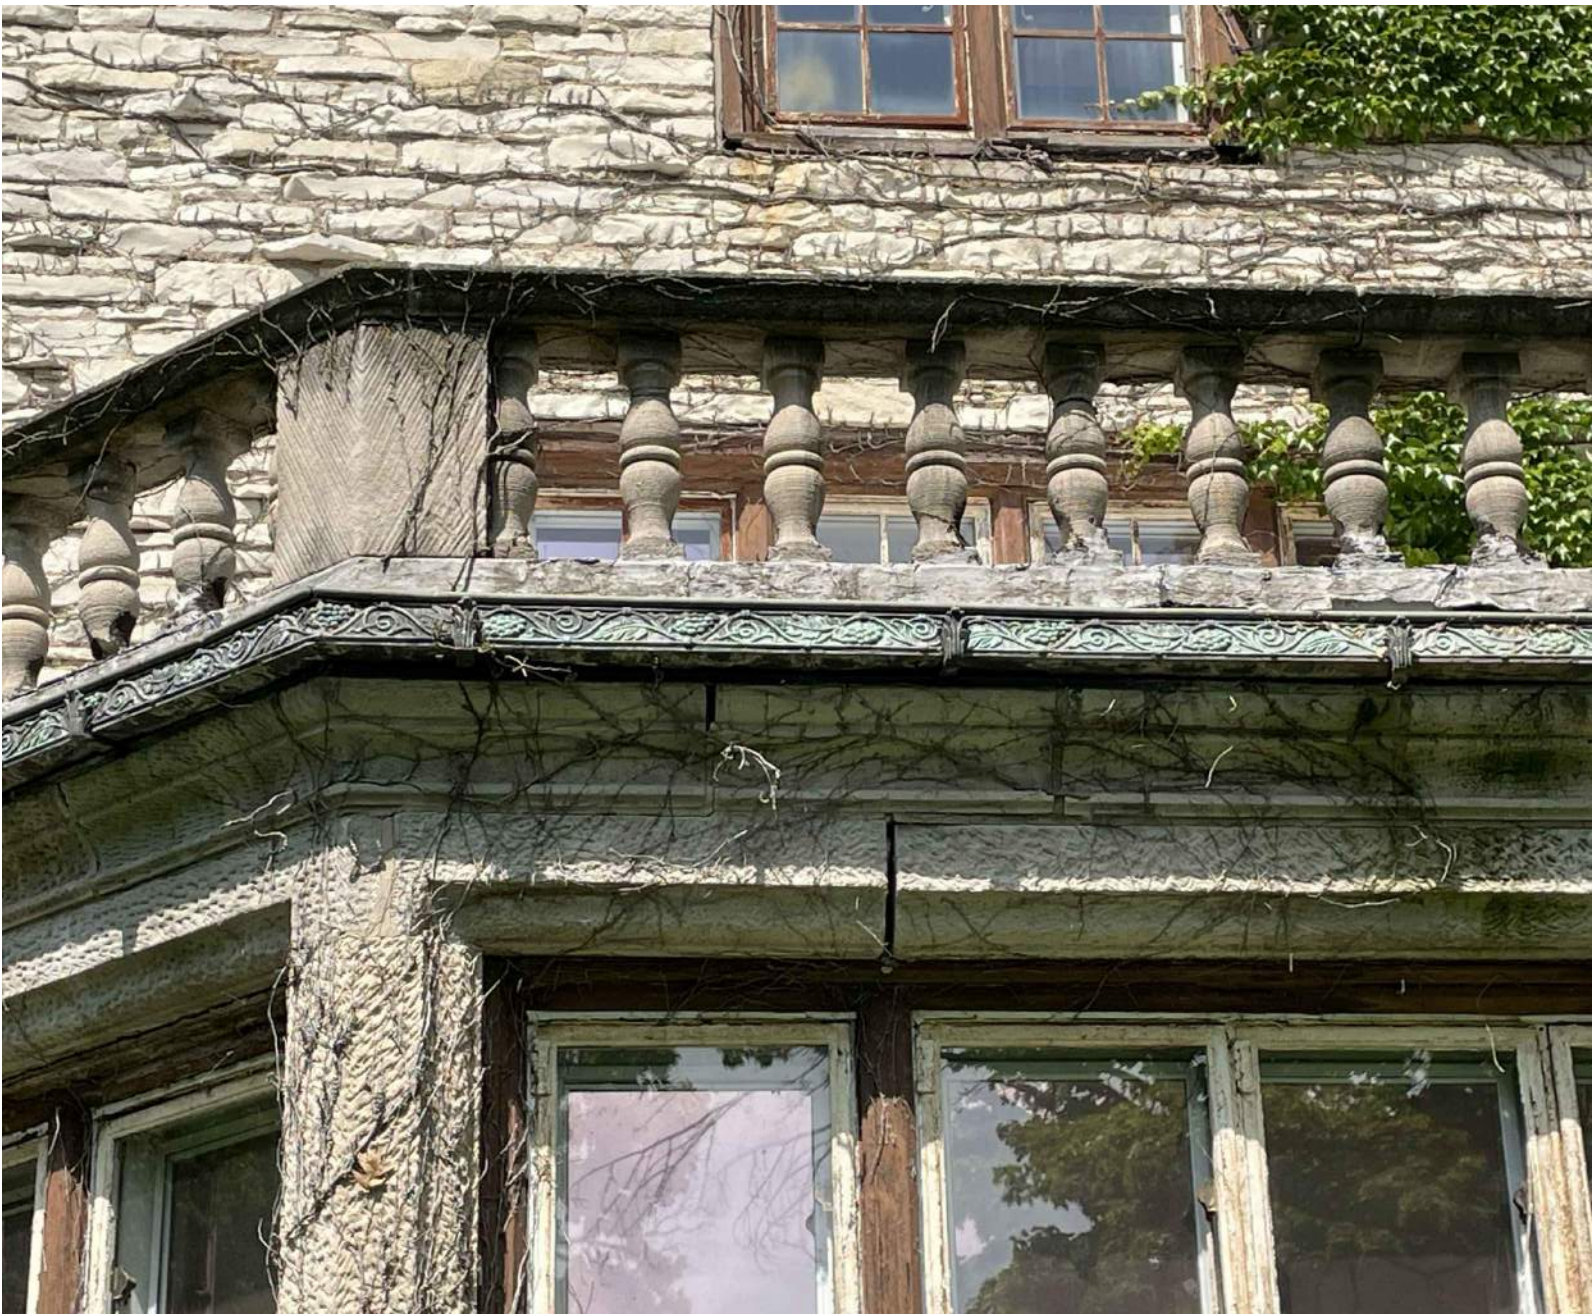
5 EAST SUNROOM PARAPET WALL  
SCALE: NONE

| BUILDING ENVELOPE REHABILITATION<br>Harley Clarke Mansion - 2603 Sheridan Rd, Evanston, IL. (DATED 06-01-2026) | | | | | |
|---|---|---|---|---|---|
| | i. Remove + reset stone parapet wall down to window head at sunroom. Include resetting of stone copings, corners, watertables and head units. Replacement stone units included separately under Item 3b. Coordinate with roof flashing work. Include stainless steel straps and pins for lateral anchorage | | LUMP SUM | | \$ - |

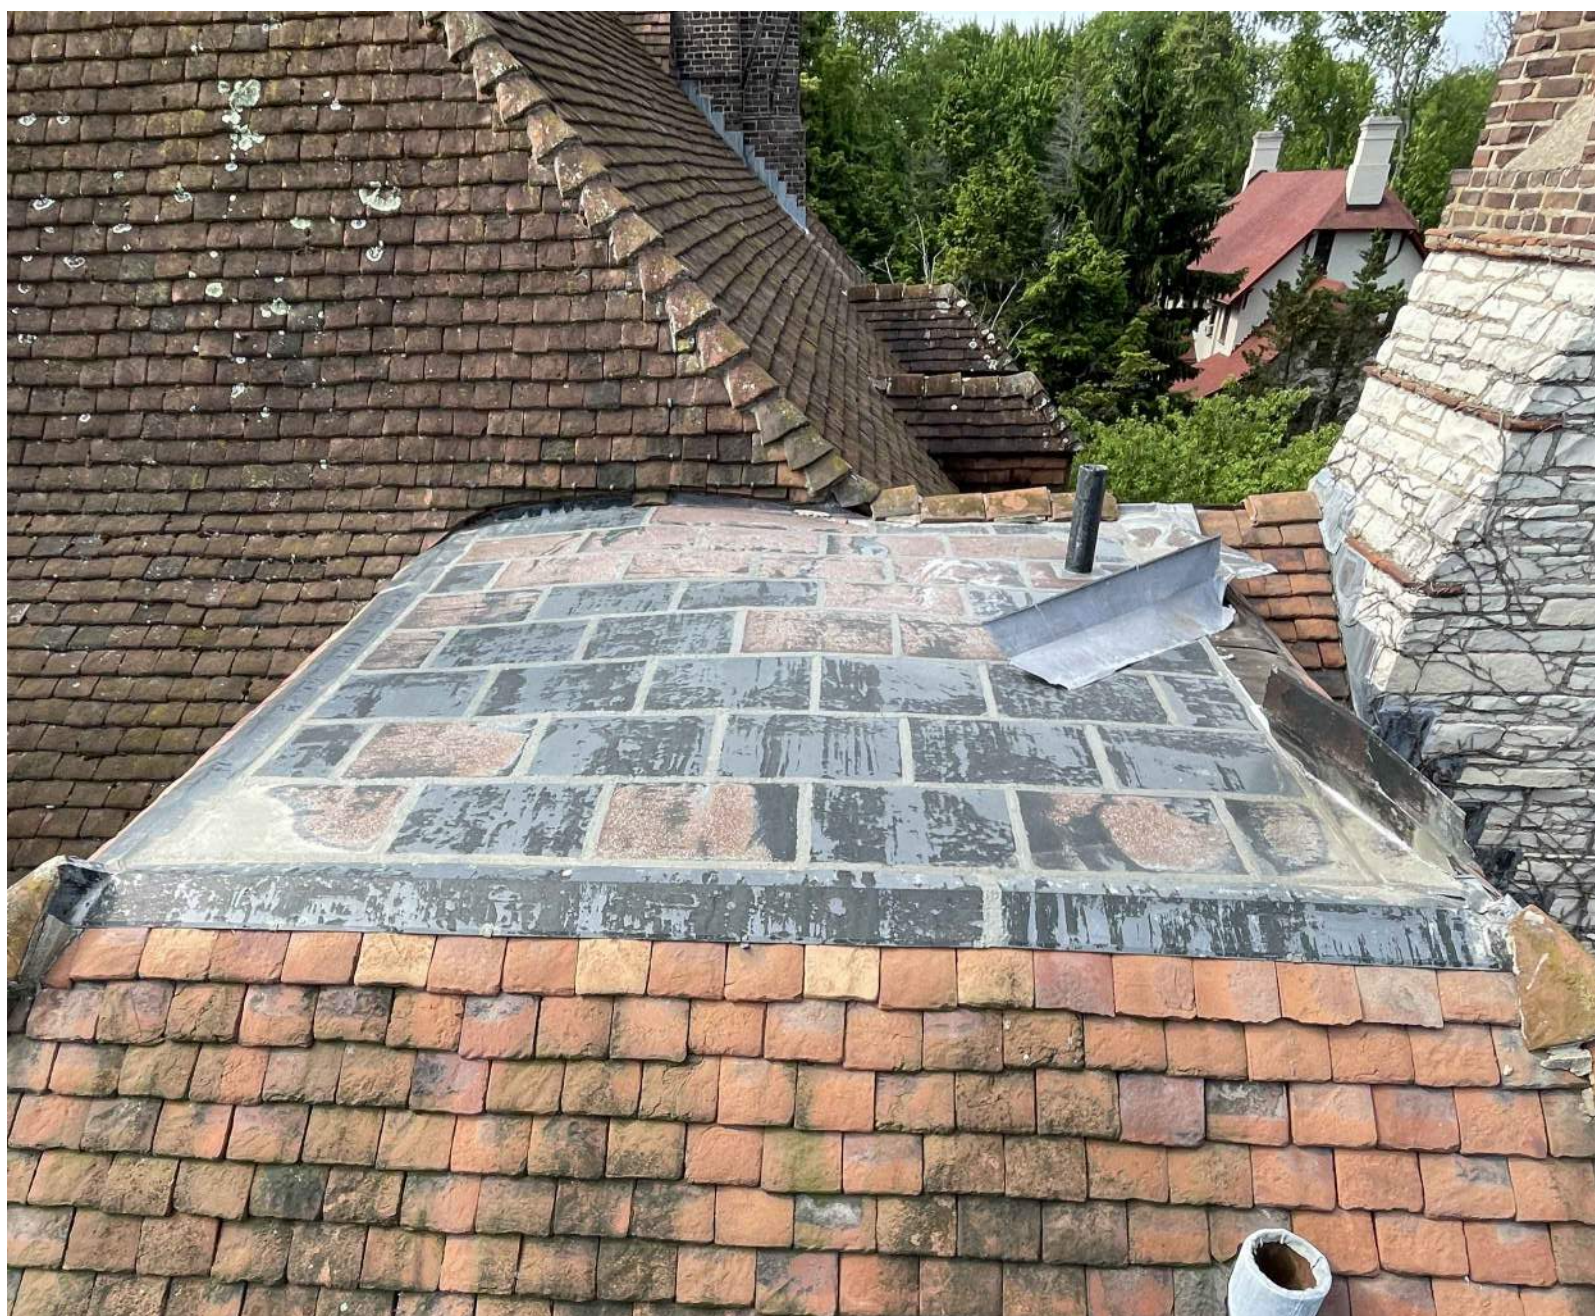
10 NORTH COPPER ROOF  
SCALE: NONE

| BUILDING ENVELOPE REHABILITATION<br>Harley Clarke Mansion - 2603 Sheridan Rd, Evanston, IL. (DATED 06-01-2026) | | | | | |
|---|---|---|---|---|---|
| | b. Replace flat copper roof in-kind at north railing. Include removal and resetting of railing as required and replacement of copper gutter | | LUMP SUM | | \$ - |

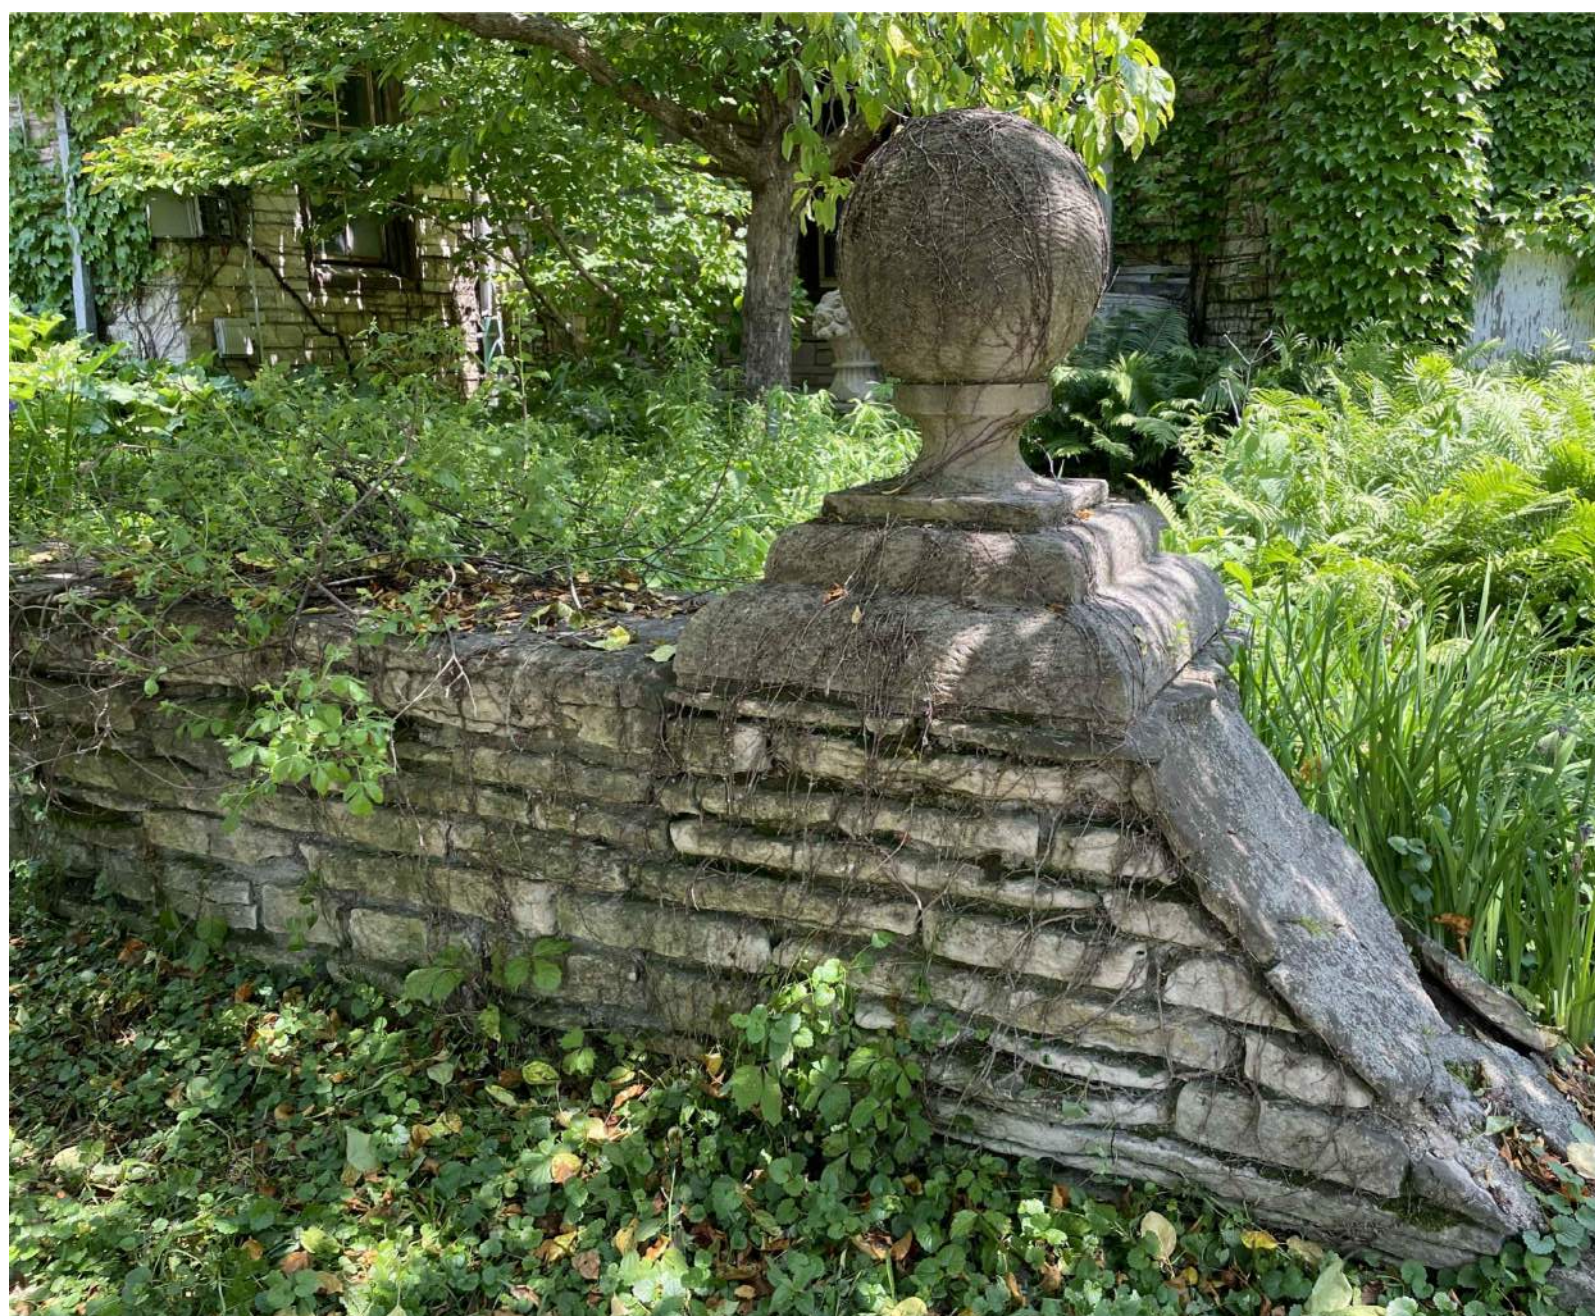
15 WEST STONE SITE WALL  
SCALE: NONE

| BUILDING ENVELOPE REHABILITATION<br>Harley Clarke Mansion - 2603 Sheridan Rd, Evanston, IL. (DATED 06-01-2026) | | | | | |
|---|---|---|---|---|---|
| | vii. Coping unit replacement at west site wall | 20 | EACH | \$ - | \$ - |
| | viii. Curved coping unit replacement at west site wall | 6 | EACH | \$ - | \$ - |
