# Mechanical Systems Assessment

## Lorraine H. Morton Civic Center

### August 26, 2019

MECHANICAL SYSTEMS ASSESSMENT AND  
REVIEW OF UPGRADE ALTERNATIVES

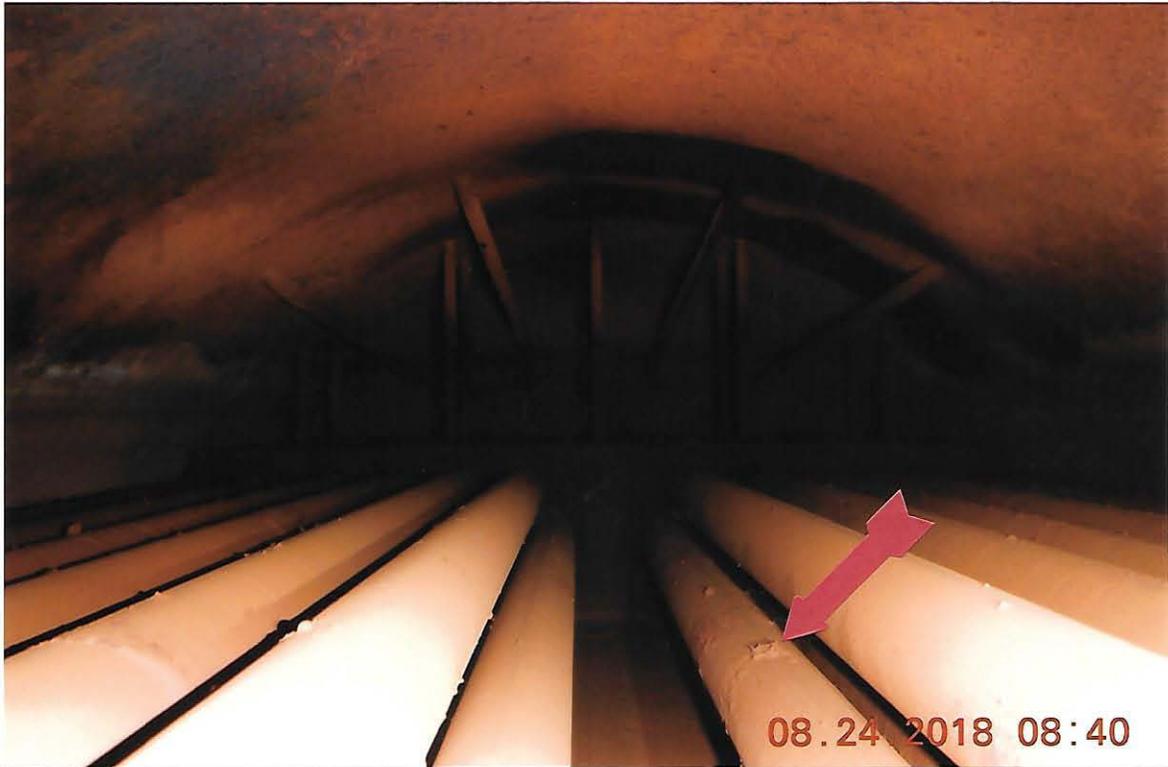
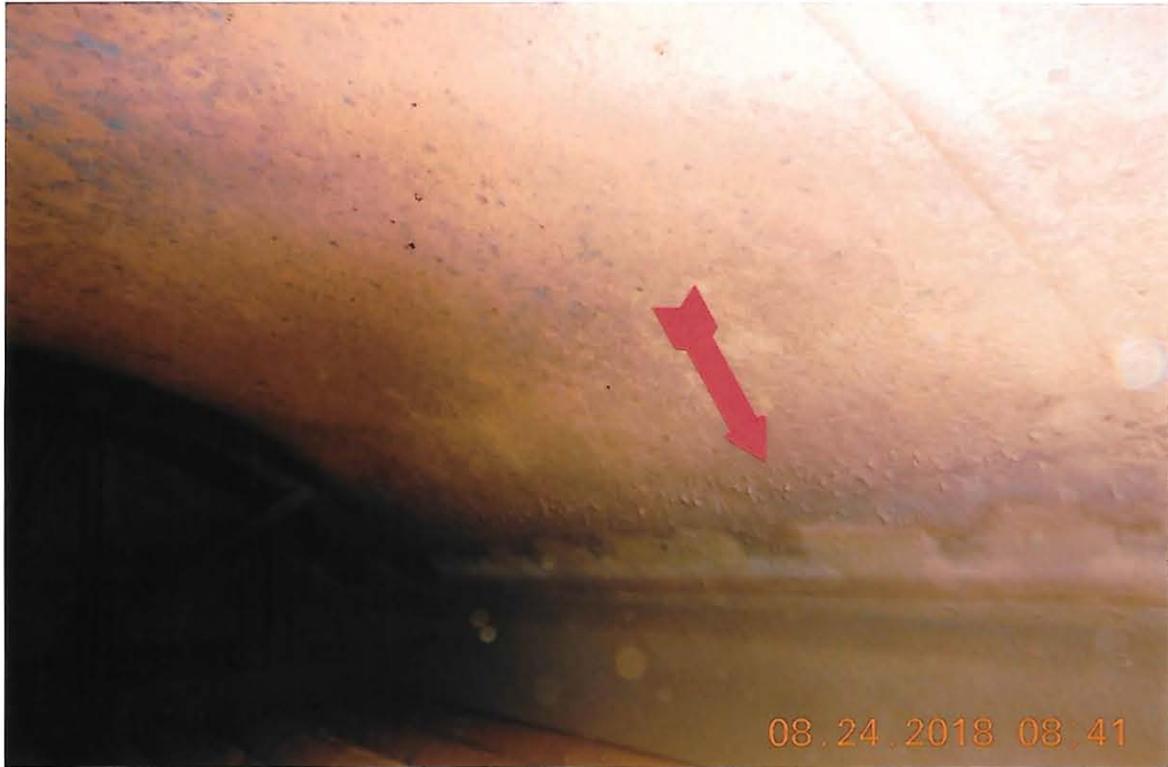
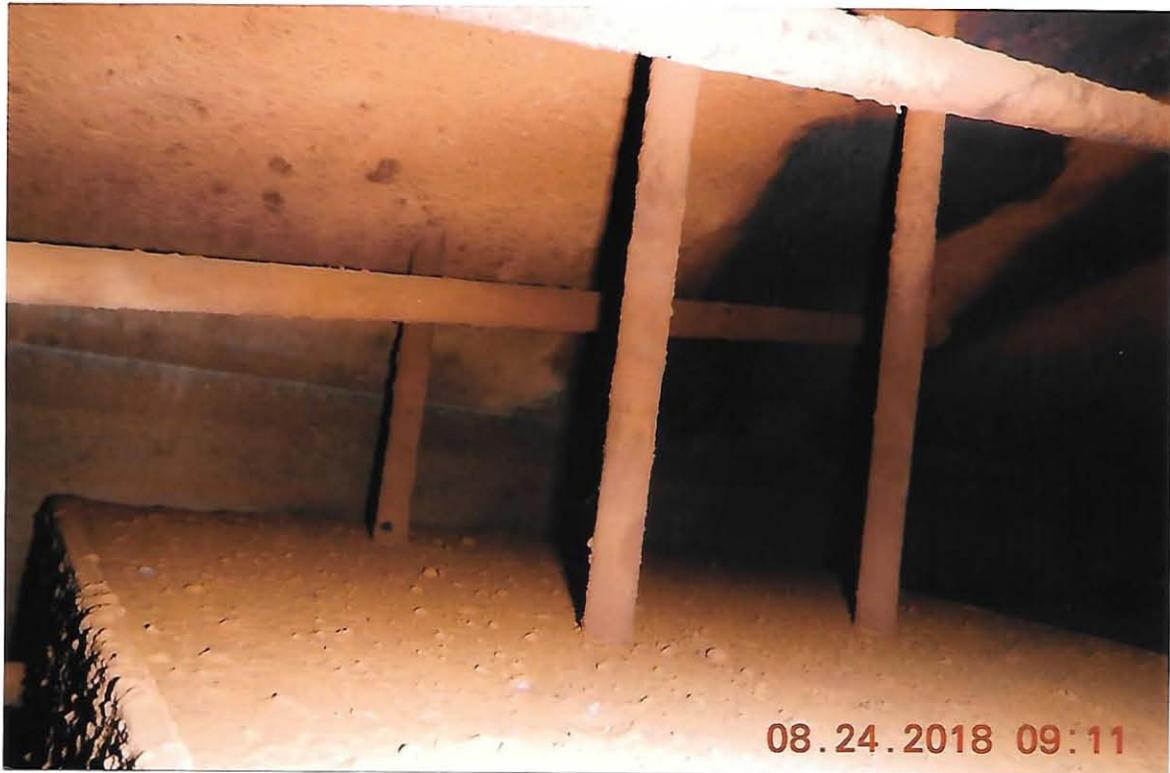
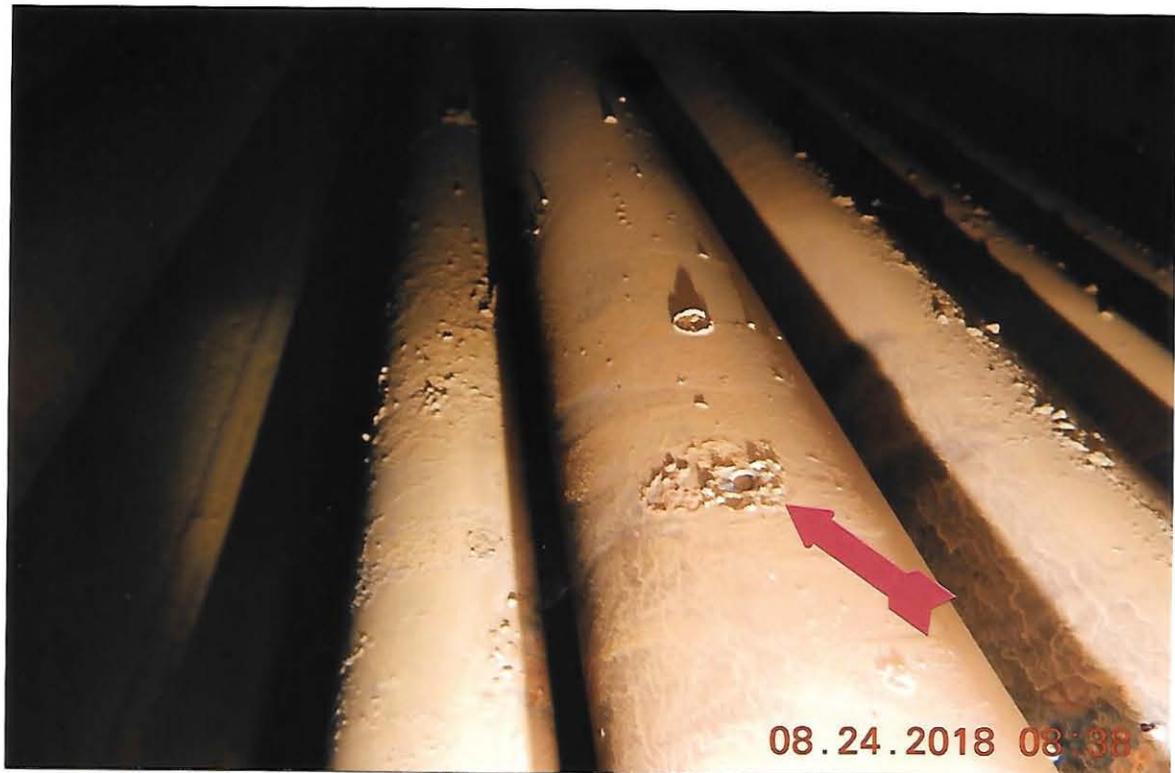
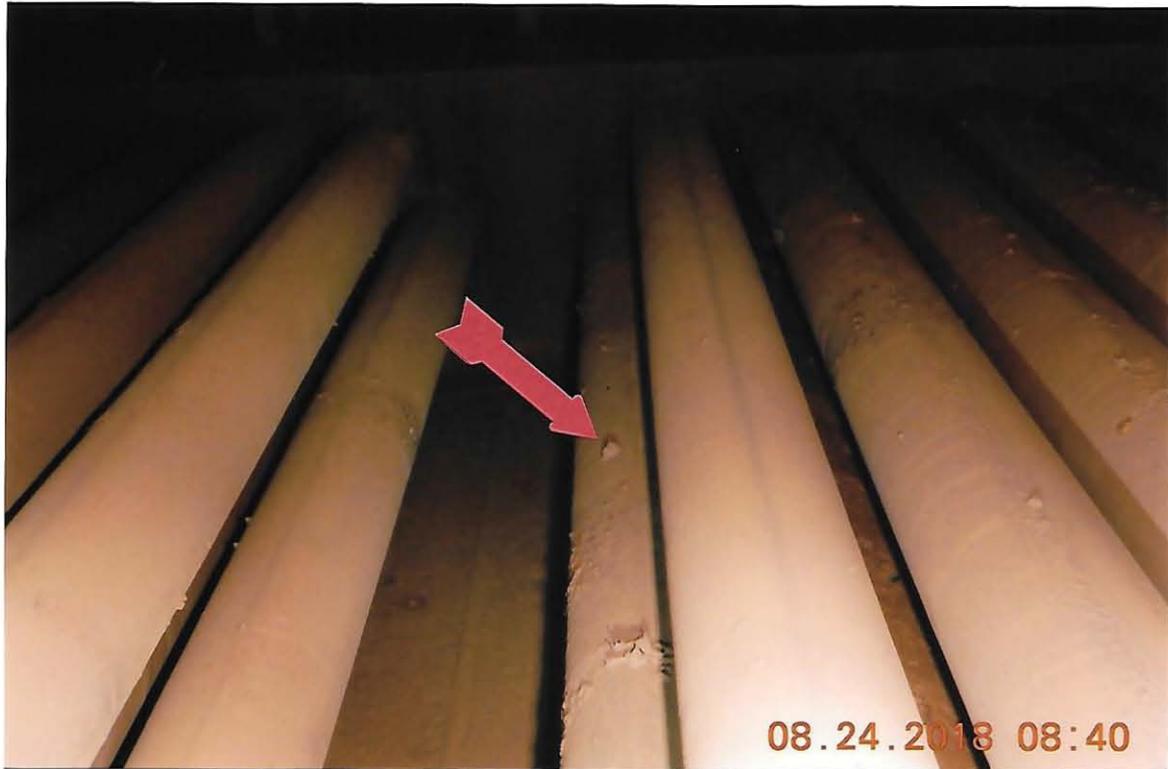
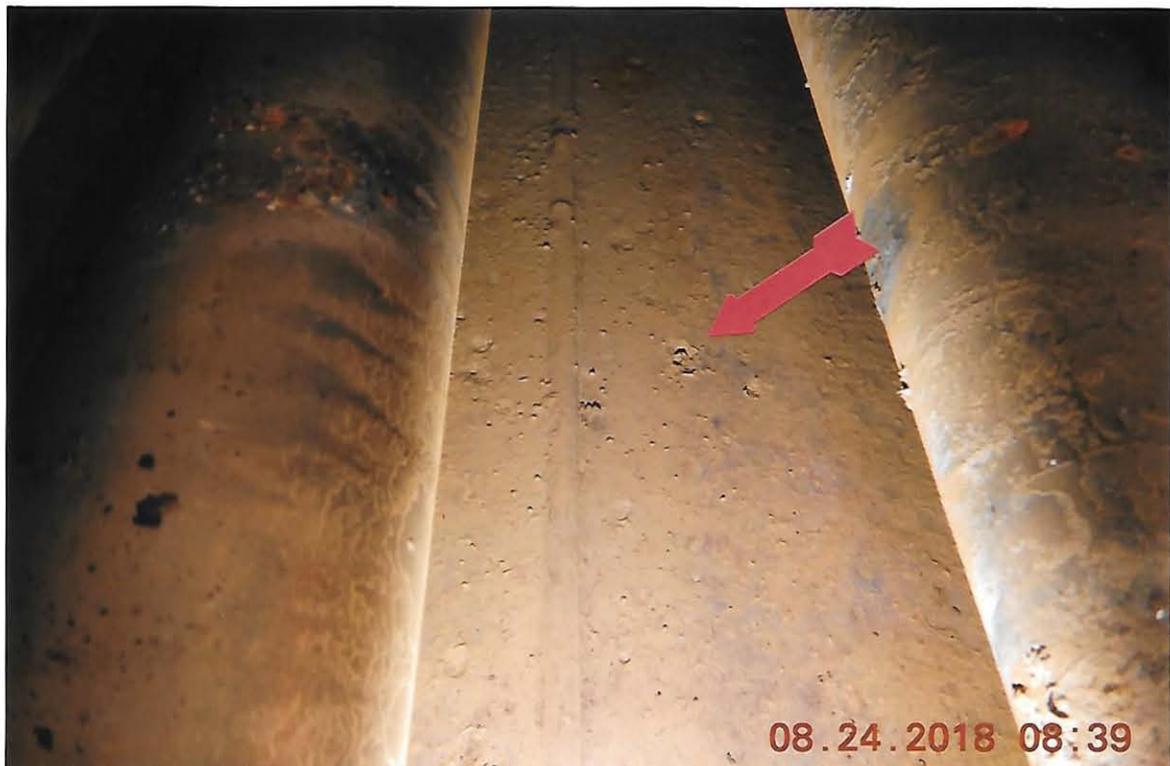
The following ten (10) photos show the condition of the boiler's waterside as viewed from the top manway. Scale and tubercles were observed on the accessible tubes, boiler shell, and furnace sheet. Heavy under deposit pitting and corrosion were observed in the tubes. Light pitting was noted on the accessible furnace sheet.

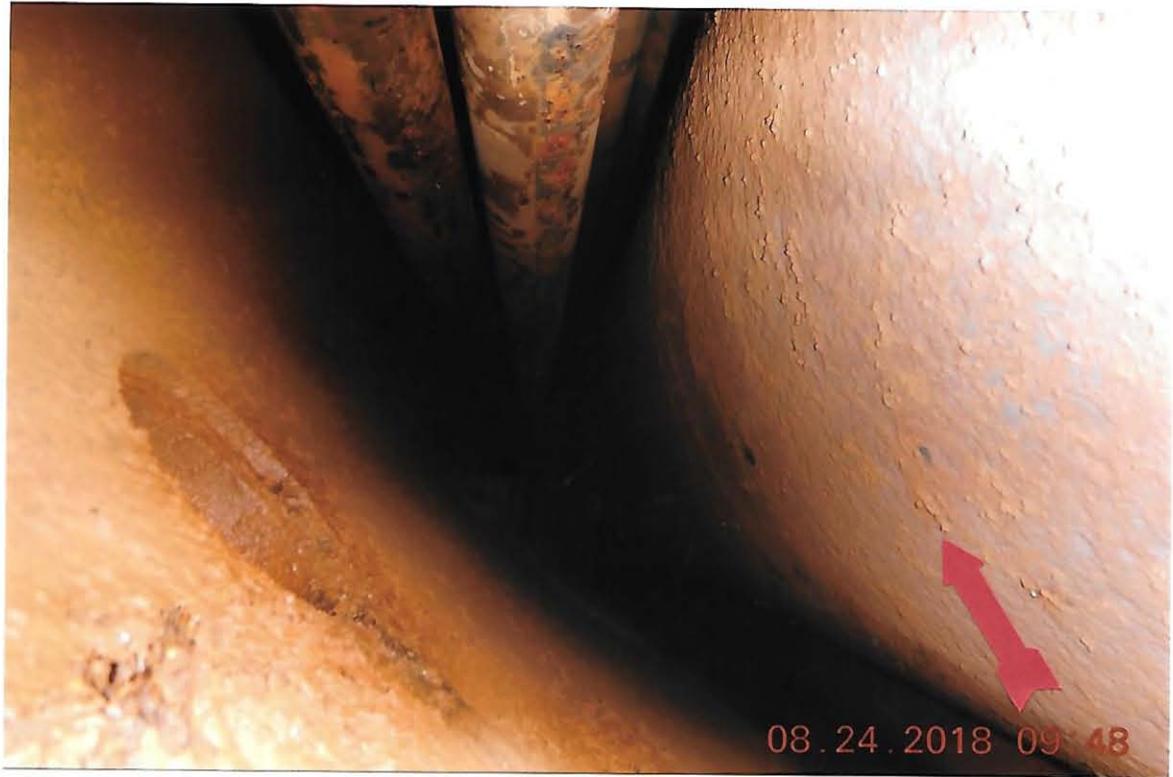
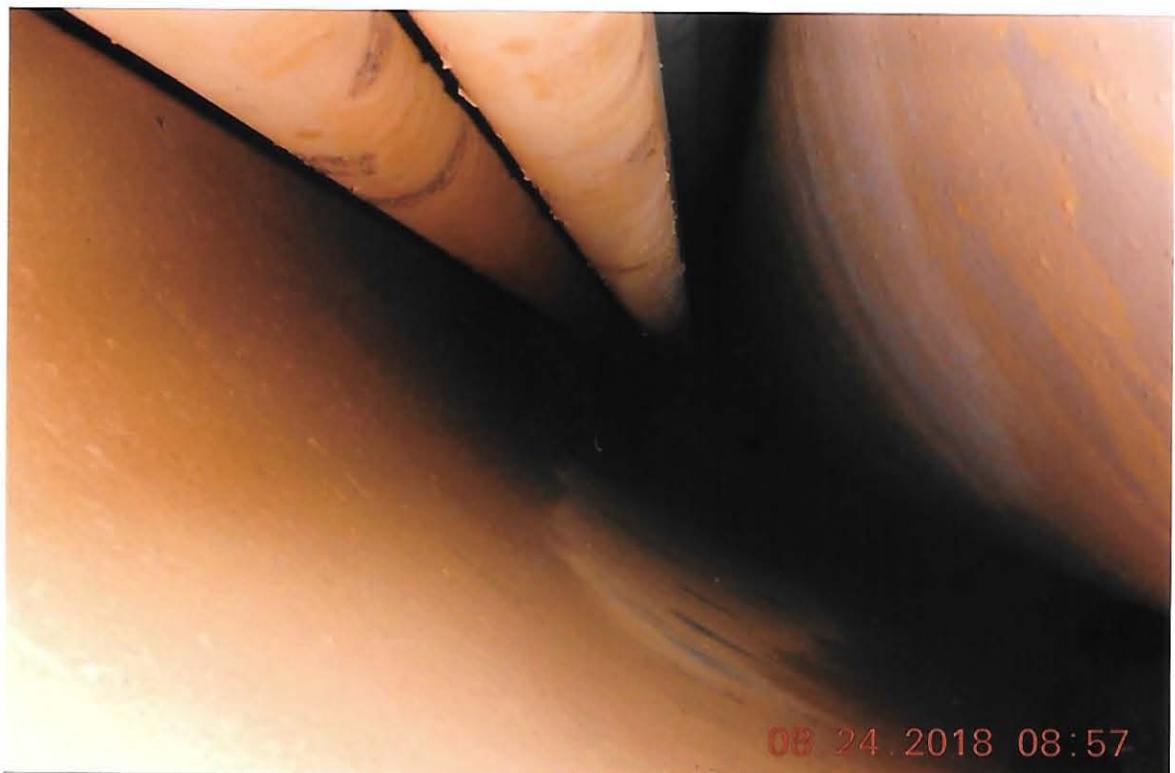
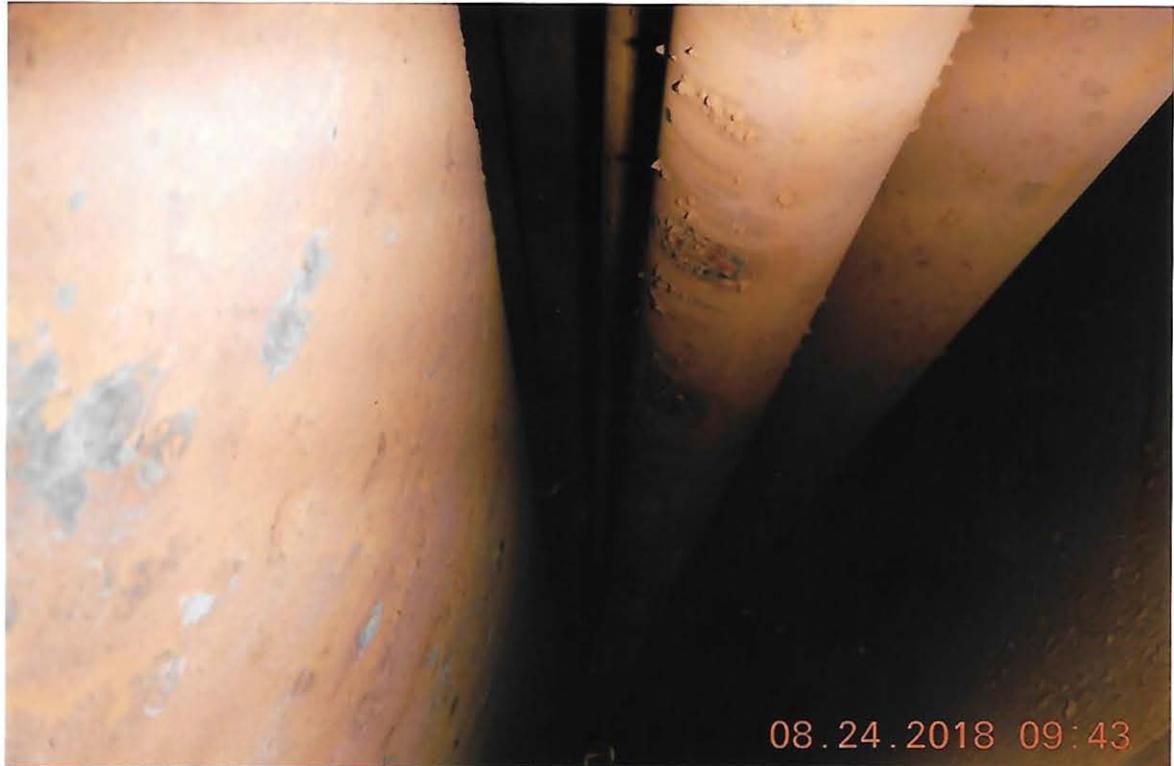
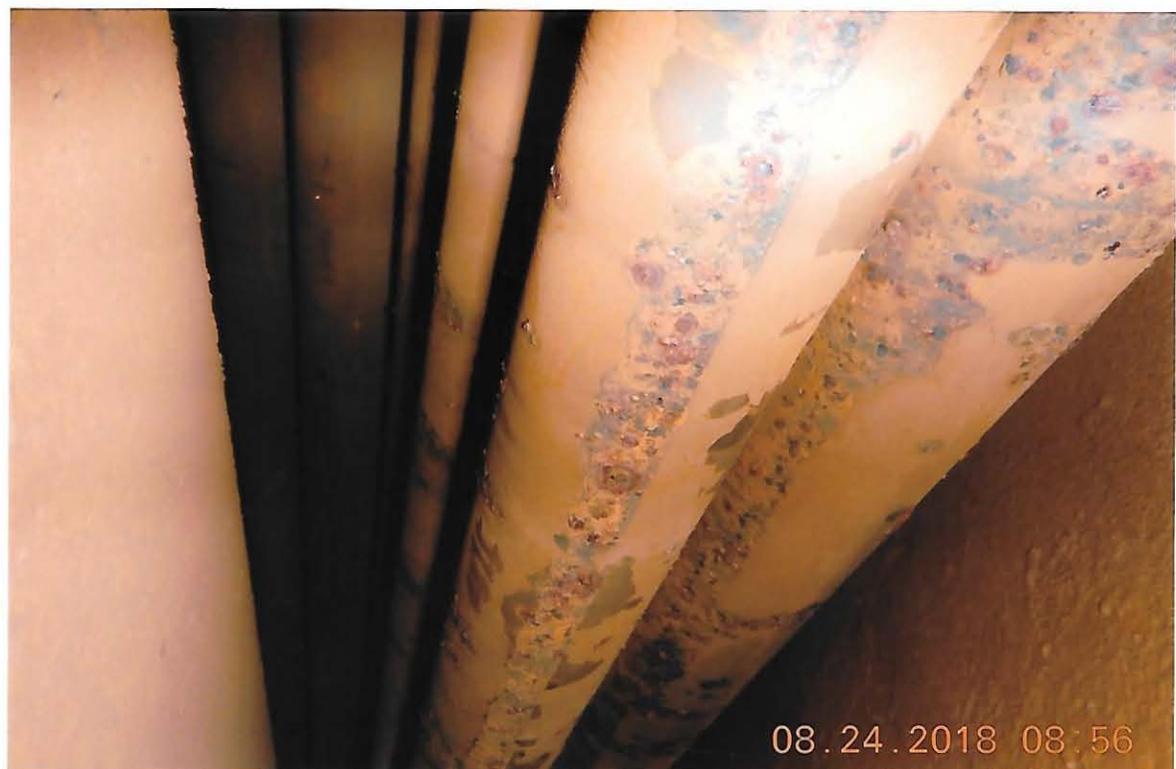
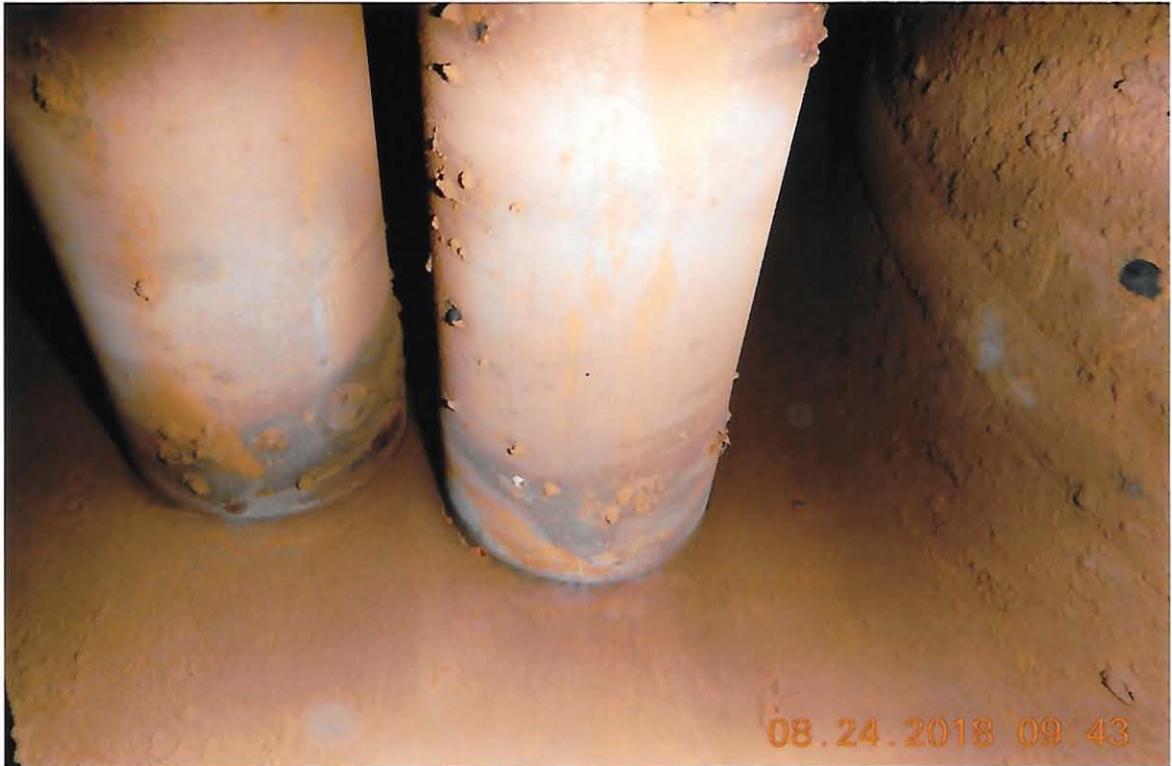
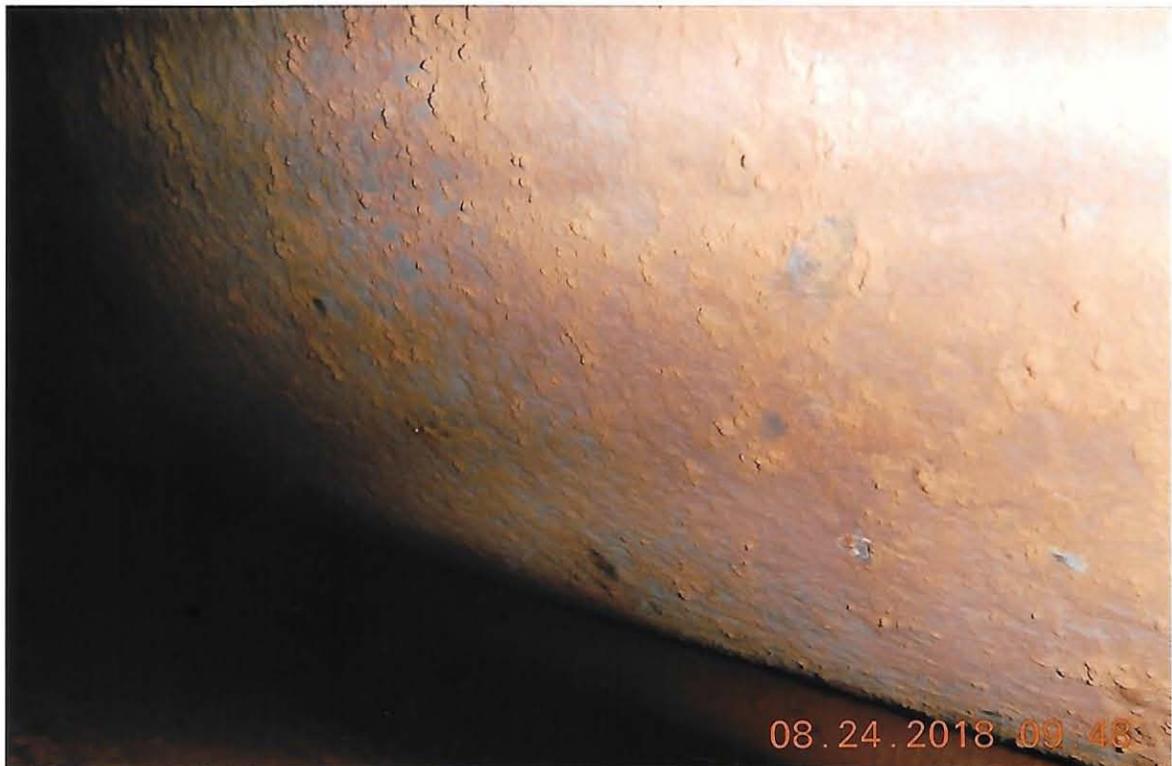
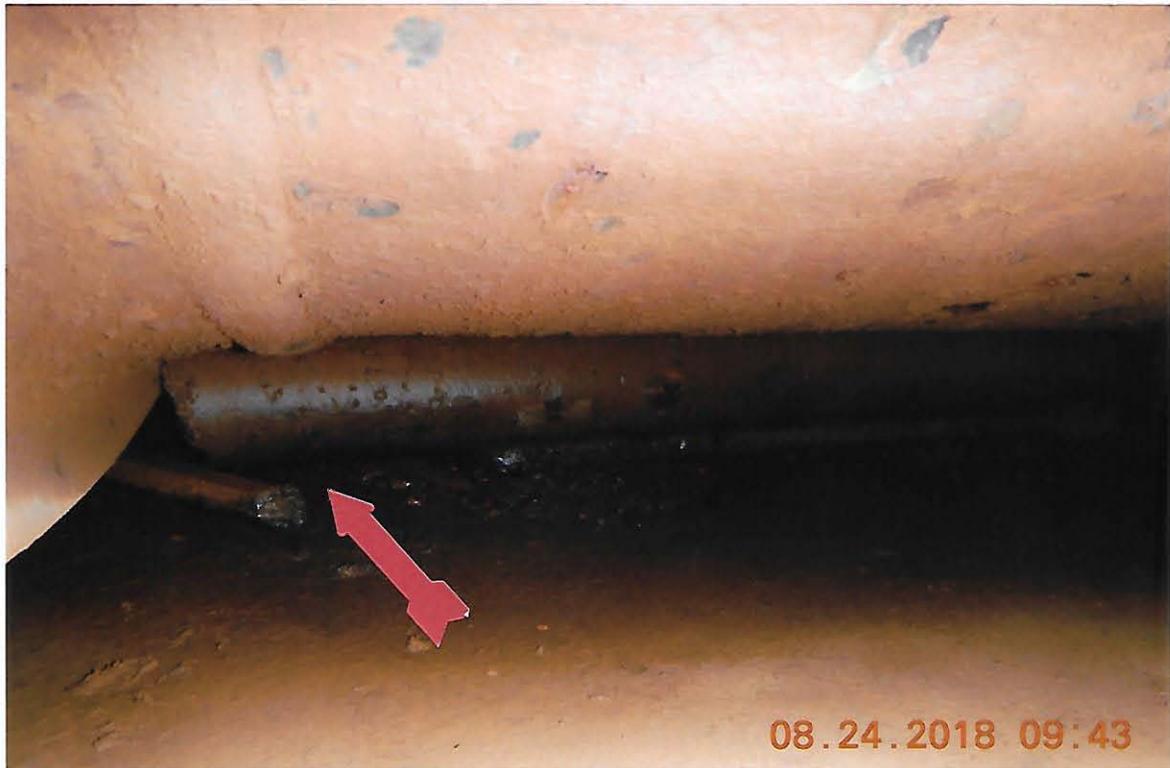
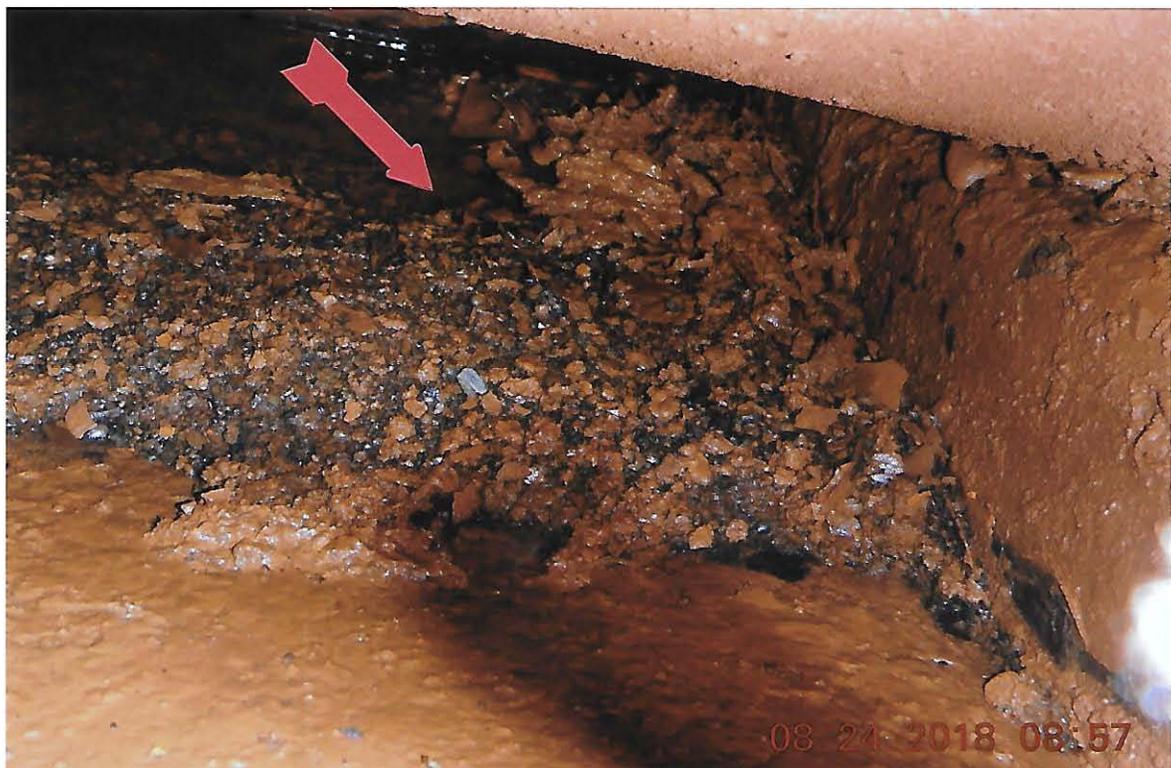
The following ten (10) photos show the condition of the boiler's waterside as viewed from the lower handholes. Scale and tubercles were observed on the accessible tubes, boiler shell, and furnace sheet. An old cut-out tube was noted at the bottom of the shell. A moderate accumulation of sediment and debris was observed at the bottom of the shell.

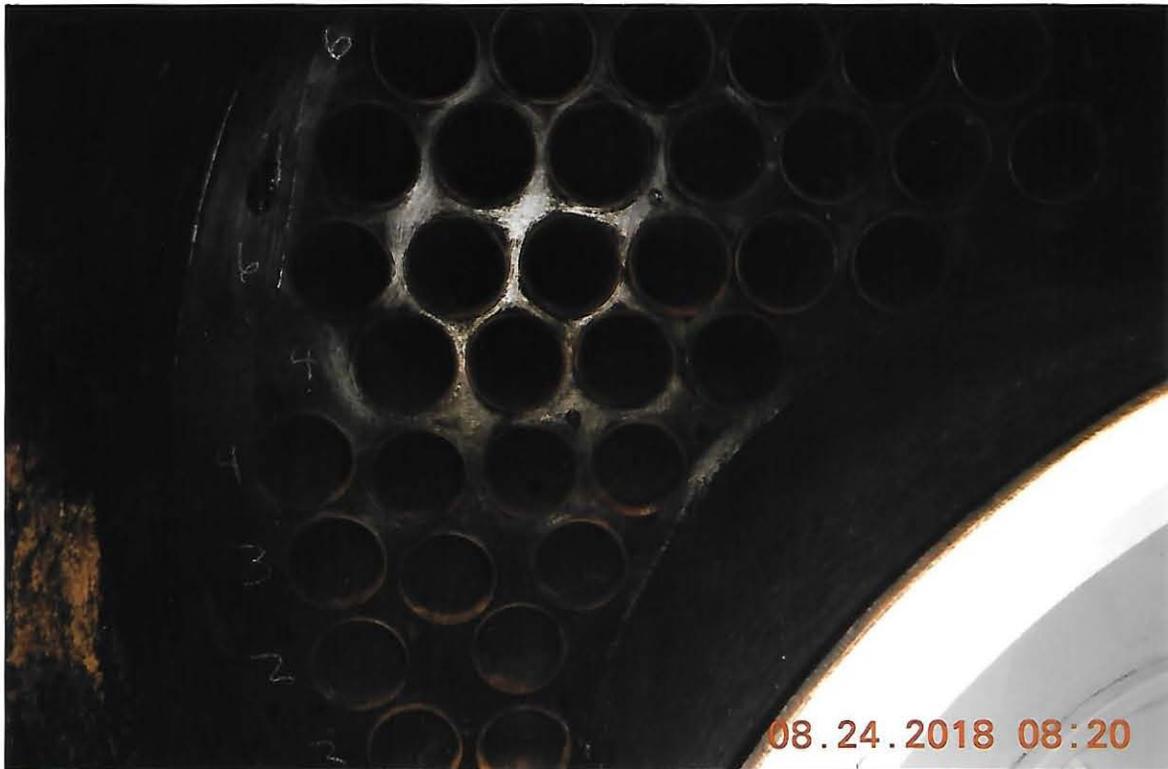
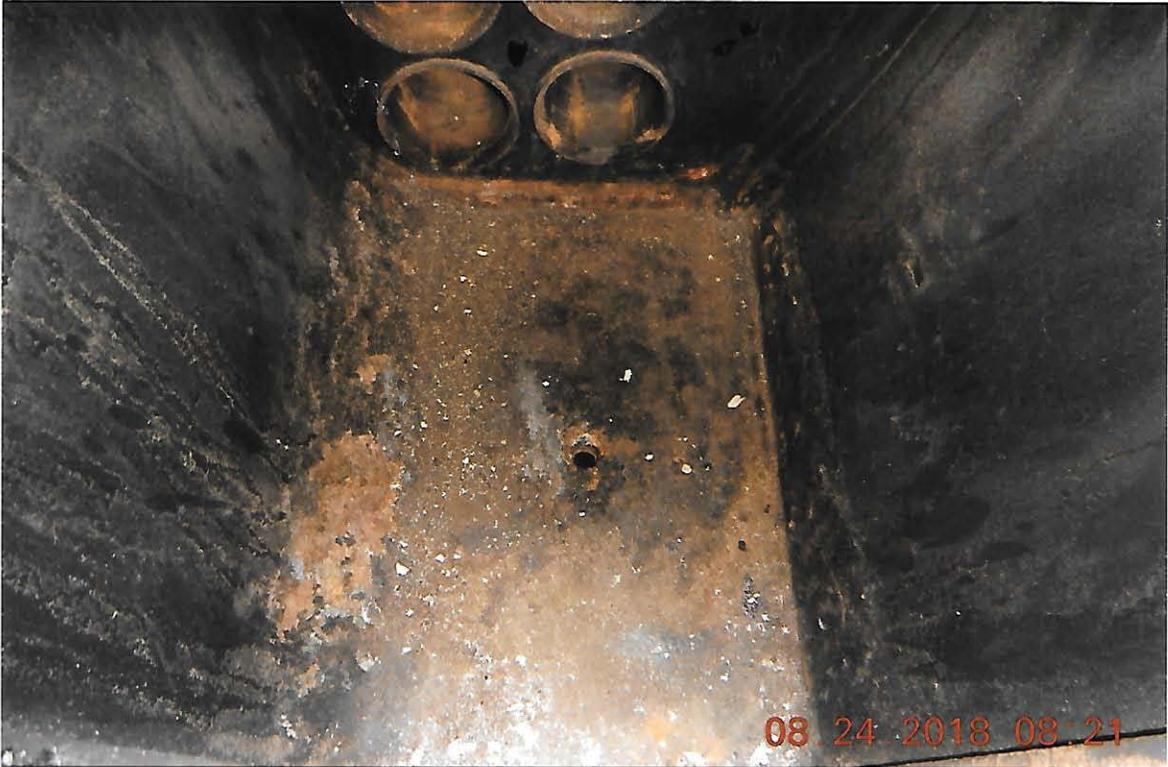
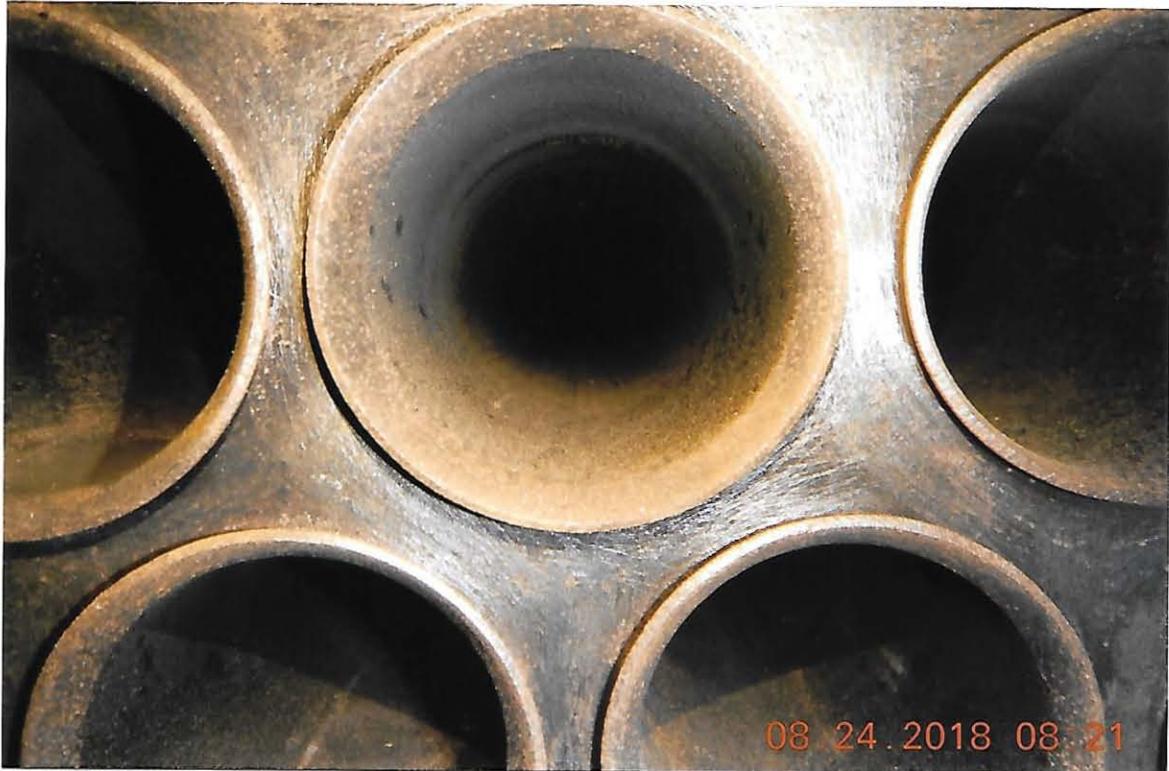
The following six (6) photos show the condition of the front tubesheet and associated smokebox. A light layer of black soot was observed on the front tubesheet, smokebox walls, and ID of the tubes. No indication of pitting was noted. The accessible welds and tubesheet ligaments appeared to be in satisfactory condition.

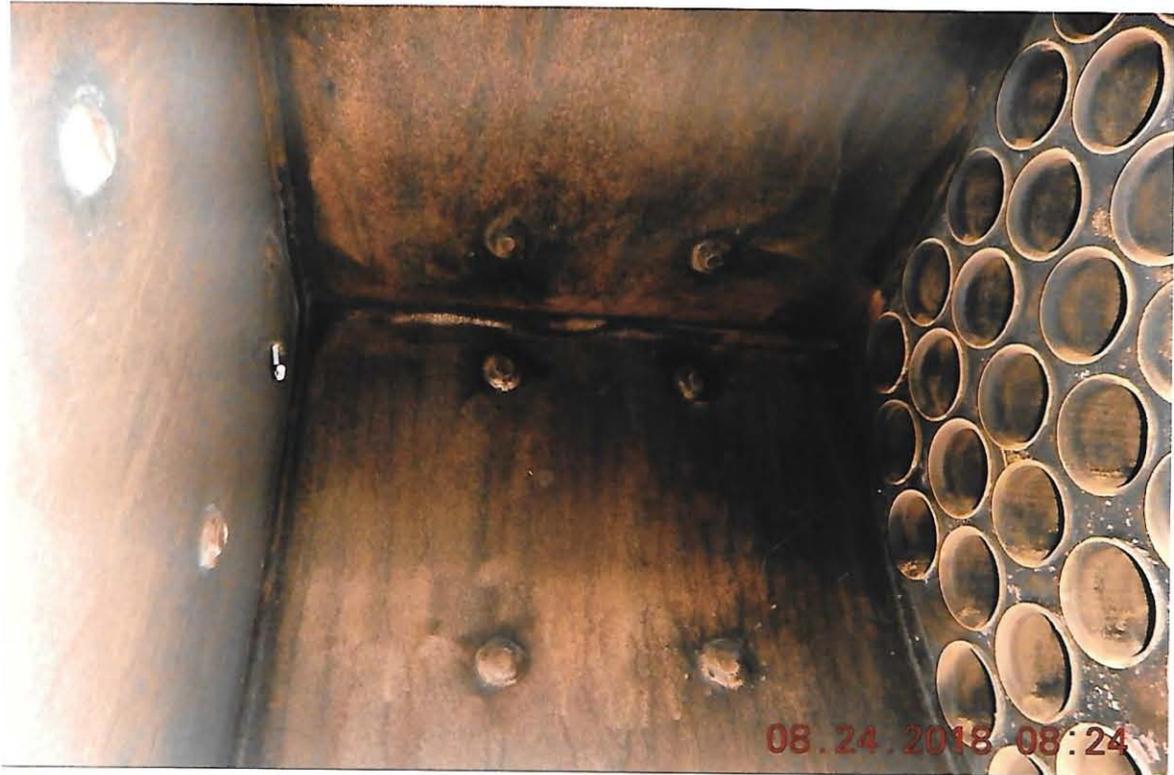
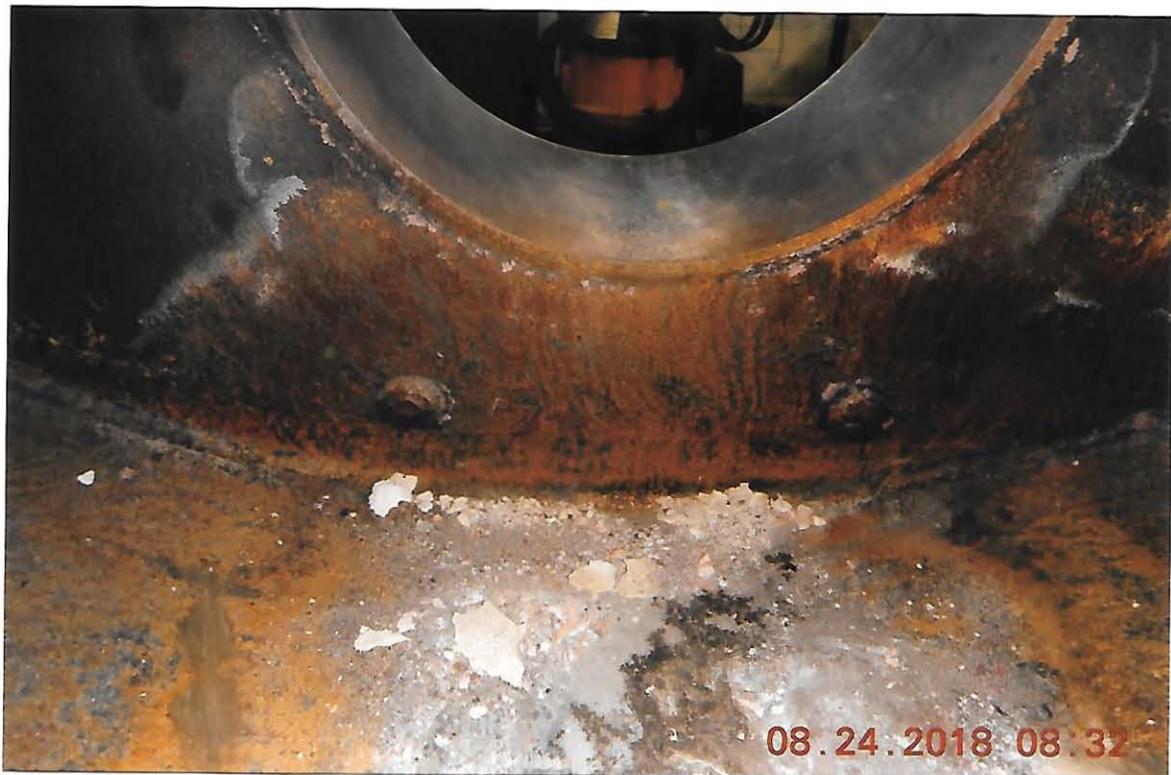
The following six (6) photos show the condition of the inner rear tubesheet and combustion chamber. A light layer of black soot was noted on the rear tubesheet, combustion chamber walls, and ID of the tubes. No indication of pitting was observed. Watermark discoloration was noted on the tubesheet and at the bottom of the combustion chamber. Accumulation of debris was observed at the bottom of the combustion chamber. The accessible welds and tubesheet ligaments appeared to be in satisfactory condition.

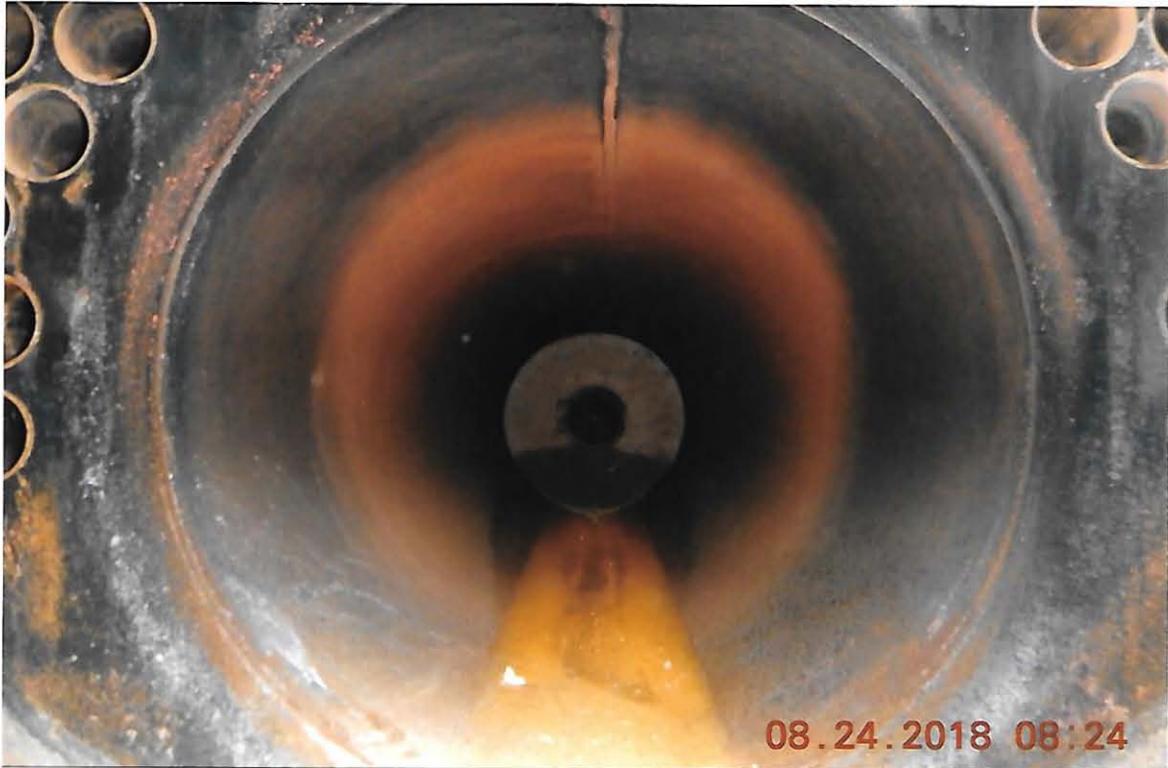
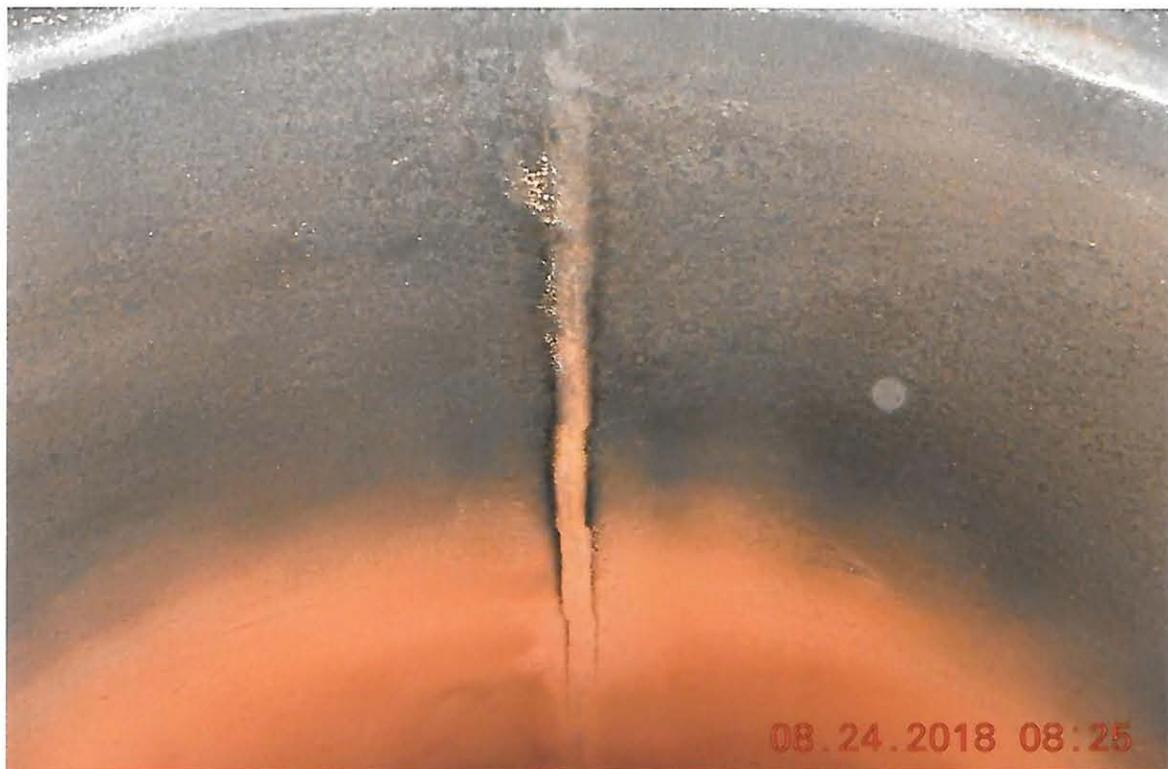
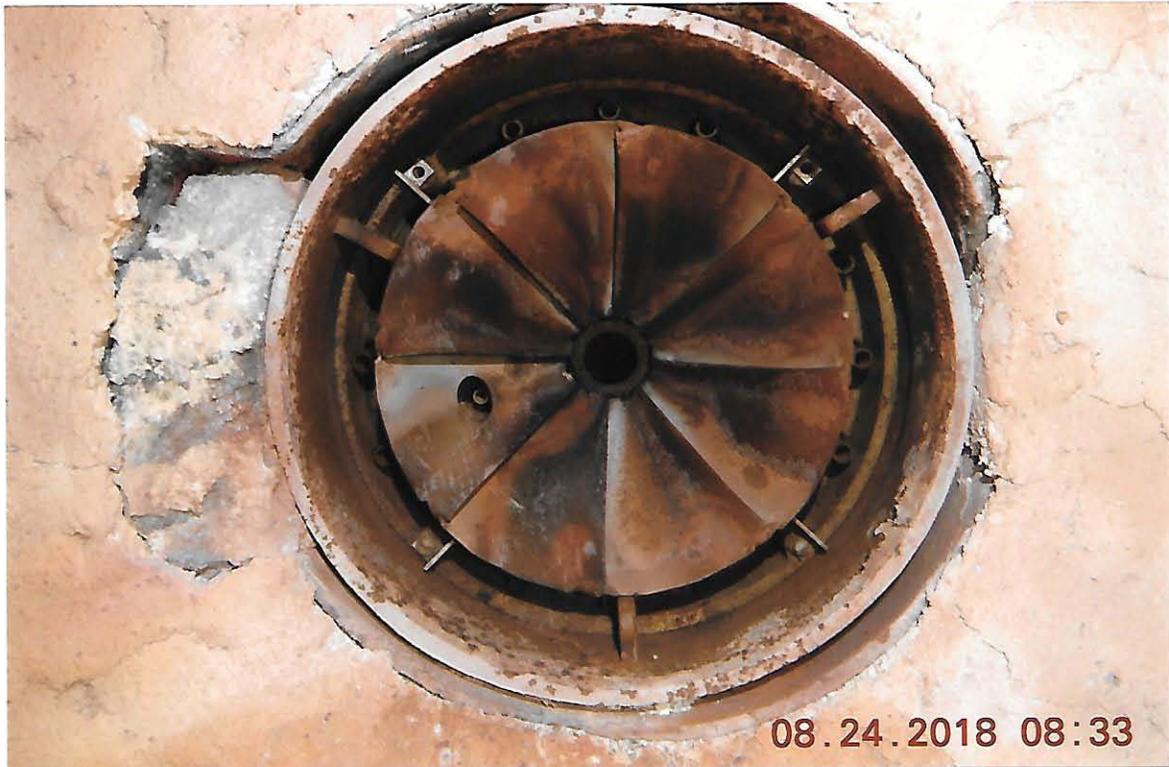
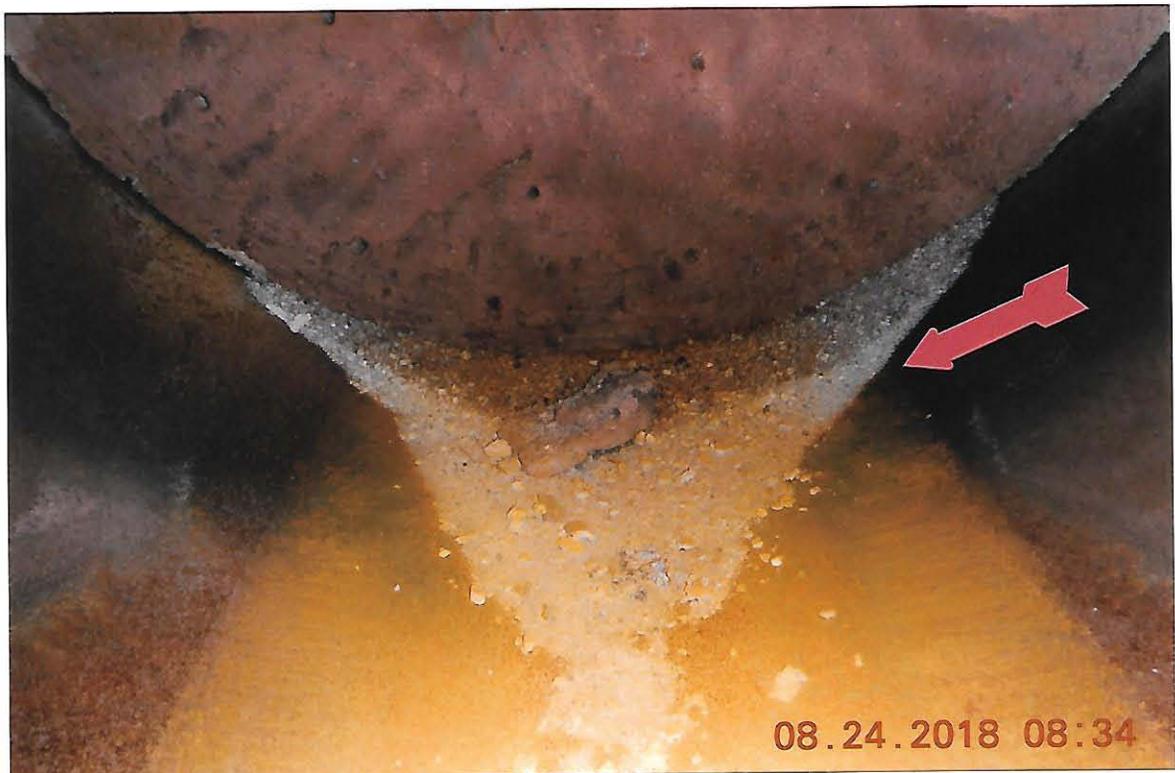
The following six (6) photos show the condition of the furnace sheet and burner. Light corrosion and pitting were observed on the furnace sheet. Soot build-up was noted near the burner. Watermark discoloration and accumulation of debris were noted at the bottom of the furnace sheet. Cracks in the burner refractory were observed. The longitudinal weld appeared to be in satisfactory condition.
