# Mechanical Systems Assessment

## Lorraine H. Morton Civic Center

### August 26, 2019

MECHANICAL SYSTEMS ASSESSMENT AND  
REVIEW OF UPGRADE ALTERNATIVES

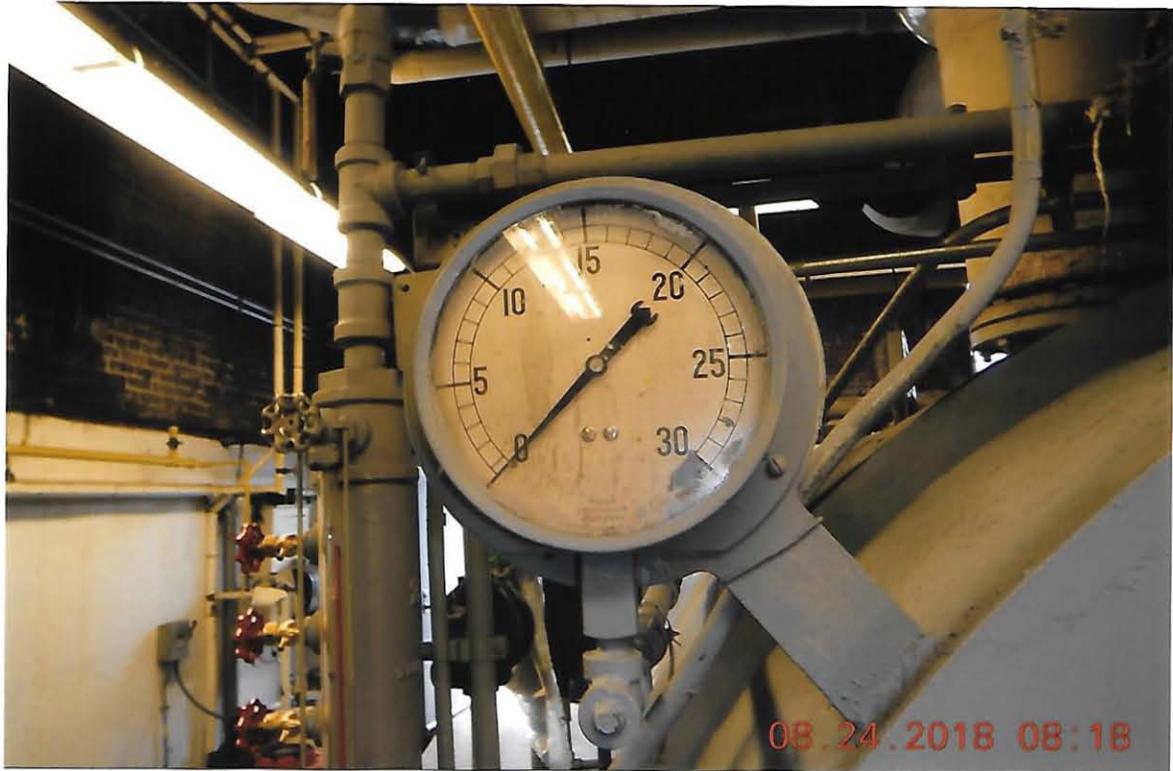
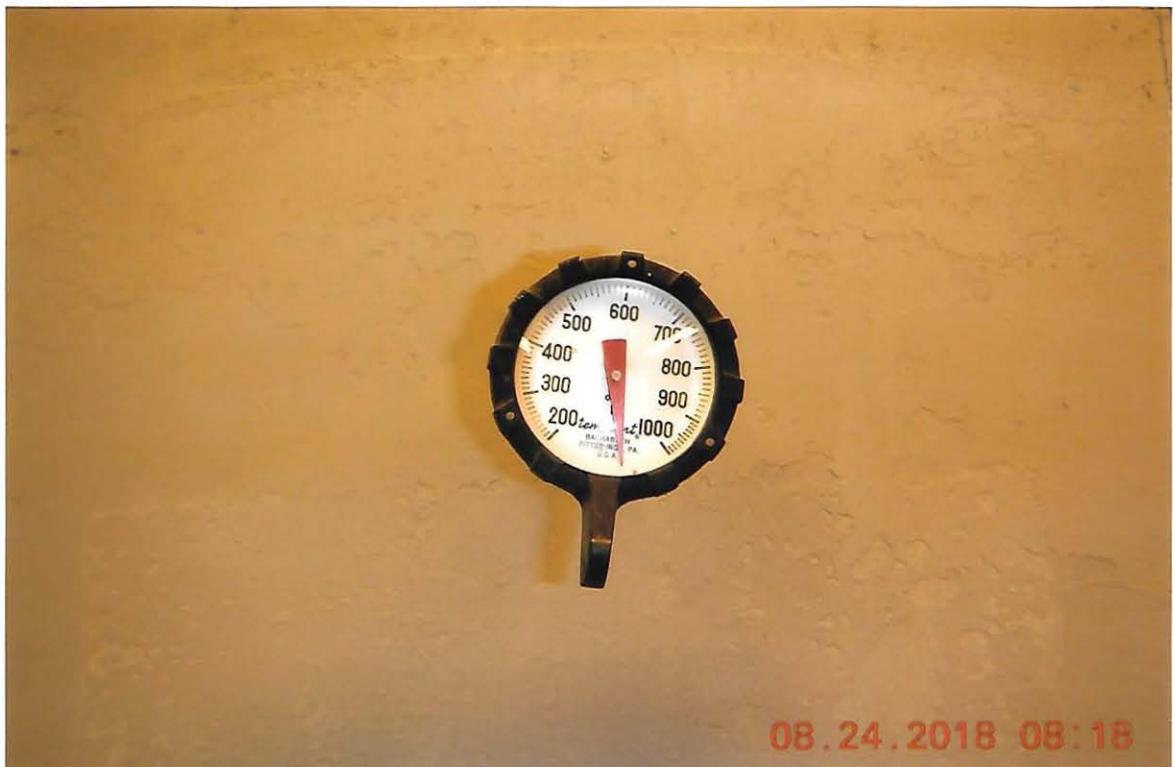
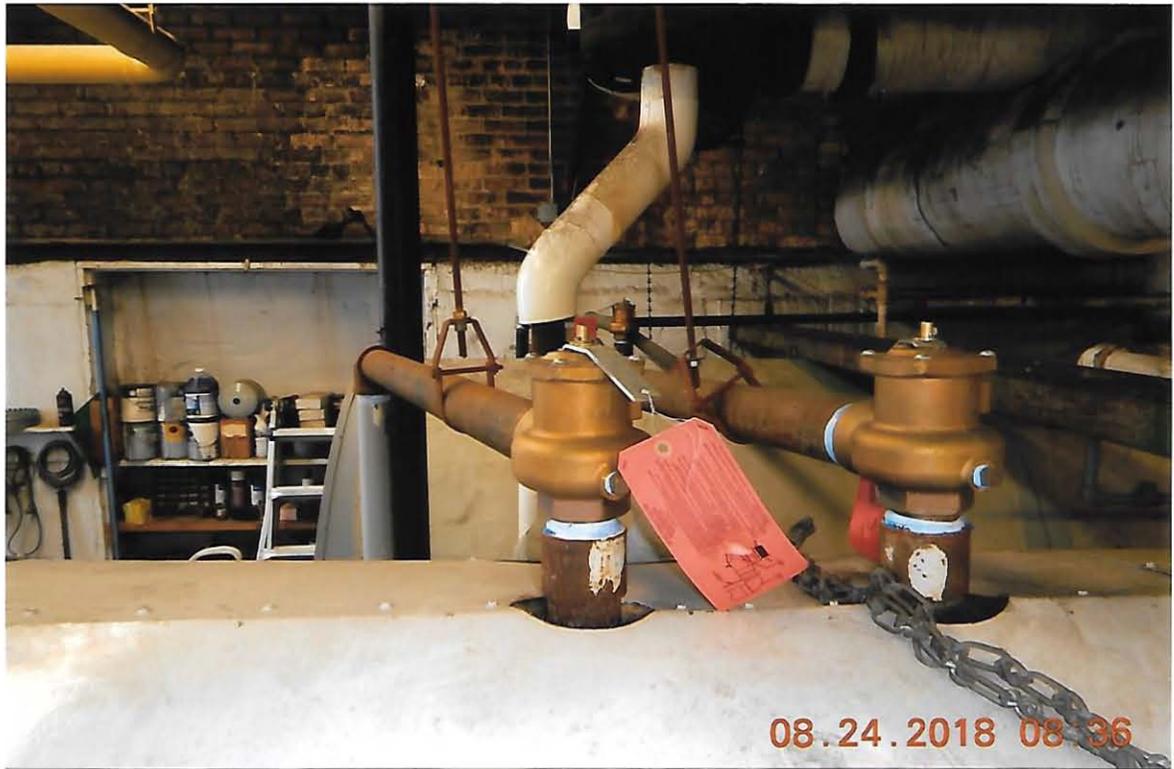
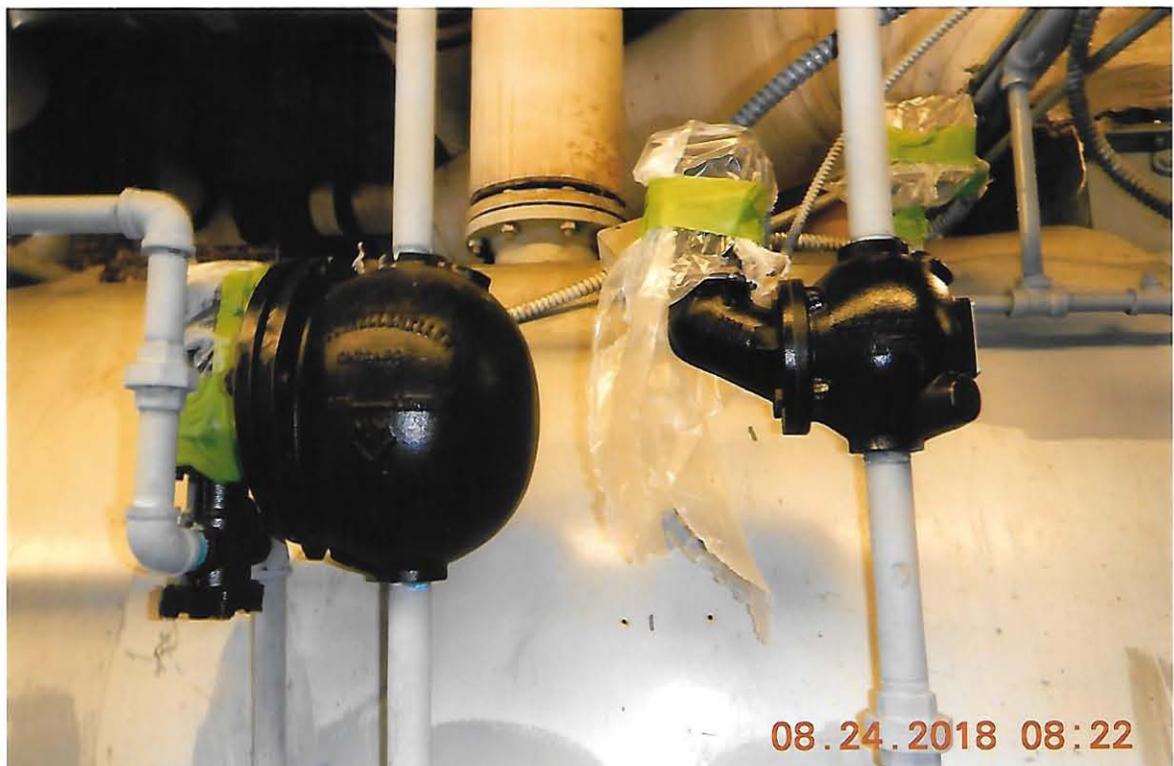
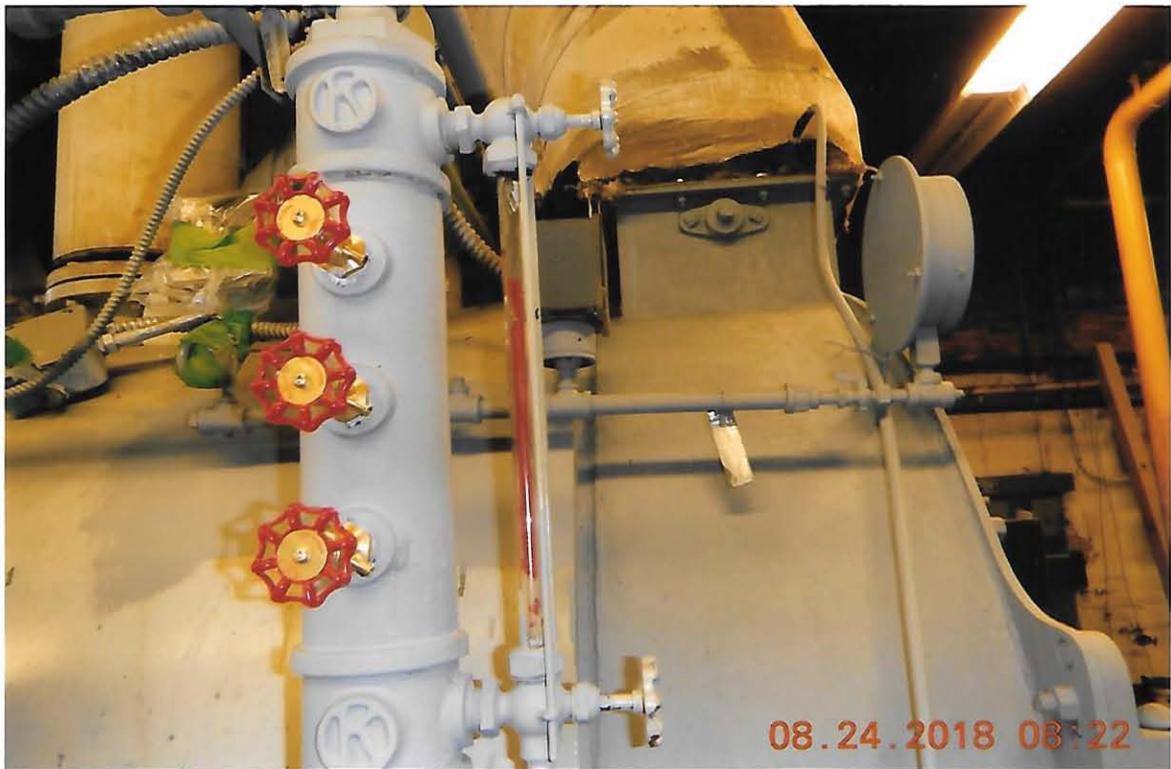
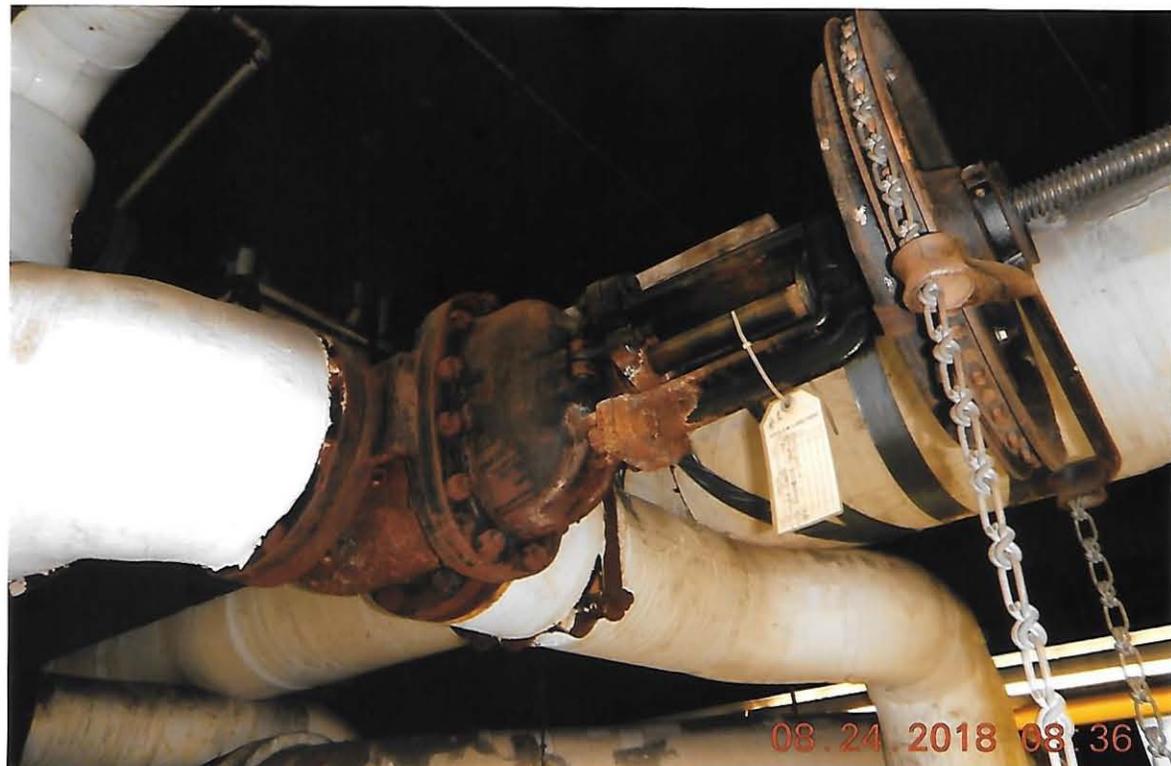
The following six (6) photos show the condition of the various safety appurtenances. No indication of up-to-date calibration was observed on the pressure/temperature gauges and pressure relief valves. The low water fuel cut-off devices were newly installed. The water level sight glass appeared to be in satisfactory condition. Indications of past leakage were noted on the main steam isolation valve.

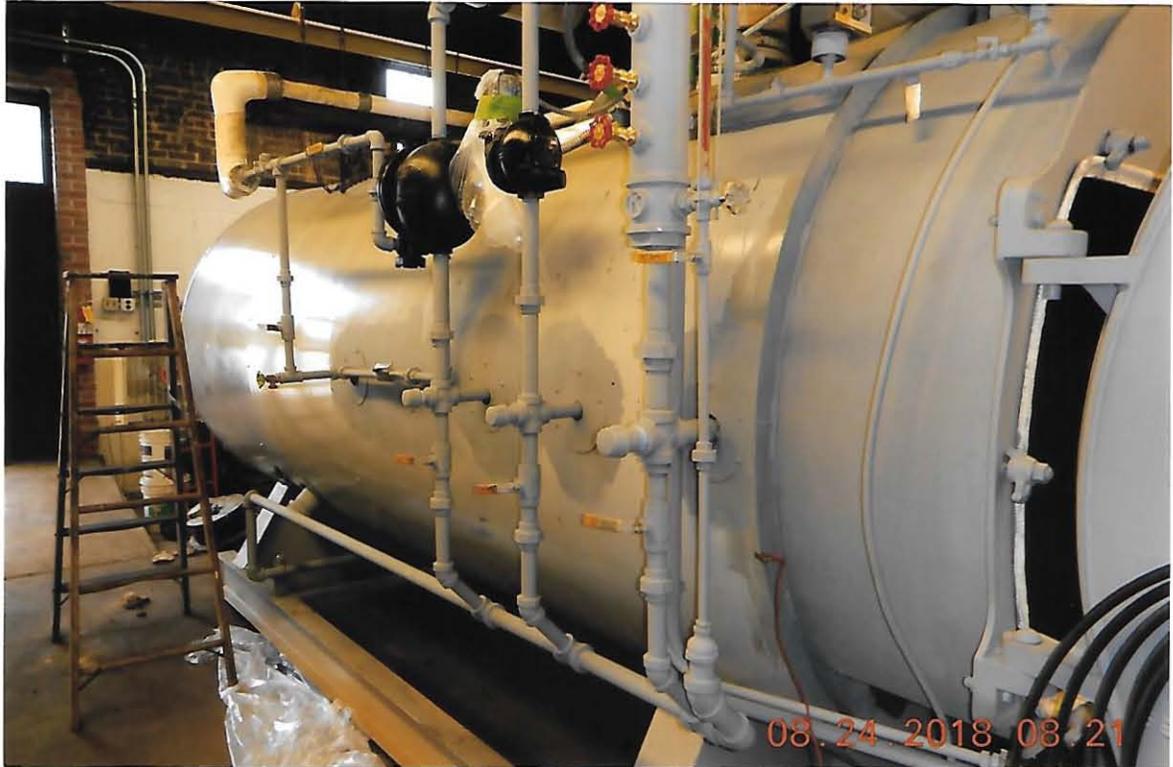
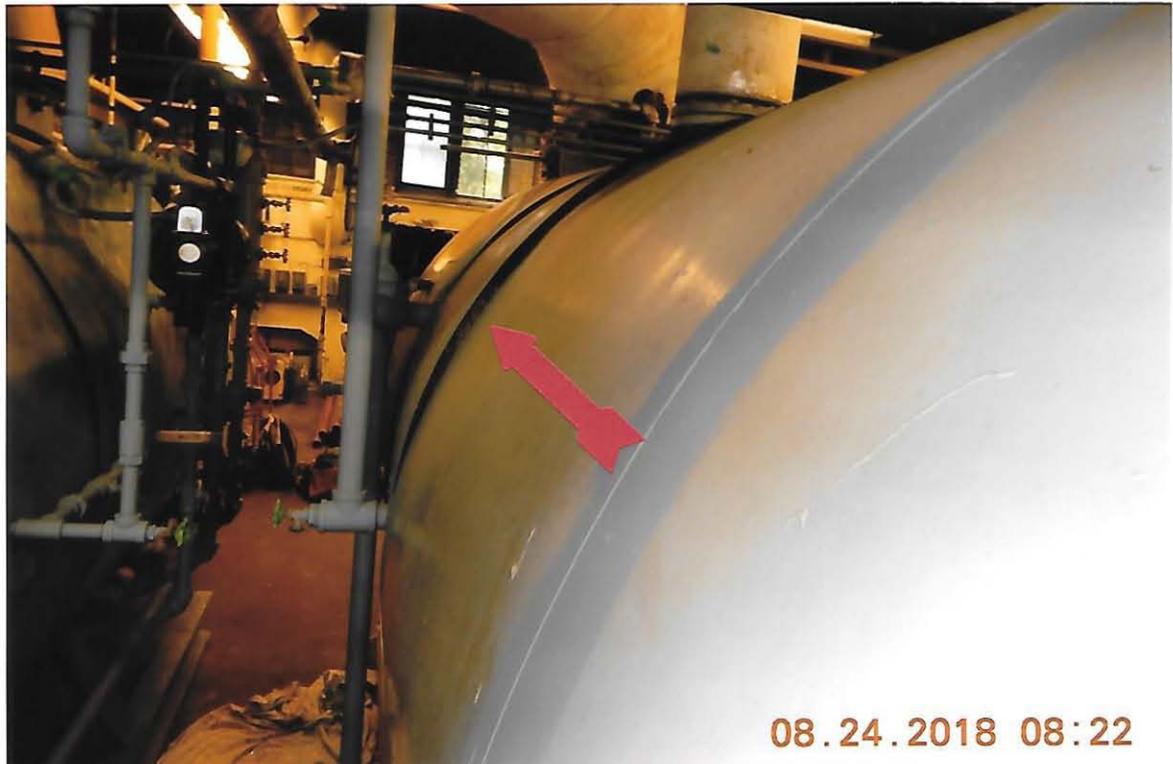
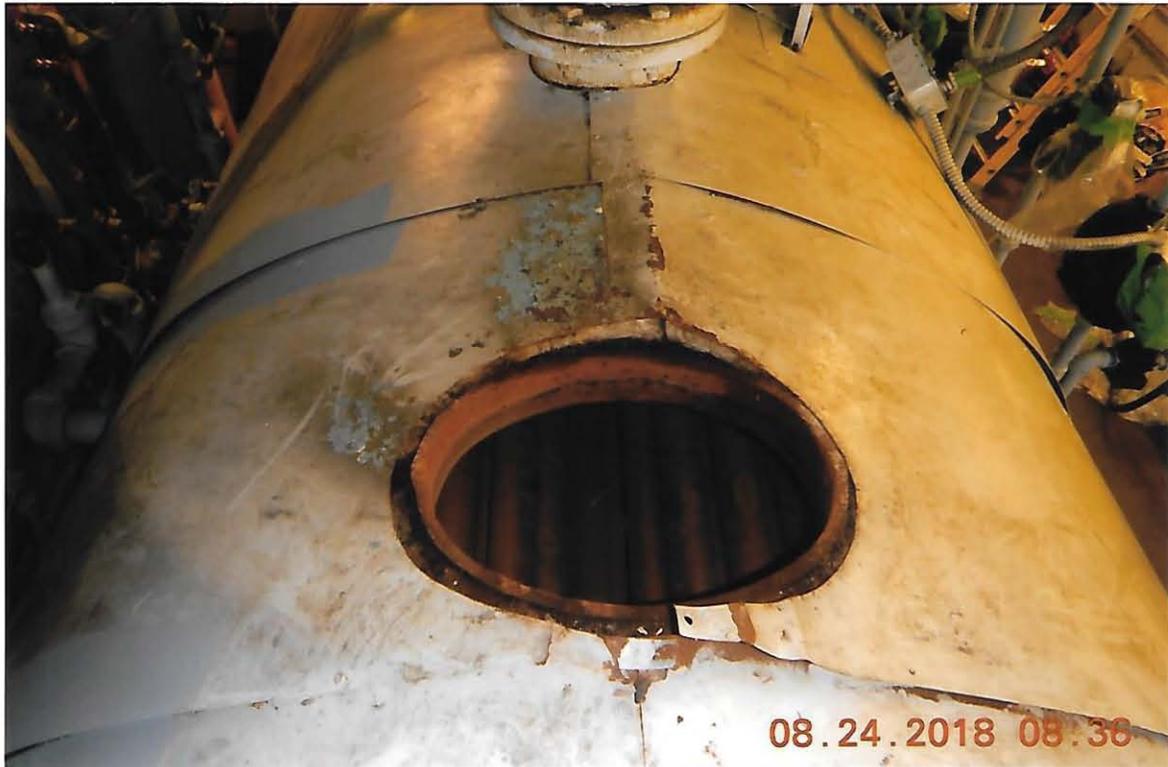
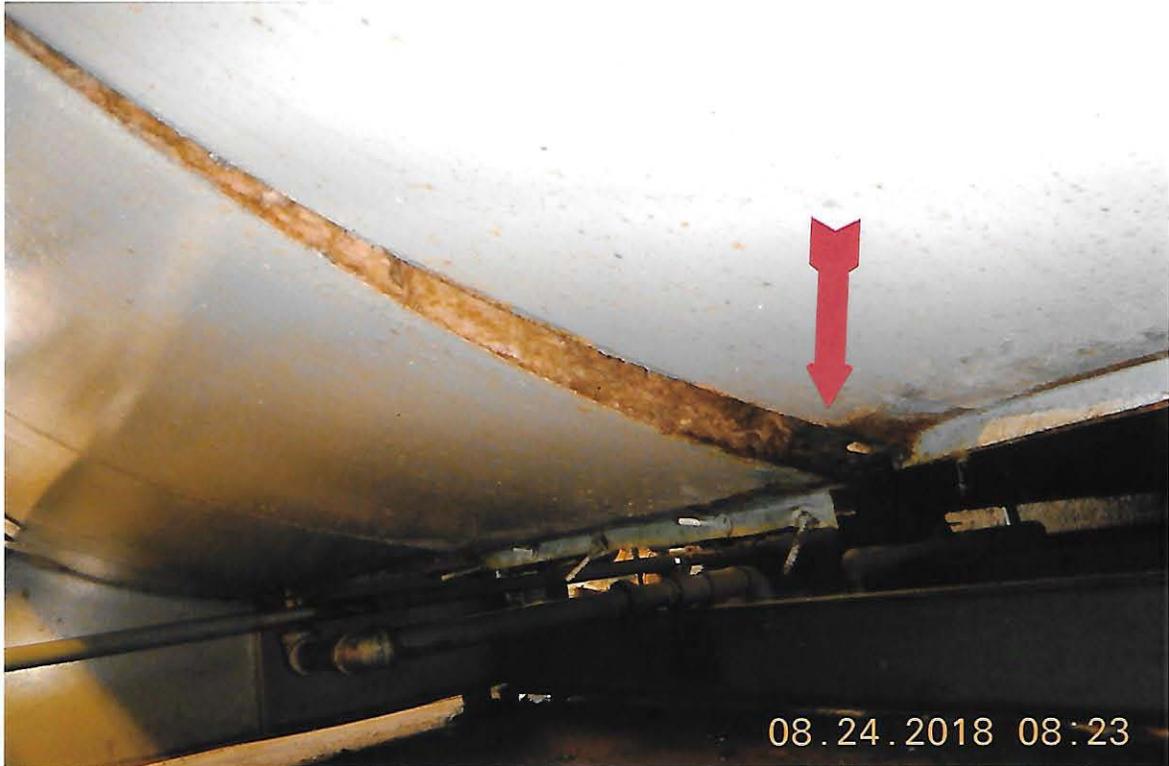
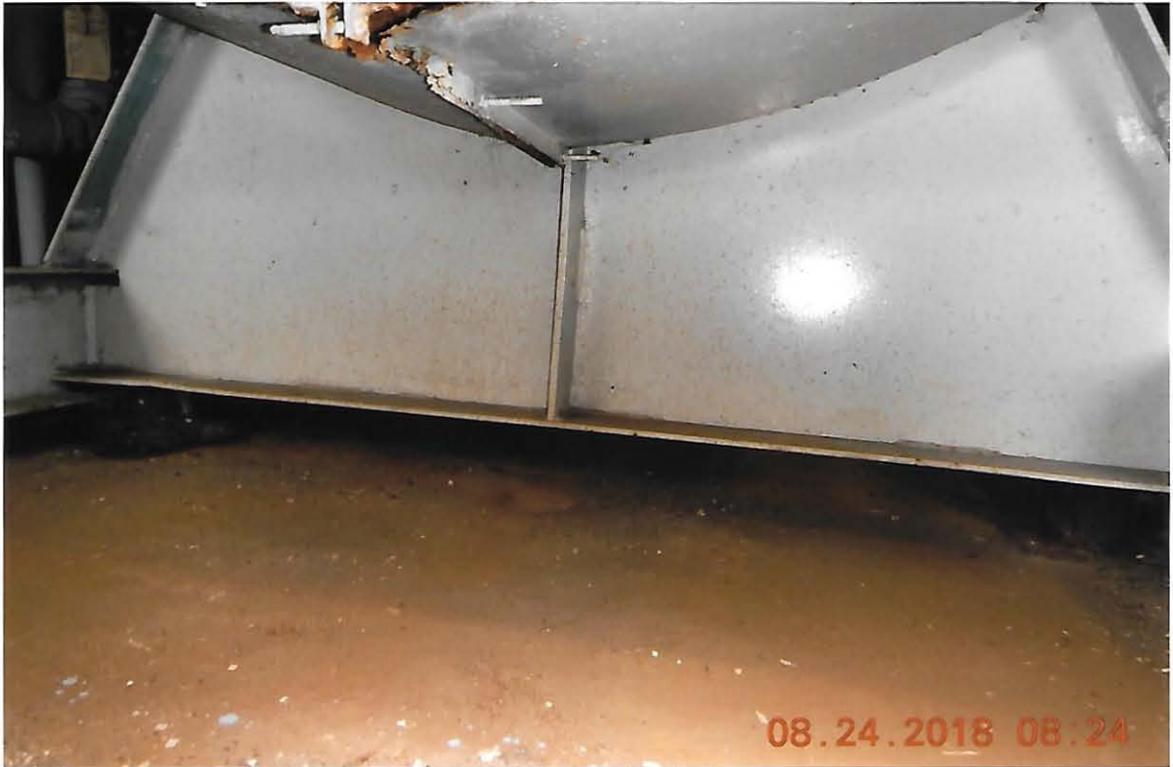
The following eight (8) photos show the external condition of the boiler. Gaps in the casing seams were noted. Staining, corrosion, and deterioration were observed on the casing beneath the boiler. Corrosion around the handholes was noted. The support structure appeared to be in satisfactory condition.

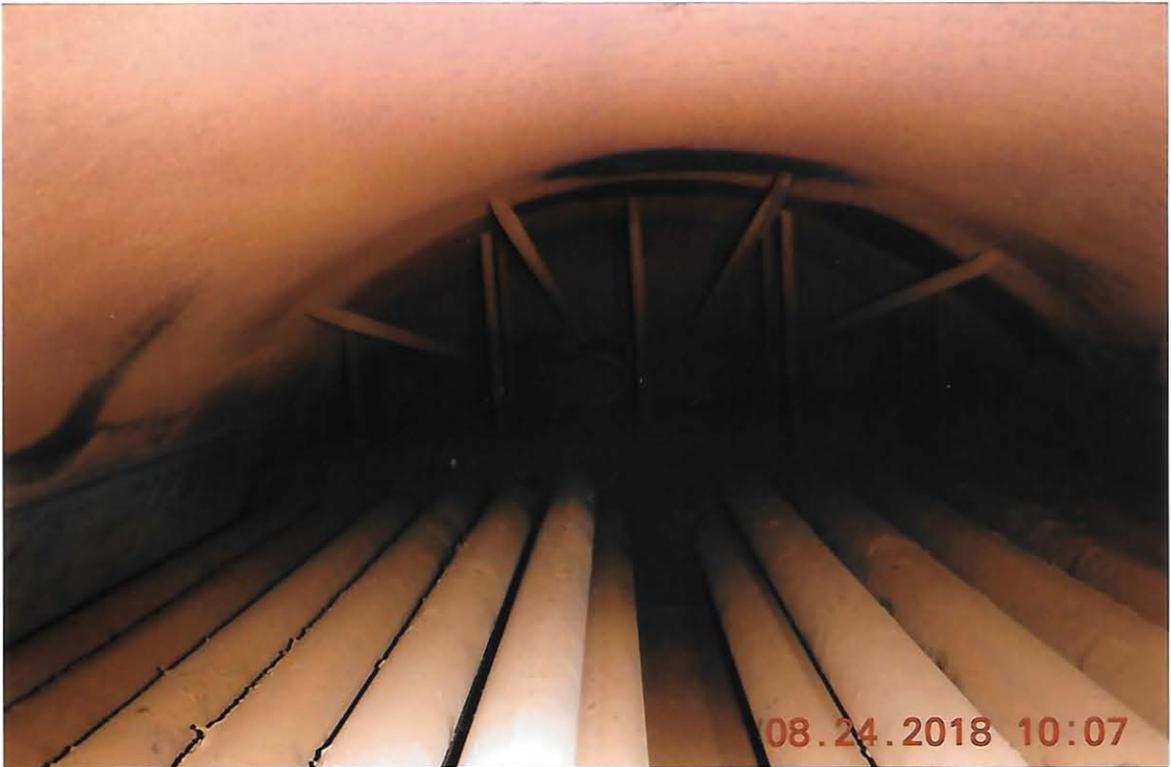
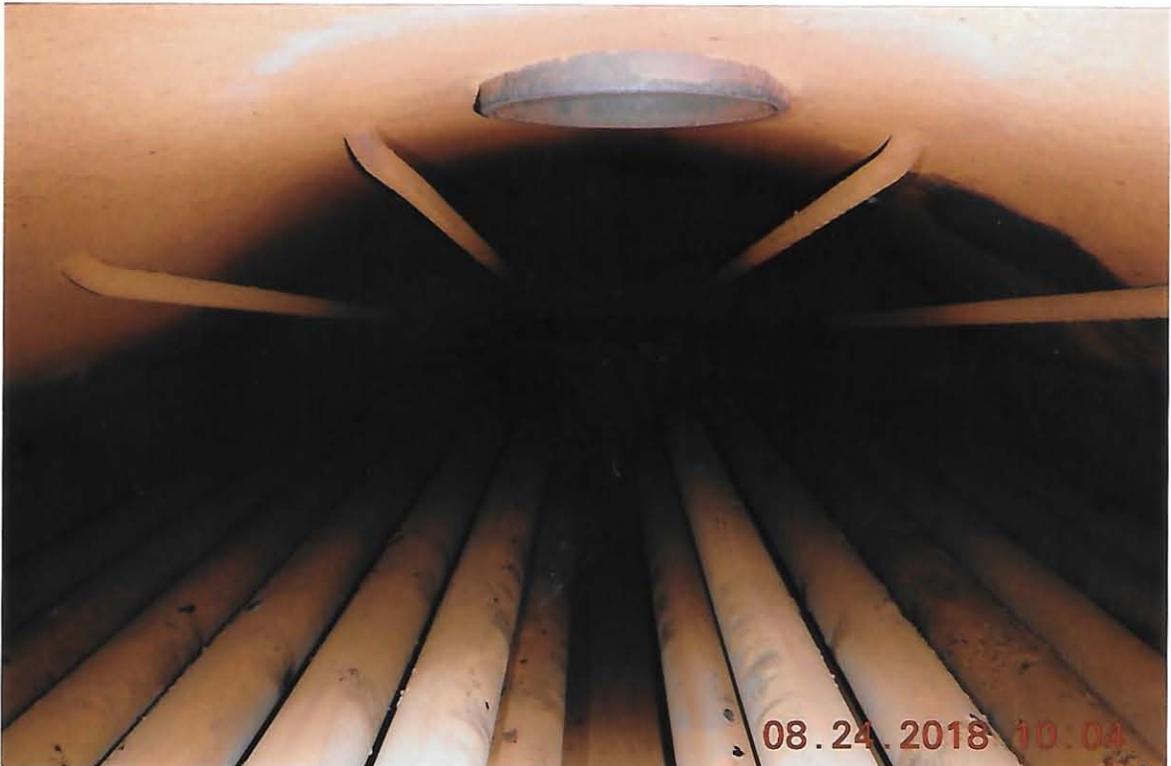
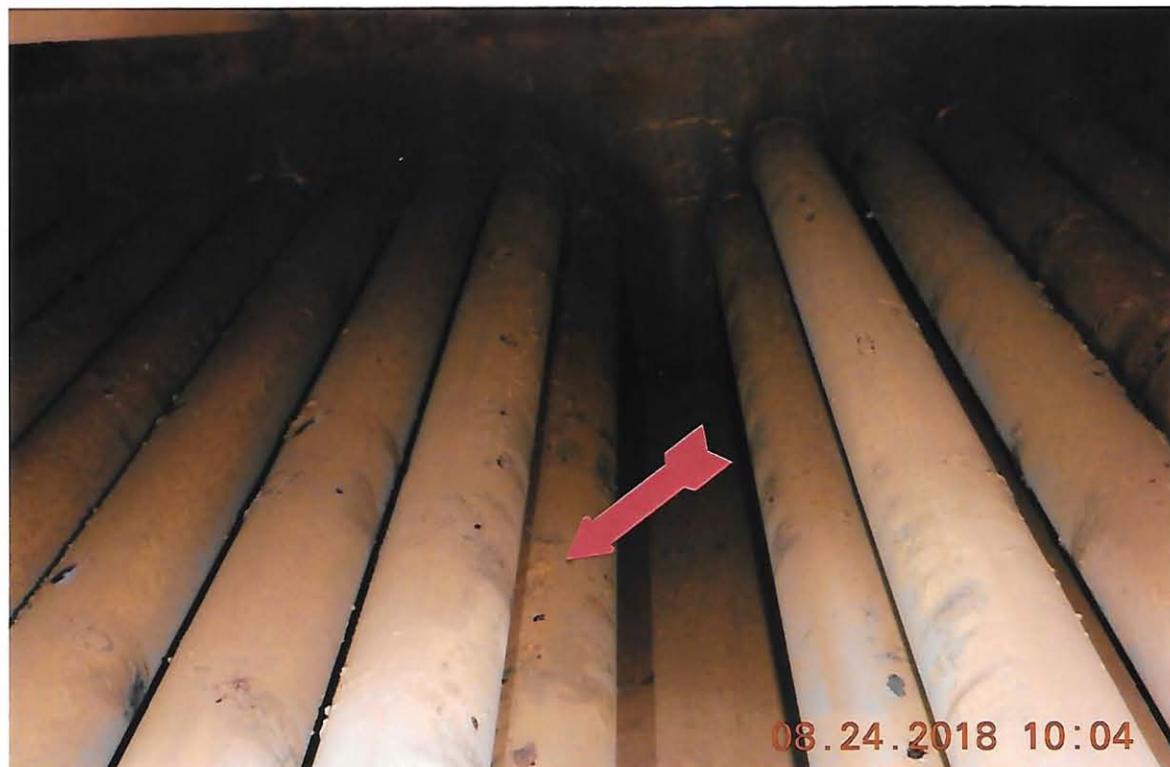
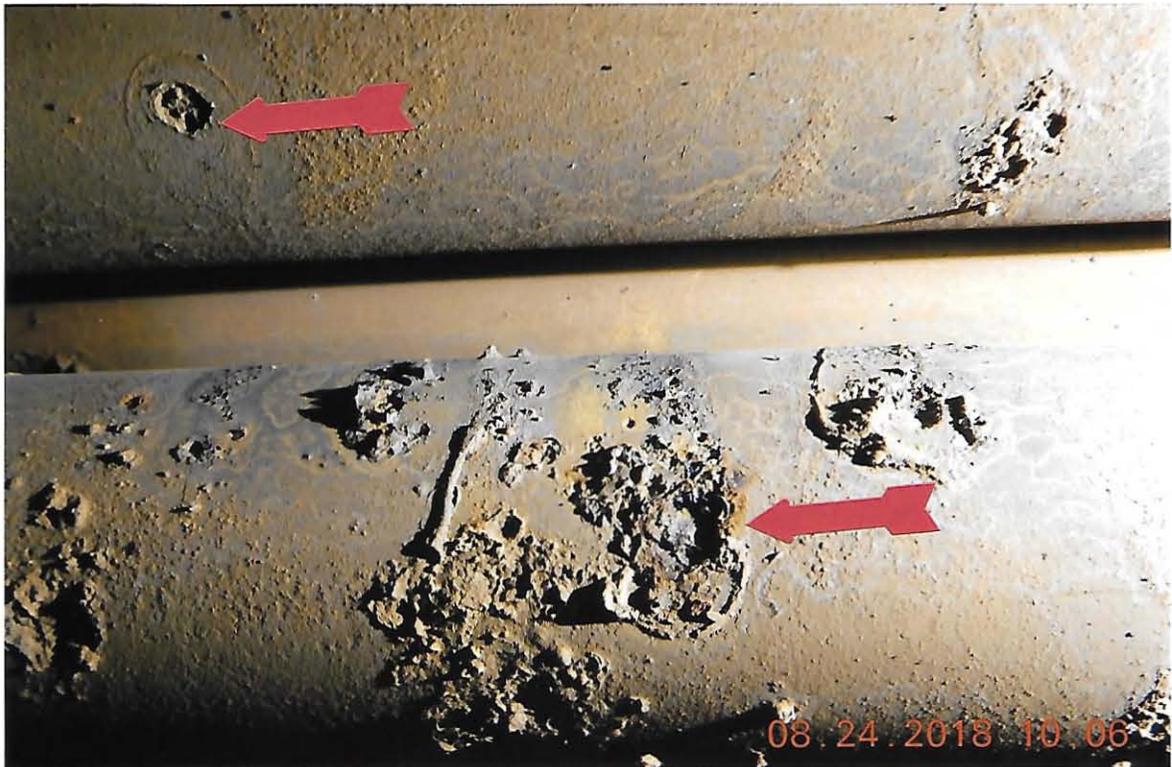
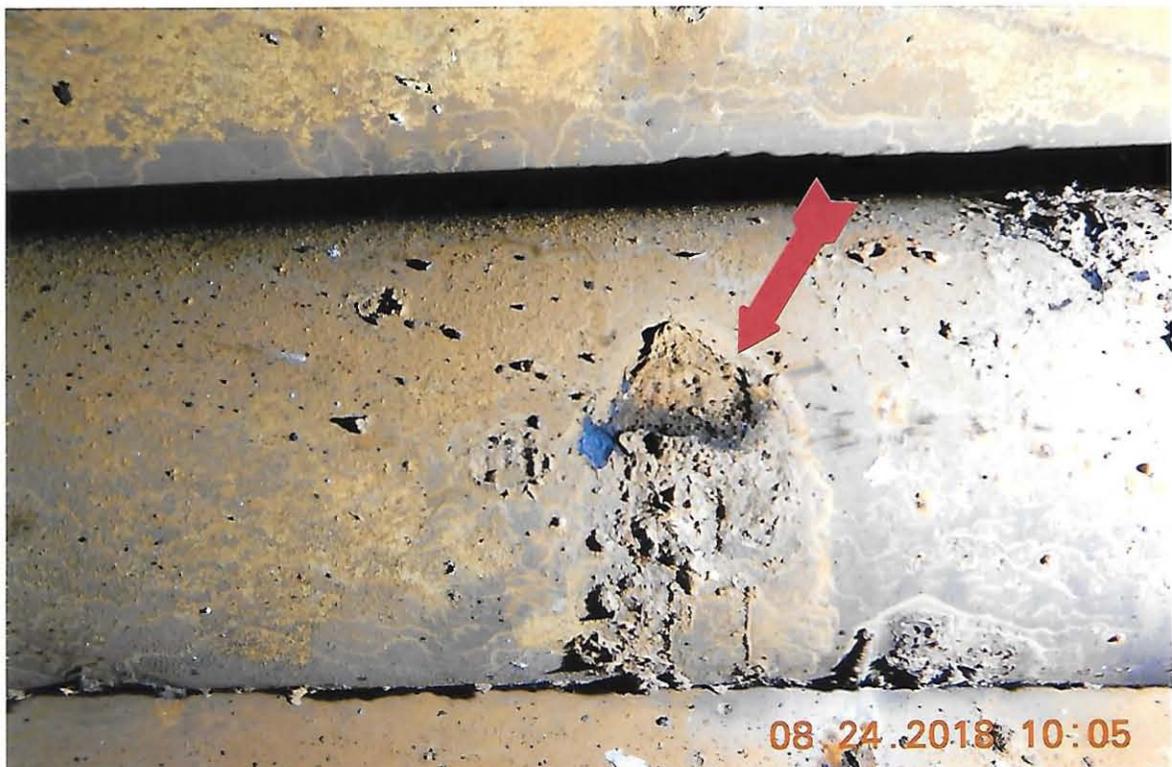
The following ten (10) photos show the condition of the boiler's waterside as viewed from the top manway. Scale and tubercles were observed on the accessible tubes, boiler shell, and furnace sheet. Heavy under deposit pitting and corrosion were observed in the tubes. Light pitting was noted on the accessible furnace sheet.

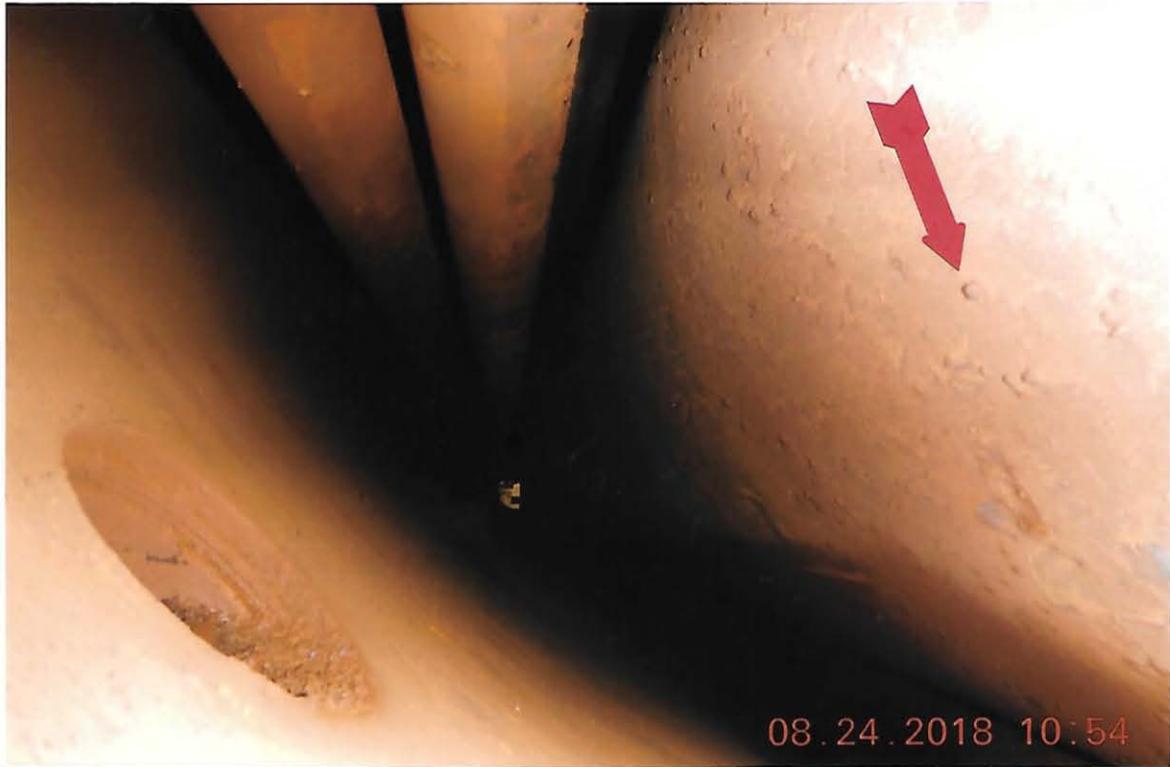
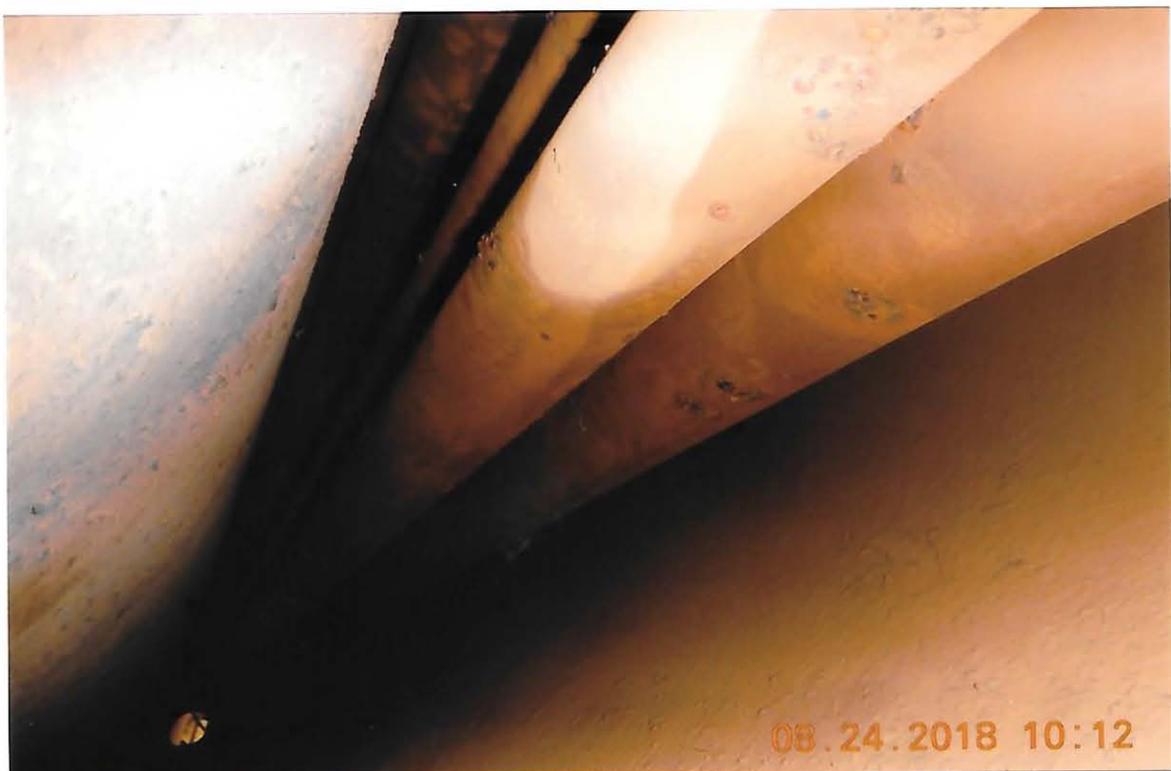
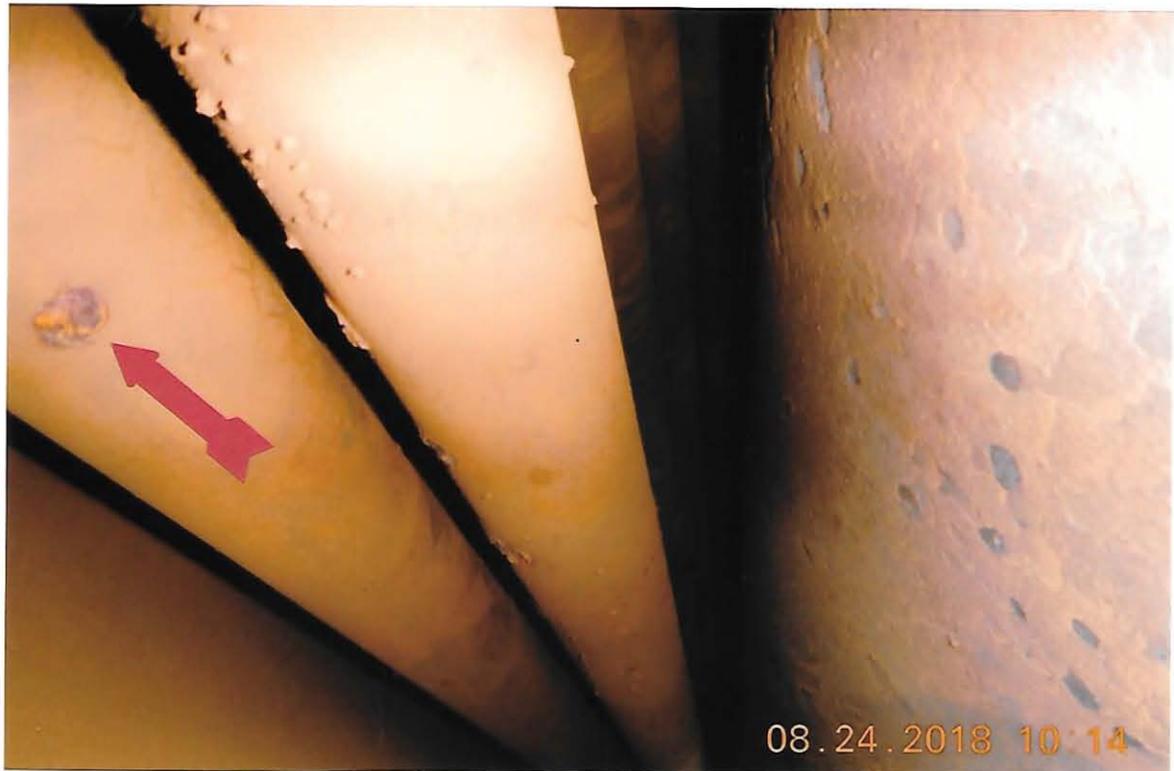
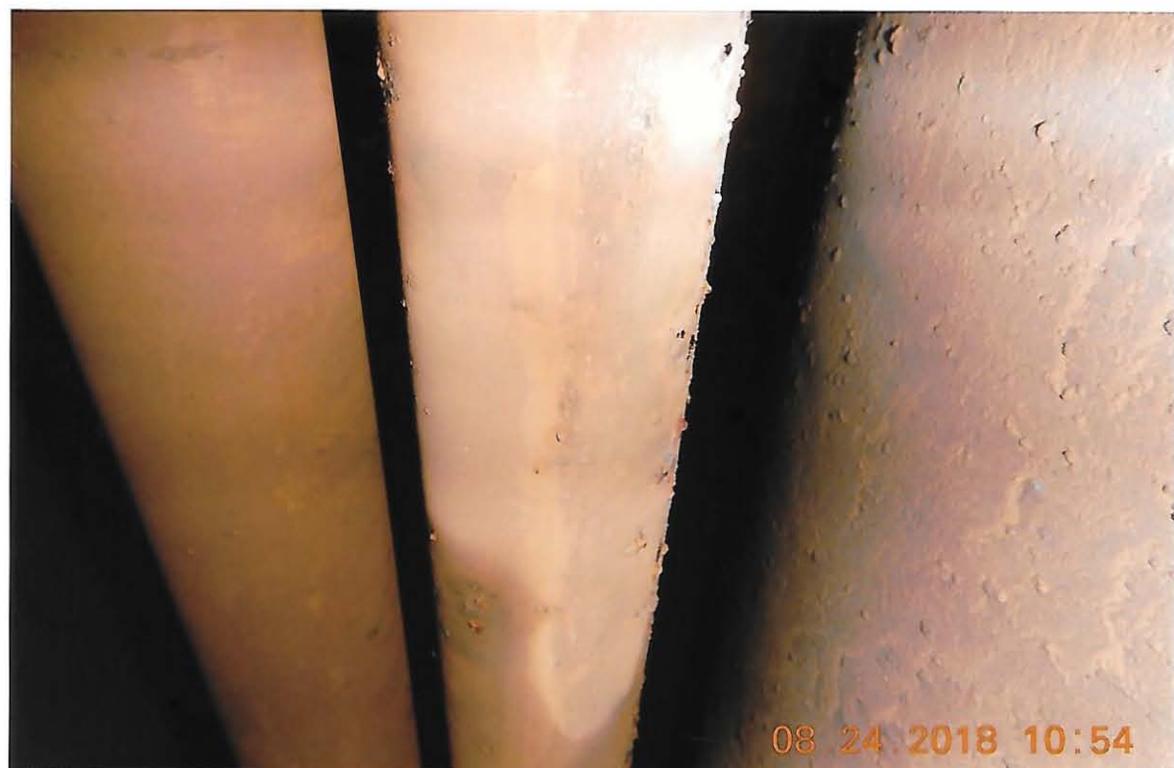
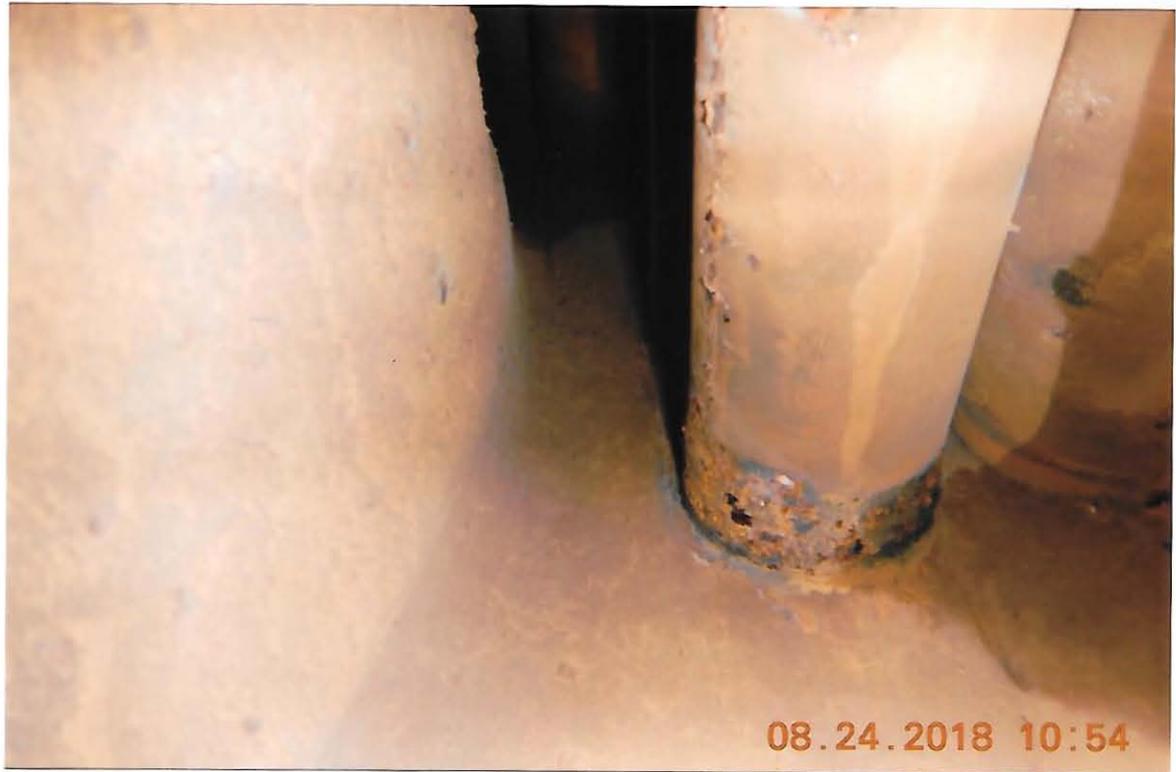
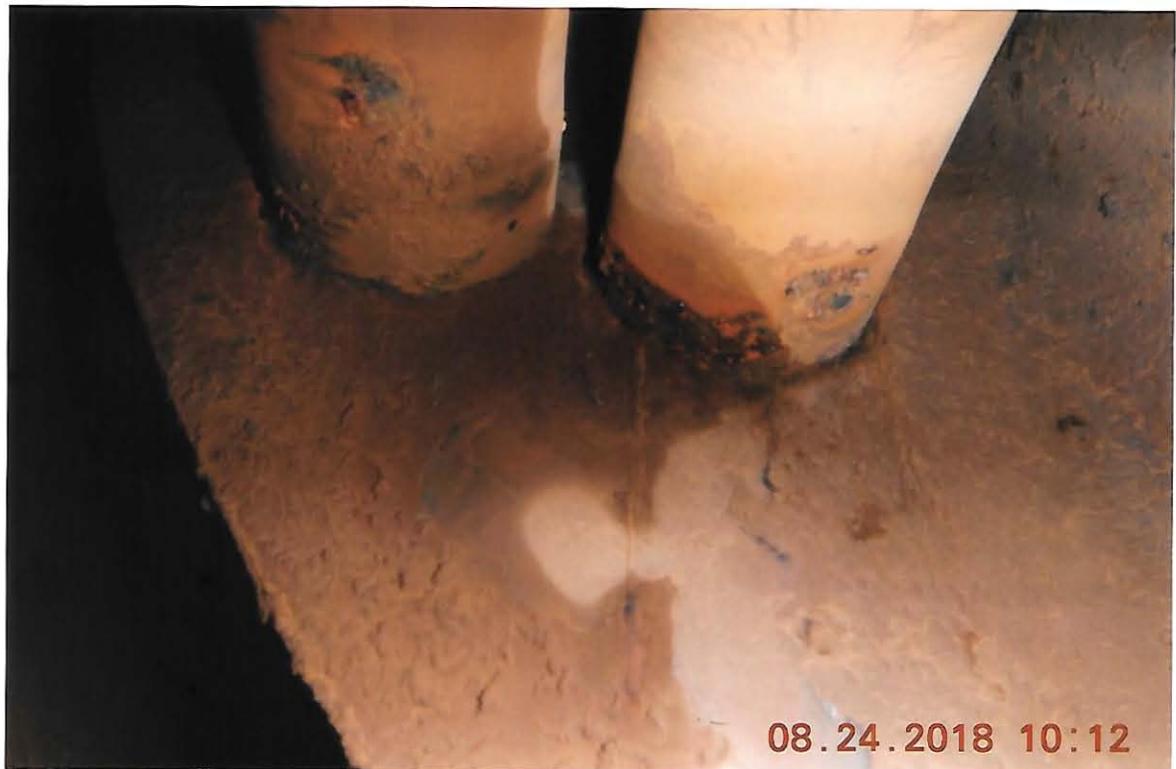
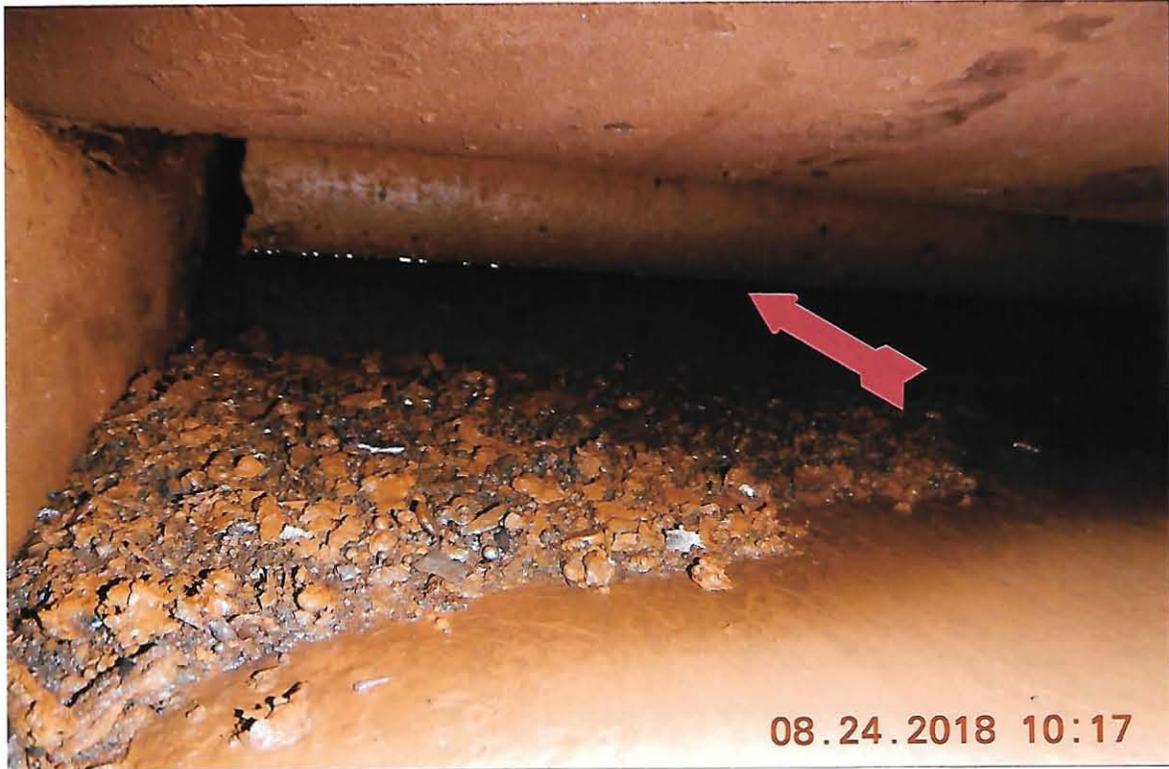
The following eight (8) photos show the condition of the boiler's waterside as viewed from the lower handholes. Scale and tubercles were observed on the accessible tubes, boiler shell, and furnace sheet. Two old cut-out tubes were noted at the bottom of the shell. A moderate accumulation of sediment and debris was observed at the bottom of the shell.
