# Mechanical Systems Assessment

## Lorraine H. Morton Civic Center

### August 26, 2019

MECHANICAL SYSTEMS ASSESSMENT AND  
REVIEW OF UPGRADE ALTERNATIVES

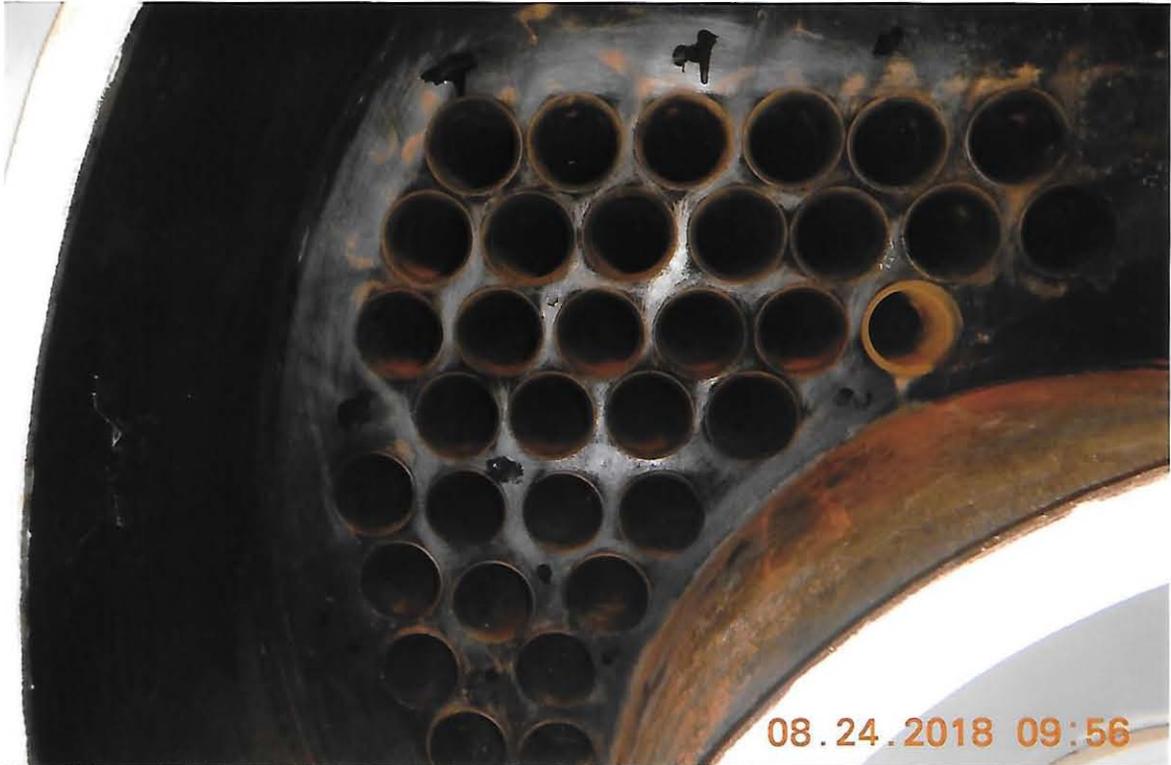
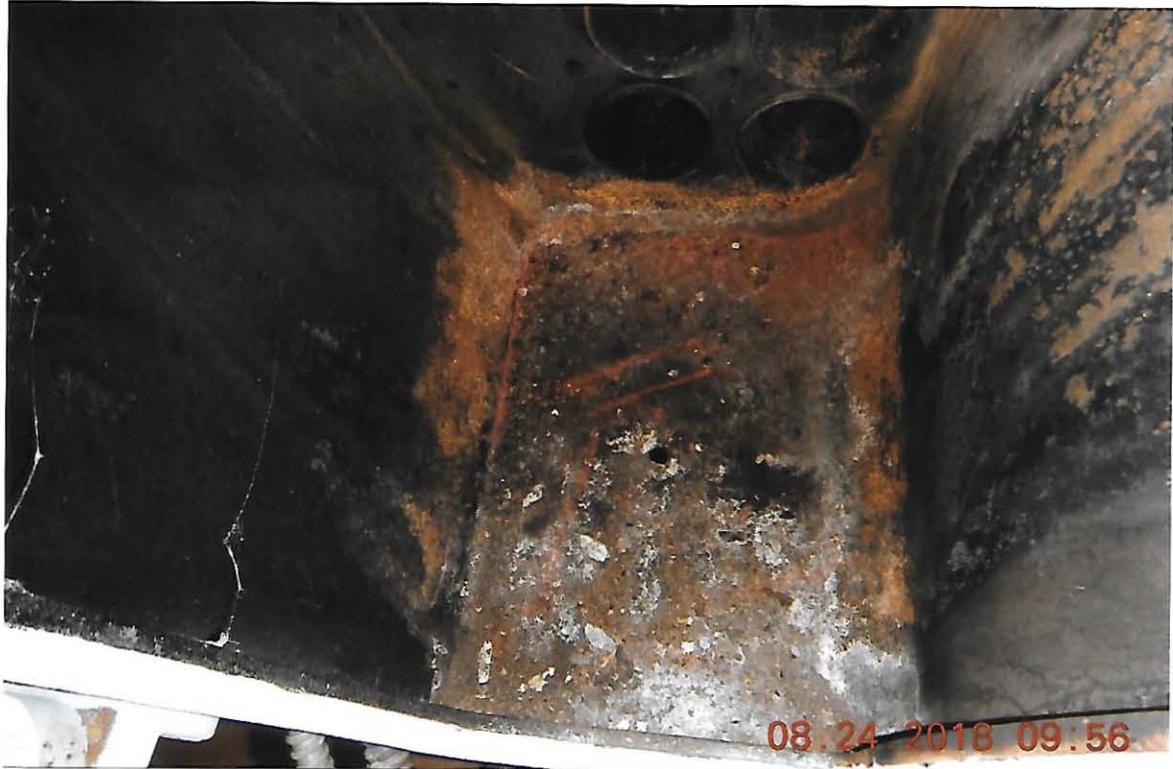
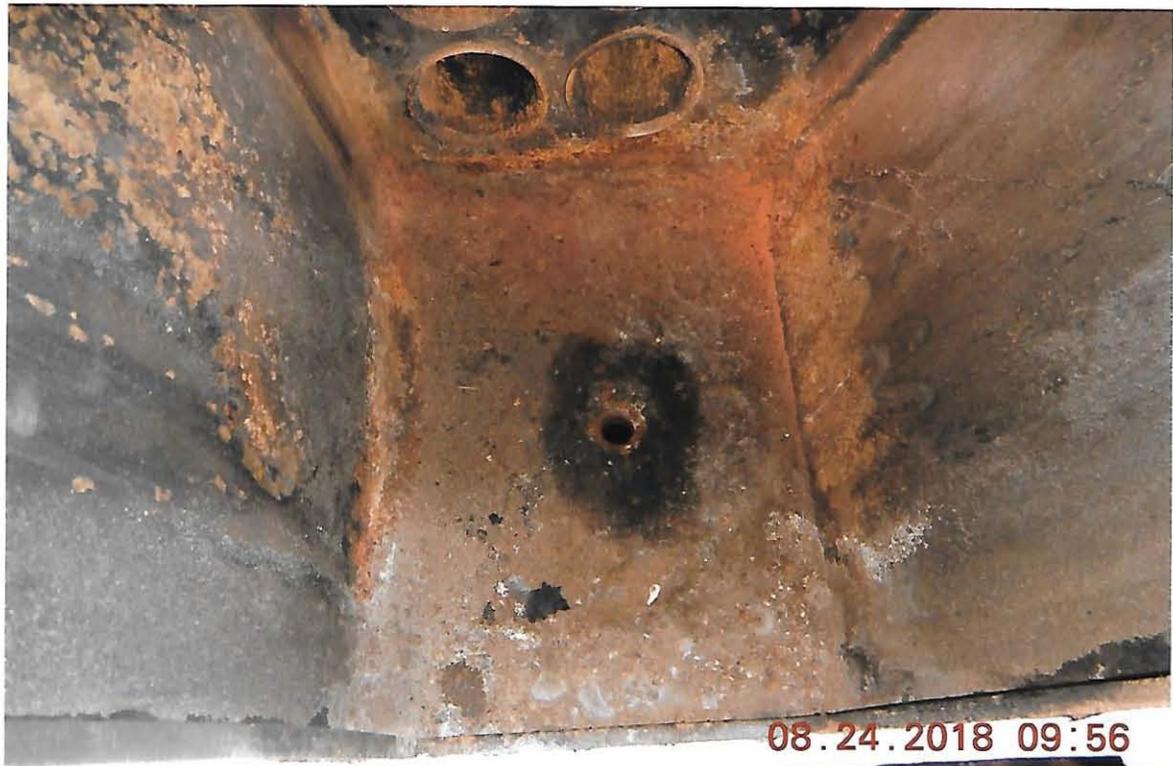
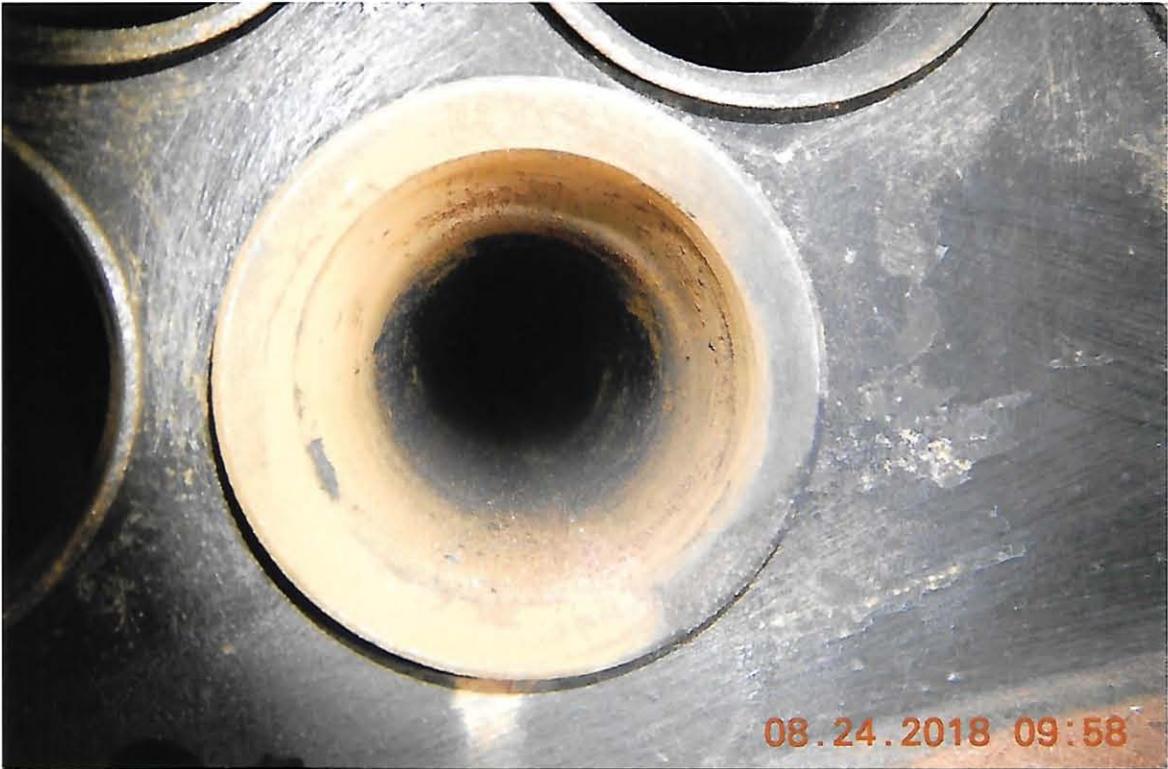
The following six (6) photos show the condition of the front tubesheet and associated smokebox. A light layer of black soot was observed on the front tubesheet, smokebox walls, and ID of the tubes. No indication of pitting was noted. The accessible welds and tubesheet ligaments appeared to be in satisfactory condition.

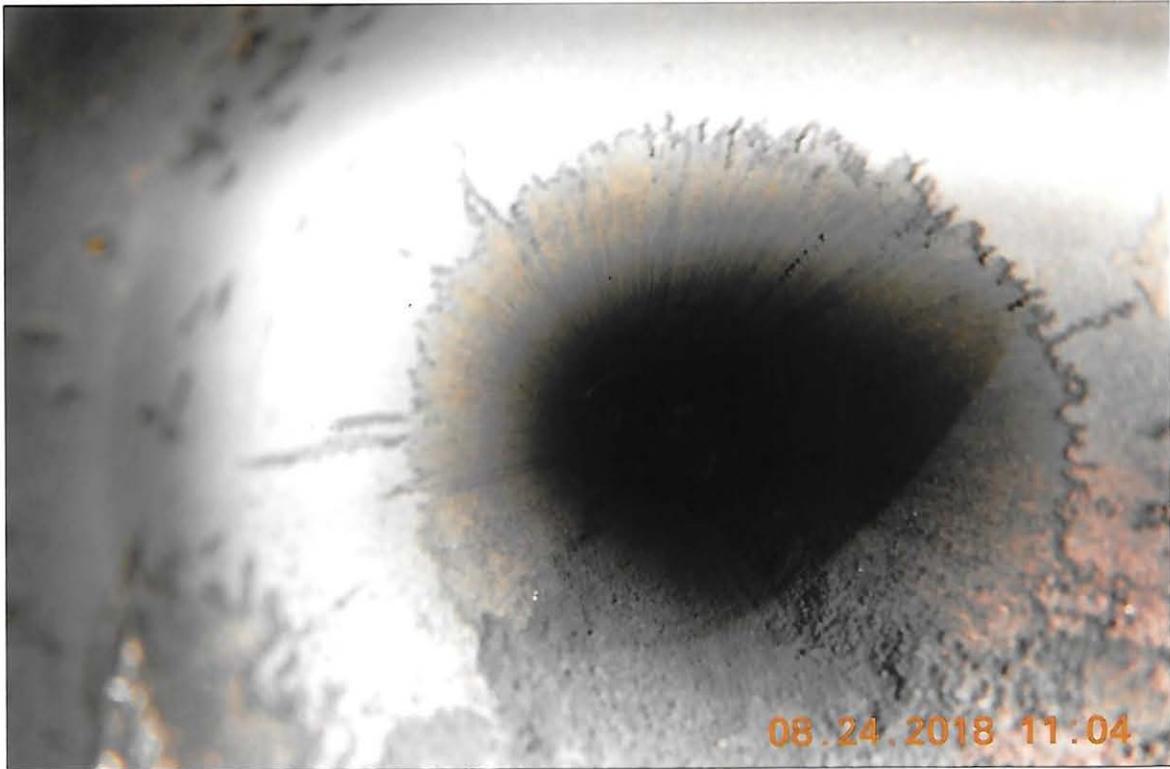
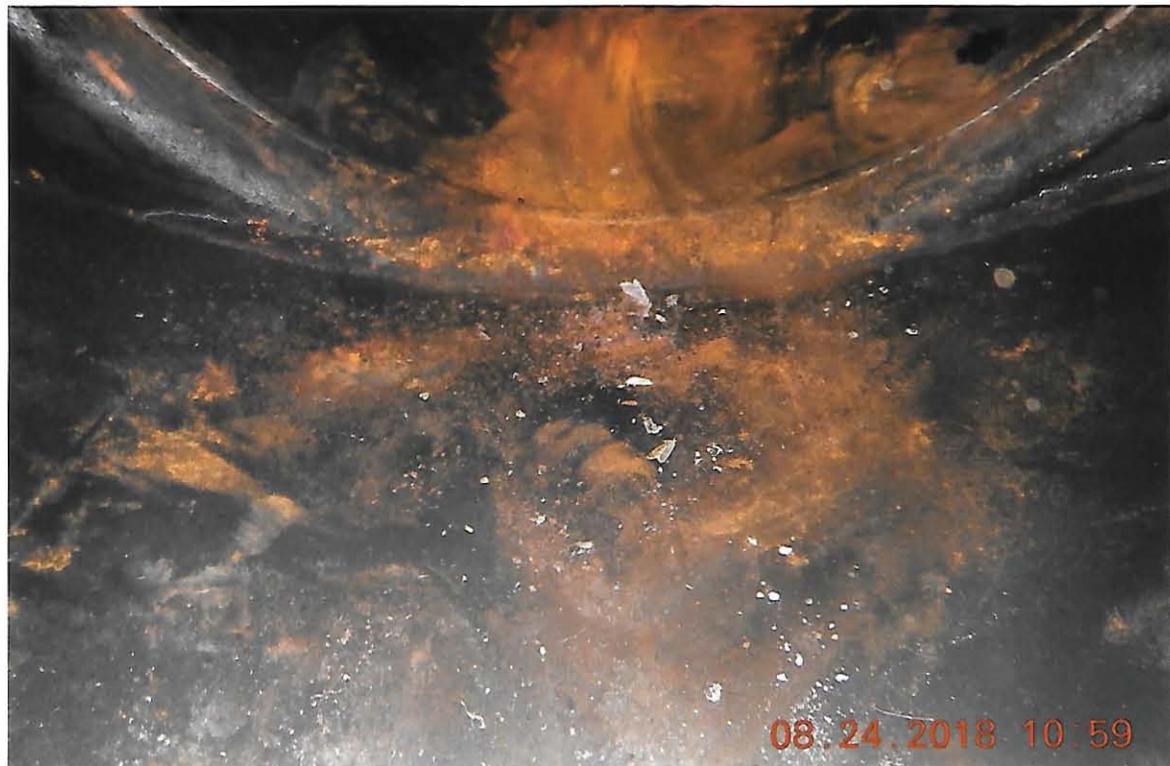
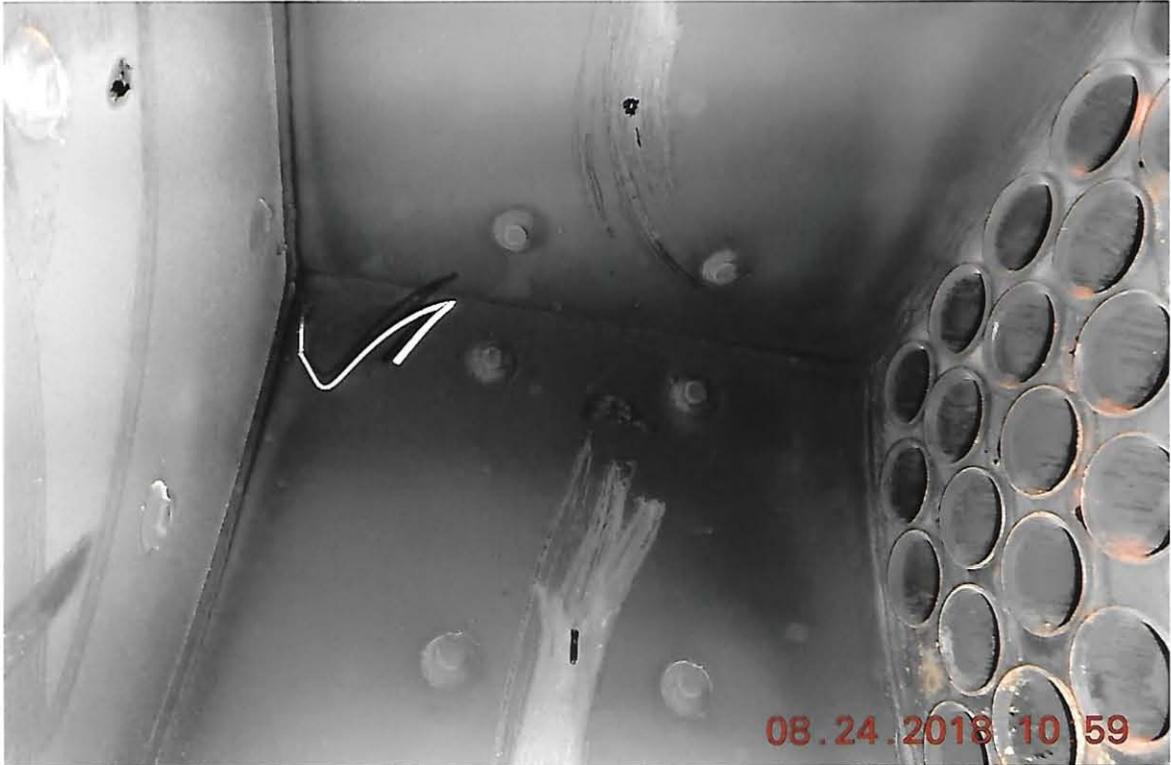
The following eight (8) photos show the condition of the inner rear tubesheet and combustion chamber. A light layer of black soot was noted on the rear tubesheet, combustion chamber walls, and ID of the tubes. No indication of pitting was observed. Watermark discoloration was noted on the tubesheet and at the bottom of the combustion chamber. Accumulation of debris was observed at the bottom of the combustion chamber. The accessible welds and tubesheet ligaments appeared to be in satisfactory condition.

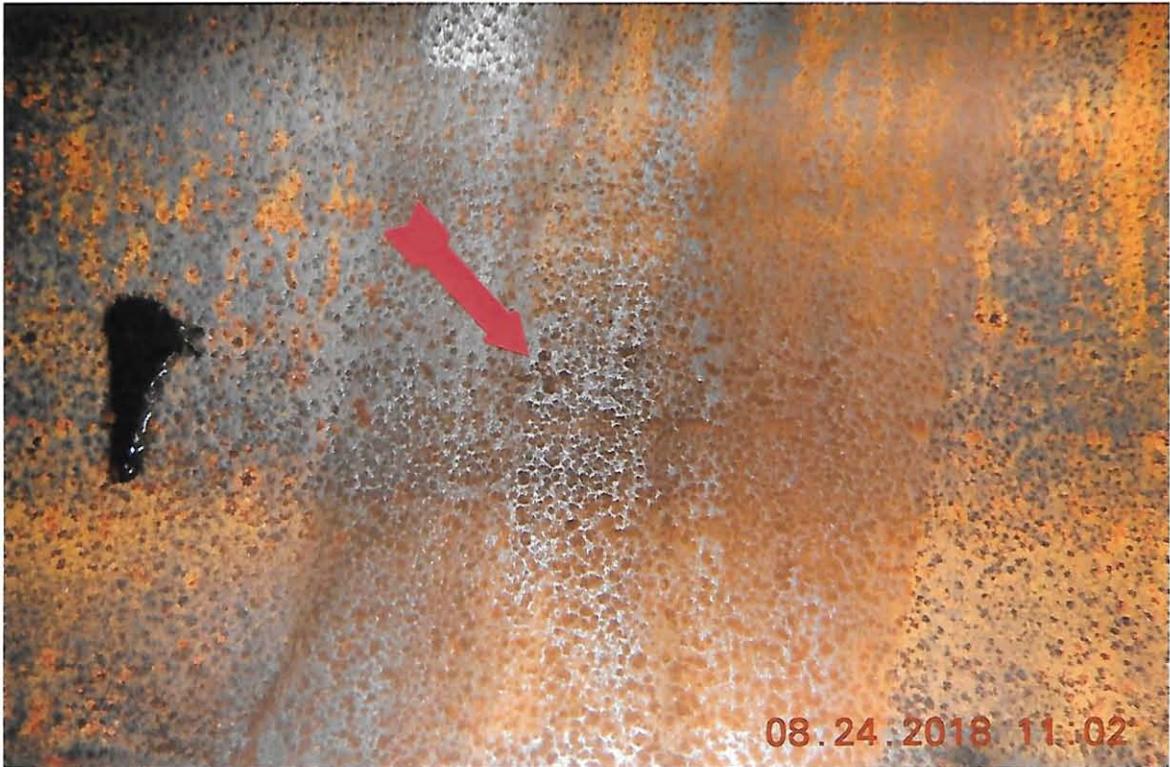
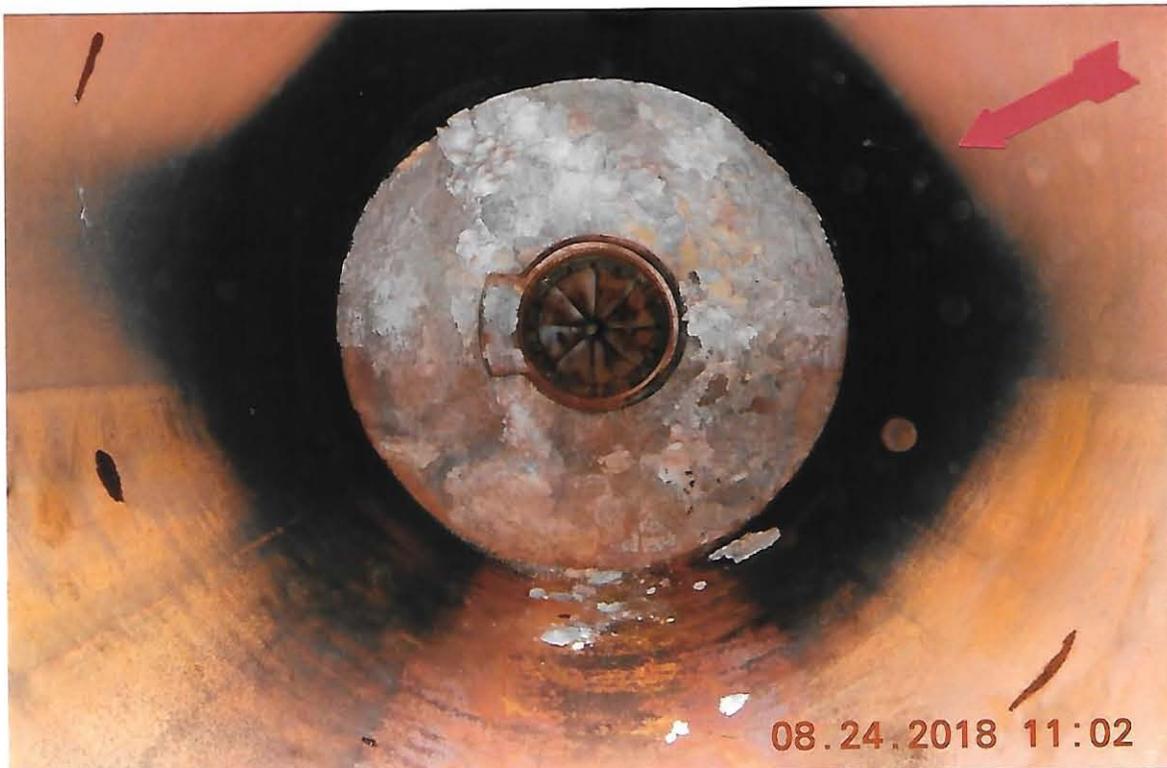
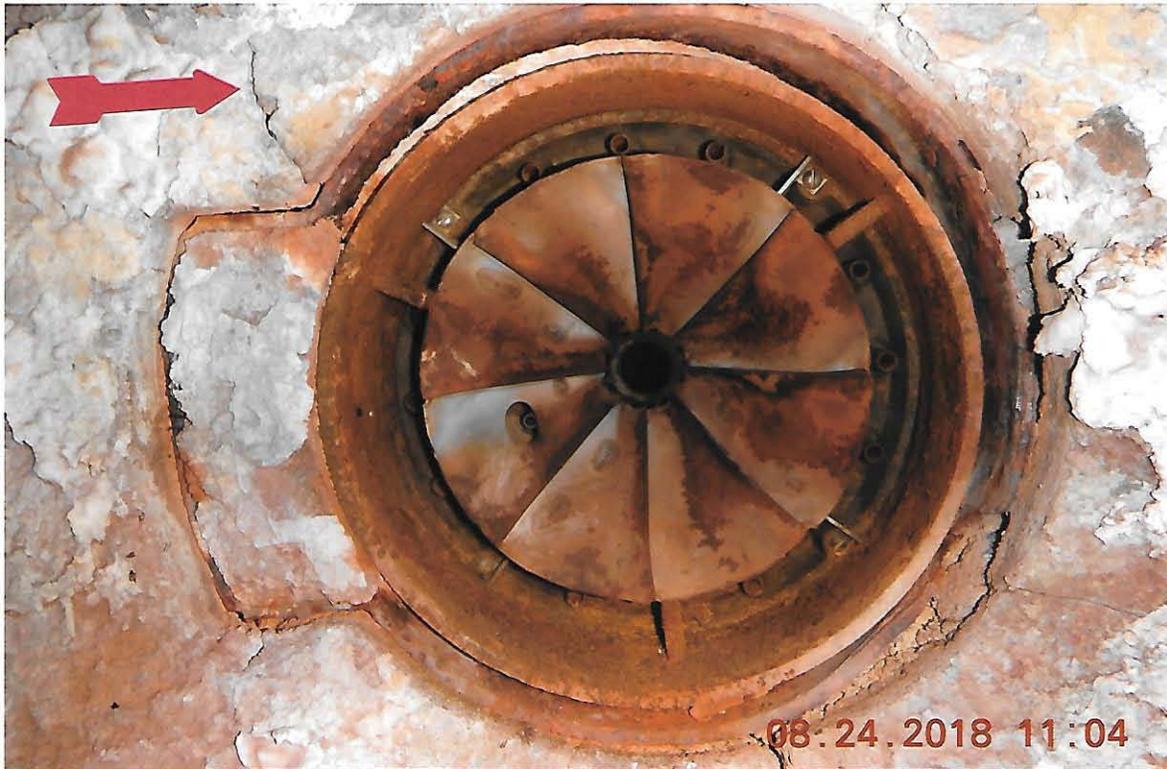
The following six (6) photos show the condition of the furnace sheet and burner. Light corrosion and pitting were observed on the furnace sheet. Soot build-up was noted near the burner. Watermark discoloration and accumulation of debris were noted at the bottom of the furnace sheet. Corrosion and warping of the burner barrels were noted. Cracks in the burner refractory were observed. The longitudinal weld appeared to be in satisfactory condition.

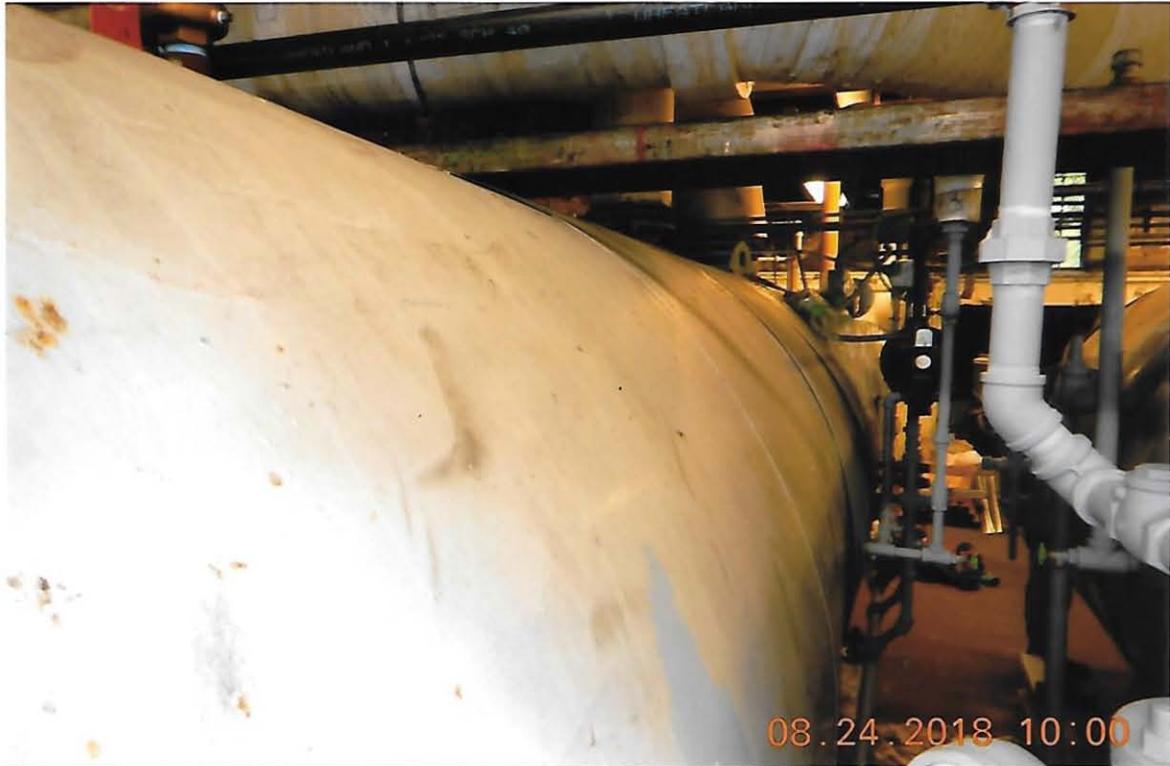
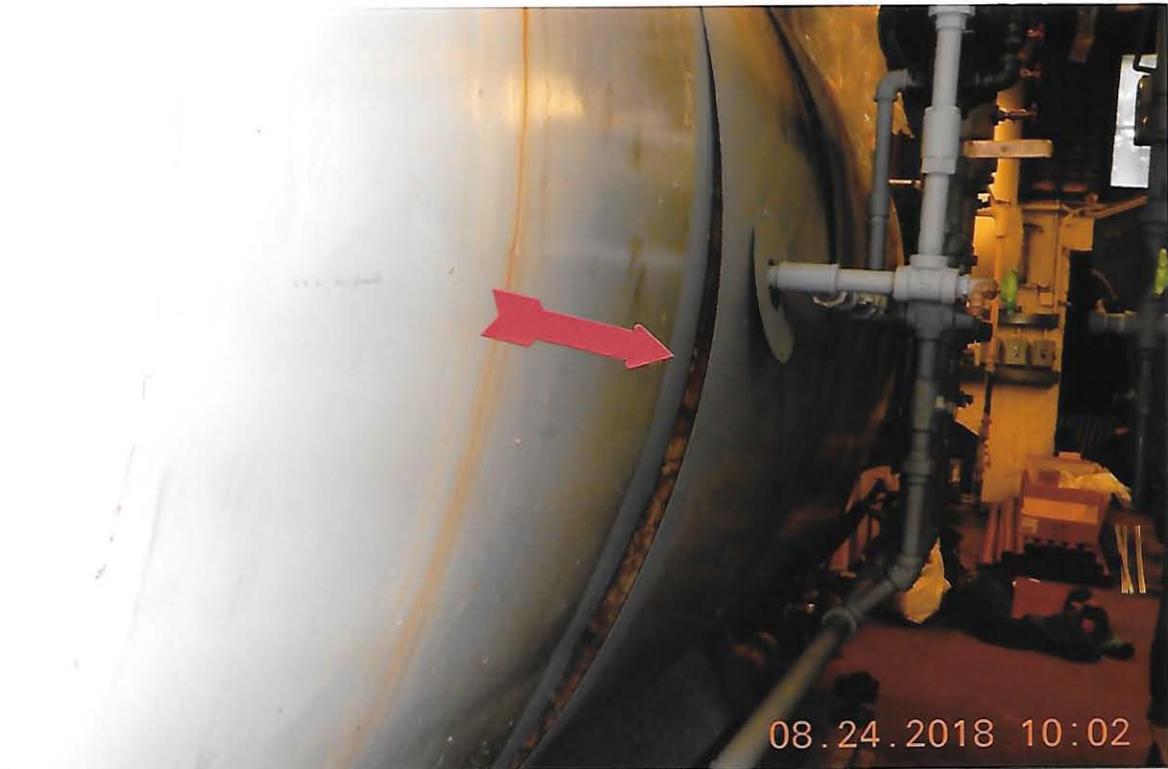
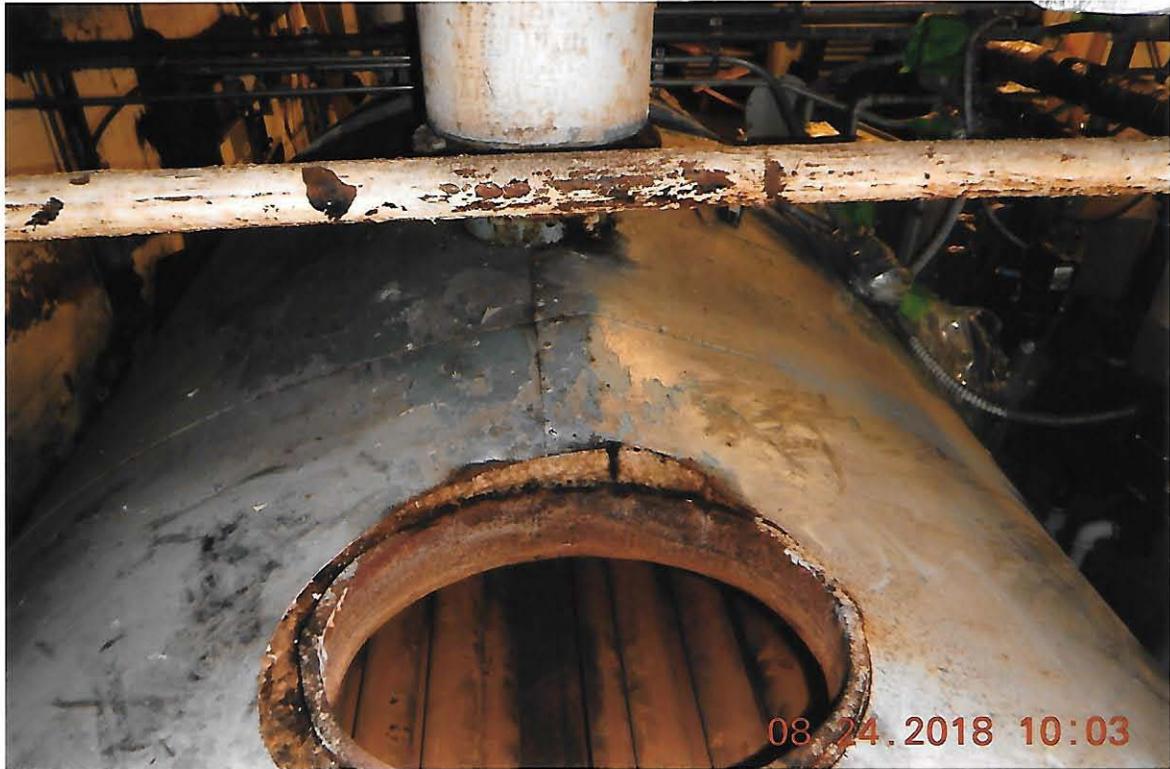
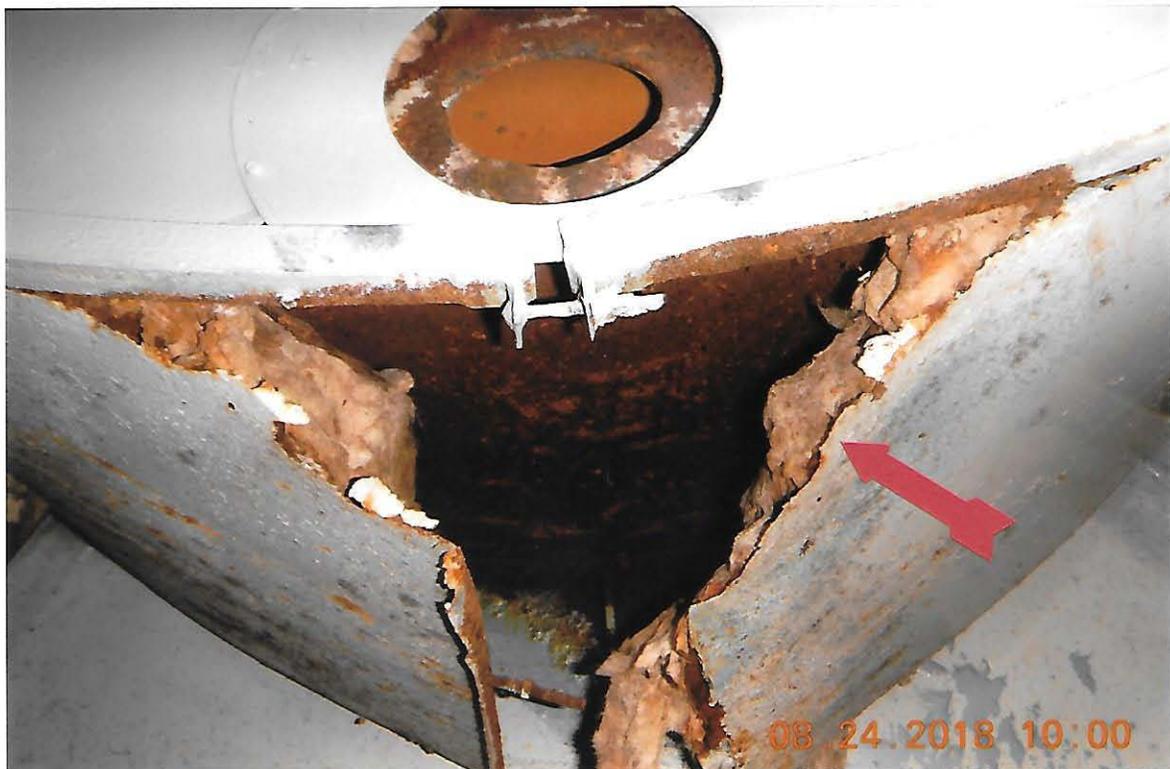
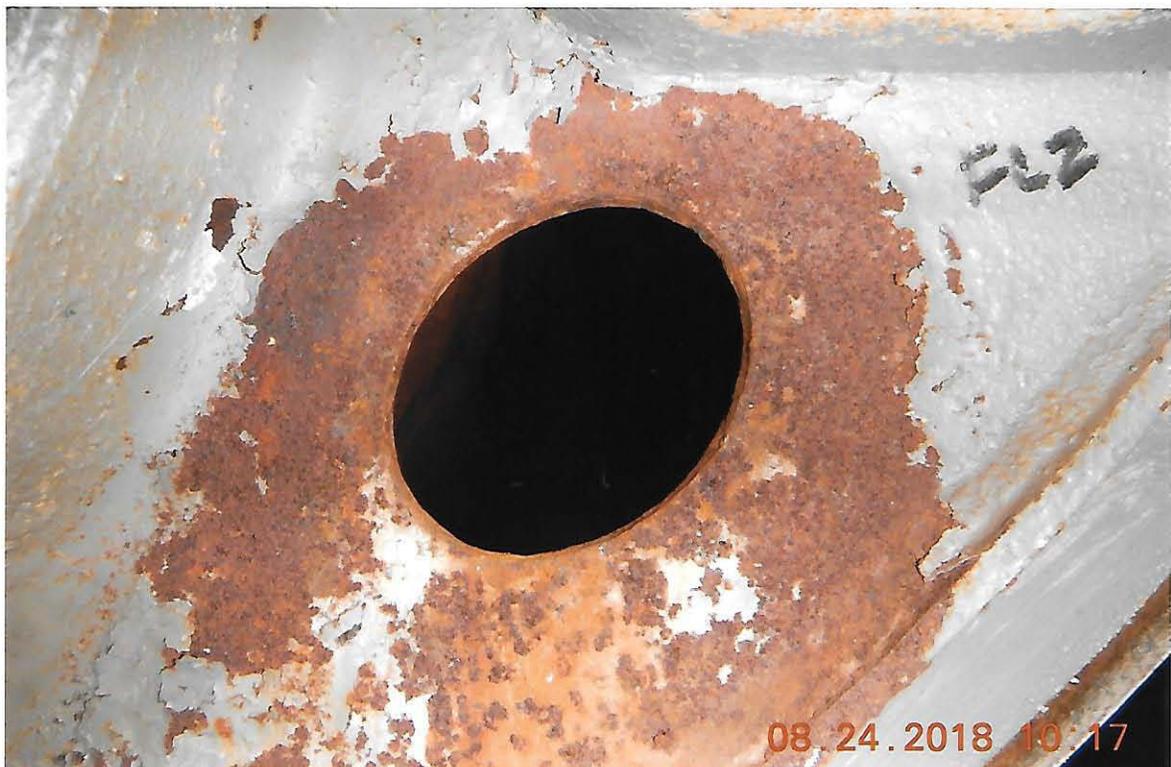
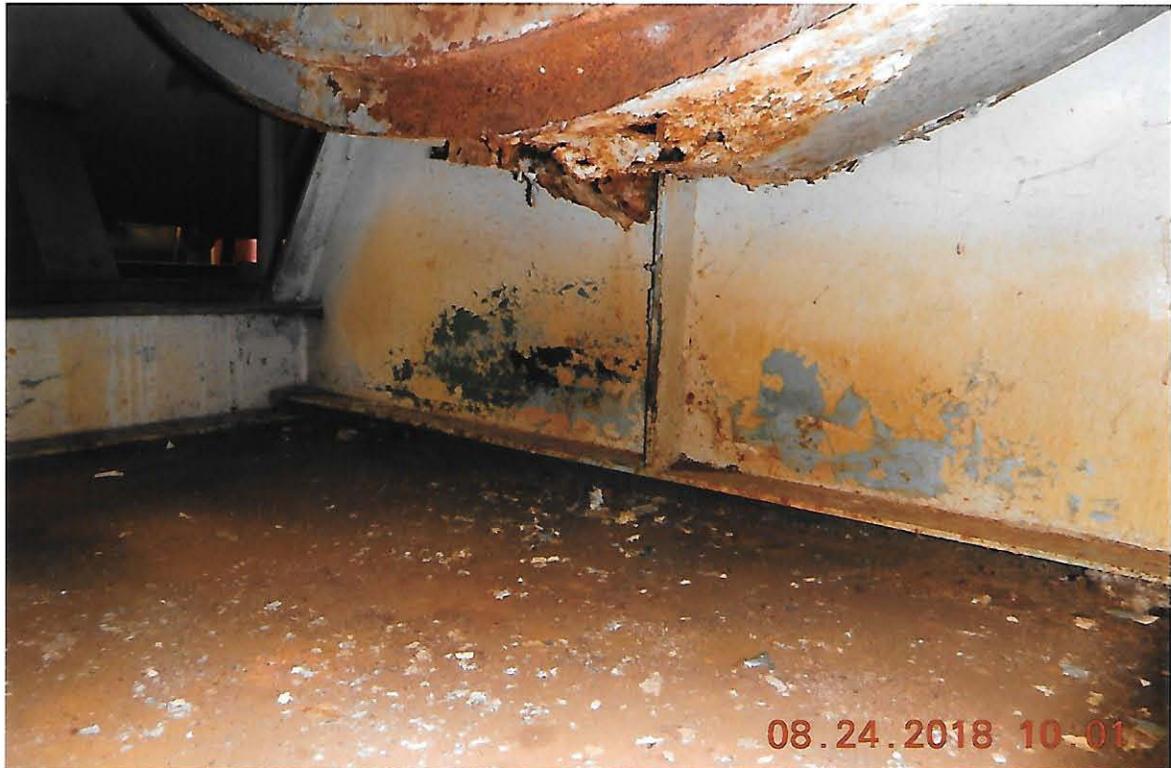
The following eight (8) photos show the external condition of the boiler. Gaps in the casing seams were noted. Staining, corrosion, and deterioration were observed on the casing beneath the boiler. Corrosion around the handholes was noted. The support structure appeared to be in satisfactory condition.
