# Evanston Ecology Center

Existing Conditions Report

March 22, 2023

**HPZS**

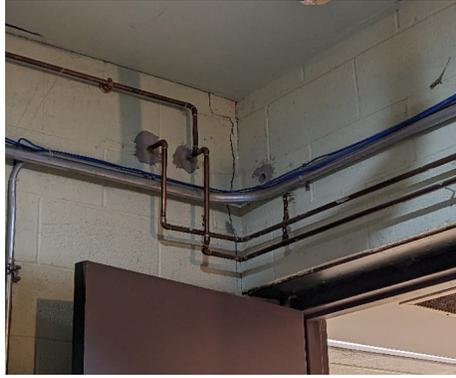
26 Crack in a Corner

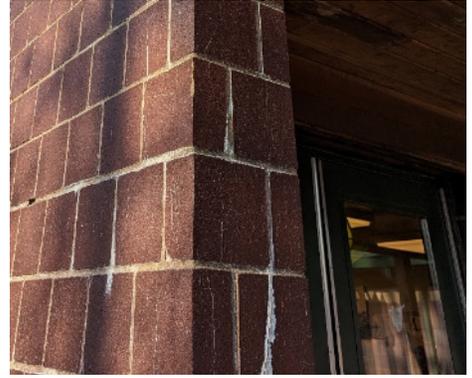
27 Exterior Brick Deterioration

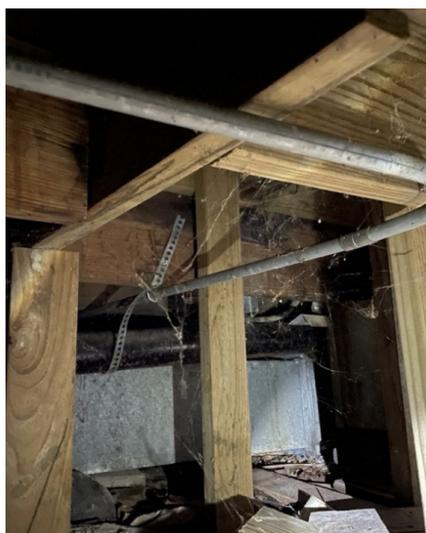
Figure 10. Existing Conditions of Joists Below Mechanical Room

At the mid-span of the classroom/office space, the existing construction documents indicate 10" deep wide flange beams spanning in the east/west direction. This area was not accessible from the access points, so Silman was unable to confirm the condition of these members. Spanning between the steel beams and the perimeter walls are 2x12 joists spaced at 16" on center. Where accessible, these joists were observed to typically be in good condition. However, a member of the EEC staff informed us that a piece of mechanical equipment in the mechanical room had been leaked, and joists below this area were observed to be deteriorating (see Figure 10. Existing Conditions of Joists Below Mechanical Room.) Temporary wood shoring posts were also observed in this area, along with rusting to the mechanical and electrical equipment.

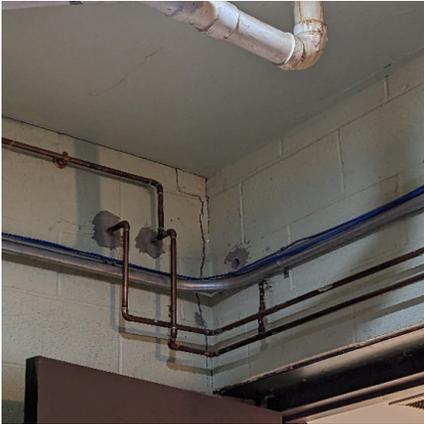
Typically, the interior and exterior masonry was observed to be in good condition. In the electrical room, some cracks were observed at the west wall interface (see Figure 14. Crack observed at Northwest Corner of the Electrical Room) At the exterior, the brick was observed to be deteriorating in a few ways on the southeast corner of the larger office space (see Figure 15. Deterioration of the exterior brick at the northeast corner of the larger office). This wall follows the upward include of the roof and extends beyond the interior space to the east. This deterioration included cracking, crazing, and open joints.

Figure 14. Crack observed at Northwest Corner of the Electrical Room

There were past repairs at some cracks were observed, but many of the past repairs were observed to have failed. A probe was completed on the interior face of the wall and no deterioration of the CMU block was observed.

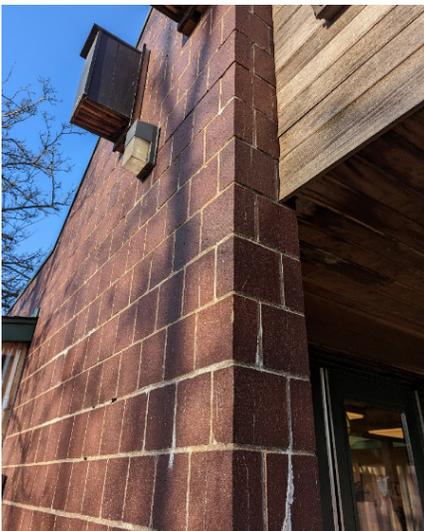
Figure 15. Deterioration of the exterior brick at the northeast corner of the larger office

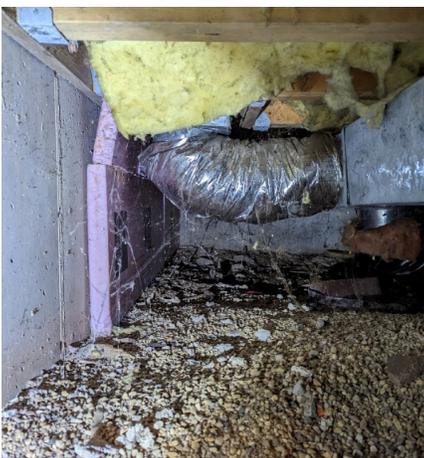
At the hallway, the main level was observed to be supported by typically (2) 2x10 joists spaced at 16" on center. The existing drawings specified (1) 2x10 spaced at 16". It is unclear why an additional ply was implemented during construction. A ledger was observed on each side of the foundation walls with hangers supporting the joists. Silman observed that only the joist was supported by the hanger at some of double-ply joists. TJI joists are spaced at 16" on center (see Figure 19. Existing Foundation and Wood Structural Members at Multi-Purpose Room). Additional framing was observed around the fireplace but was not accessible. The additional drawings indicate (2) 2x12 members. However, an EEC staff member indicated the area around the chimney had additional structural work completed later to resolve a deflection and/or vibration issue.

Figure 16. Existing Foundation Wall in the Hallway

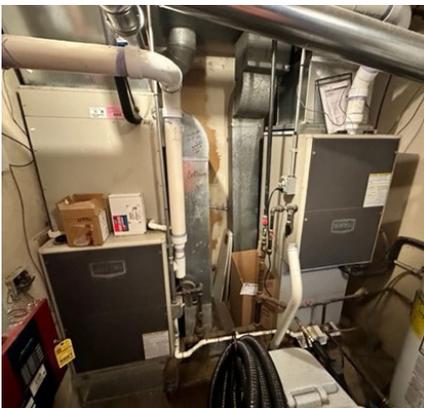
Figure 23. Maytag MGC2TC120D45D & MGC2TL120D45D (2009, 2011)

The furnaces are manufactured by Maytag in 2009 and 2011. (See Figure 23. Maytag MGC2TC120D45D & MGC2TL120D45D (2009, 2011)) There are several low curbs and penetrations through curb sides on the roof that may contribute to water infiltration into the mechanical room.

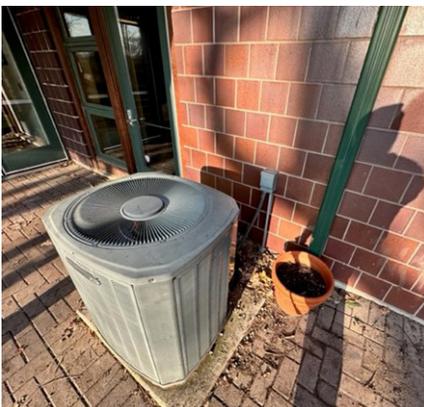
The system consists of a Trane cooling coil and 5-ton outdoor condensing unit manufactured in 2002. (See Figure 24. Trane 2TTR2060A1000AA Condensing Unit (2002)) It uses discontinued R-22 refrigerant. A Goodman gas-fired heating and fan section was retrofitted onto the cooling coil in 2013. The ASHRAE typical life expectancy for a residential grade system is 15 years.

Figure 24. Trane 2TTR2060A1000AA Condensing Unit (2002)

Overall, the system appears to be in poor condition. There is no outside air connection for code-required ventilation. It is past its useful service life and it was reported by the engineering department that the system is near failure and will require immediate replacement. It was also reported that the system is deficient at conditioning the entry corridor. They would like the future system to have separate zoning for the corridor.

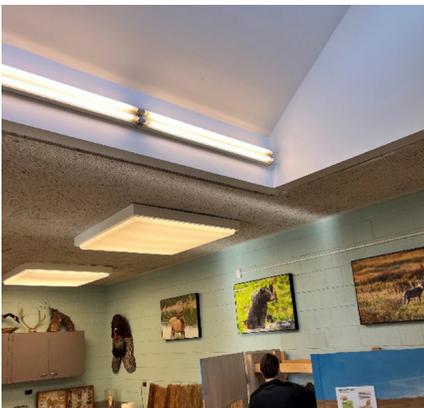
Figure 27. Typical fluorescent light fixtures

Most light fixtures for the facility still utilize fluorescent bulbs (See Figure 27. Typical fluorescent light fixtures) except some fixtures with LED replacement bulbs. The areas which will be modified shall be equipped with high efficient LED type fixtures with energy code complaint control system such as occupancy sensor, daylight sensor and dimming control.

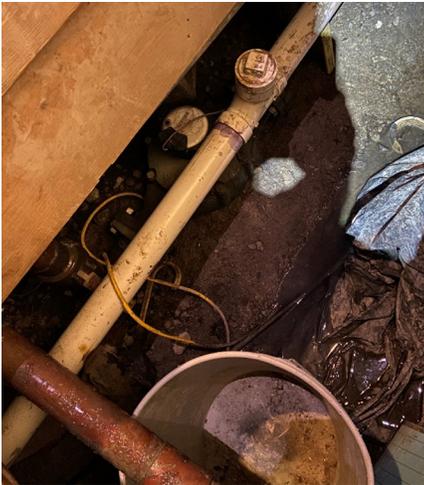
Domestic water is provided from the municipal main at McCormick Blvd and enters the building within the crawlspace below the main toilet rooms. The service size appears to be 2" which is adequate to provide code compliant demand for all existing

Figure 28. Domestic water meter in crawlspace and PVC waste below floor

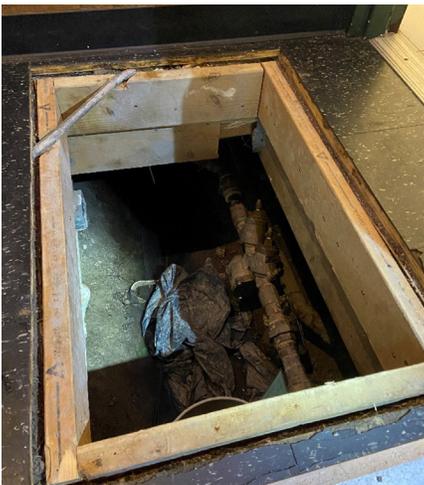
fixtures. An RPZ (See Figure 29.. RPZ in crawlspace) supplies exterior water features and irrigation and is located adjacent to the water meter in the crawlspace. It is recommended that the RPZ be moved outside of the crawlspace to a space more conducive to access and testing. The building relies on city pressure and no issues were reported with pressure at the fixtures. Observable piping from the hatch access point was copper, uninsulated, and appears to be in relatively good condition.

Figure 29.. RPZ in crawlspace.
