## Appendix C: Infrastructure

## Roadway Conditions

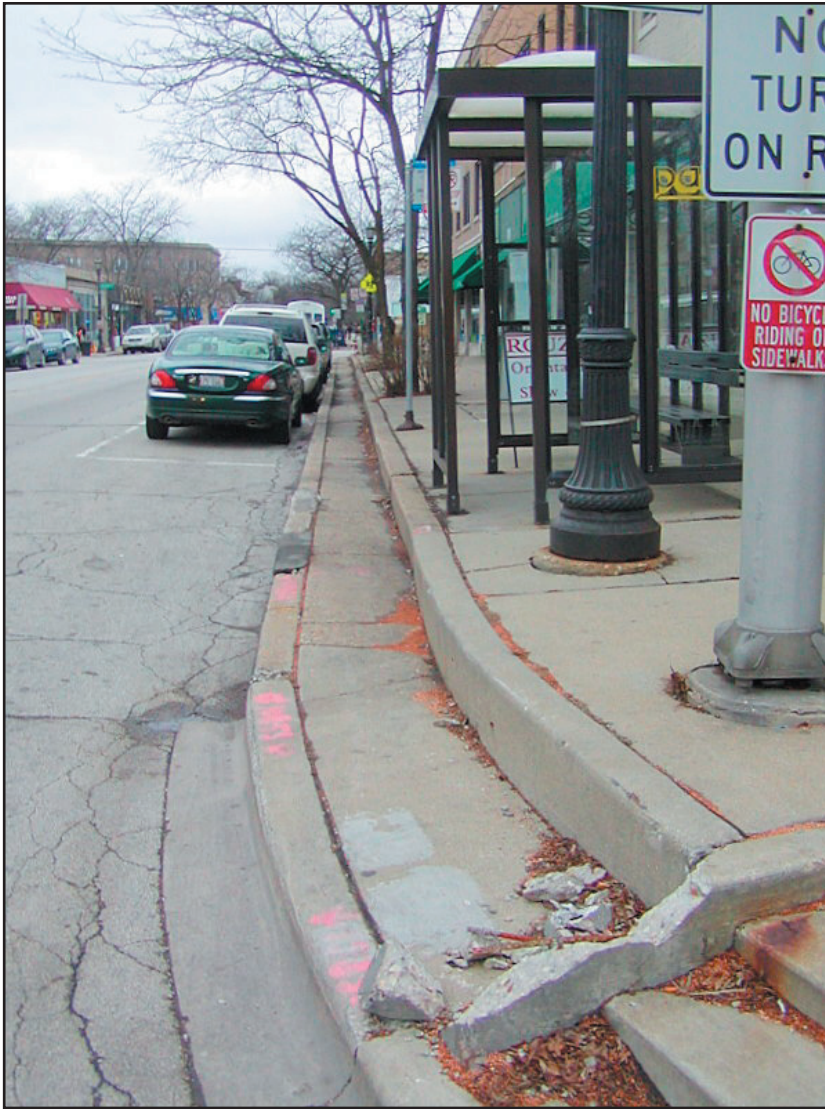
Pavement and curbing conditions vary considerably between the western and eastern sections of Central Street. Pavement conditions west of Hartrey are generally fair to good, although pavement and curb conditions are generally poor at the Gross Point/Crawford/Central intersection. Pavement conditions are generally in fair to poor condition. Deteriorated, broken and non-existent pavement and curbing is present, particularly between Green Bay and Jackson. Between Prairie (north of Central) and Green Bay, there is a high, double-curb, as well as crumbling concrete stairs at the Green Bay crosswalk.

A stepped and broken curb at the intersection of Central and Green Bay.

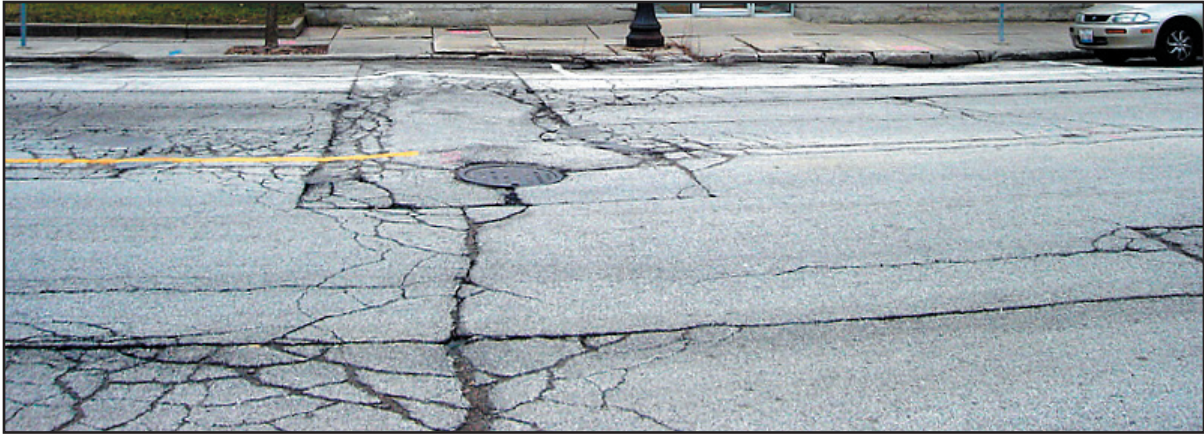
Deteriorated roadway conditions along west Central Street.

EDOT has scheduled repaving for Central Street between Asbury and Ridge for 2008. IDOT has scheduled repaving between Lincolnwood and Ashland for 2011. Although the section between Ashland and Asbury is generally in good condition, some patching is required.
