## Ryan Field Stadium

### Construction Management Plan

PUBLISHED: 02/08/2024

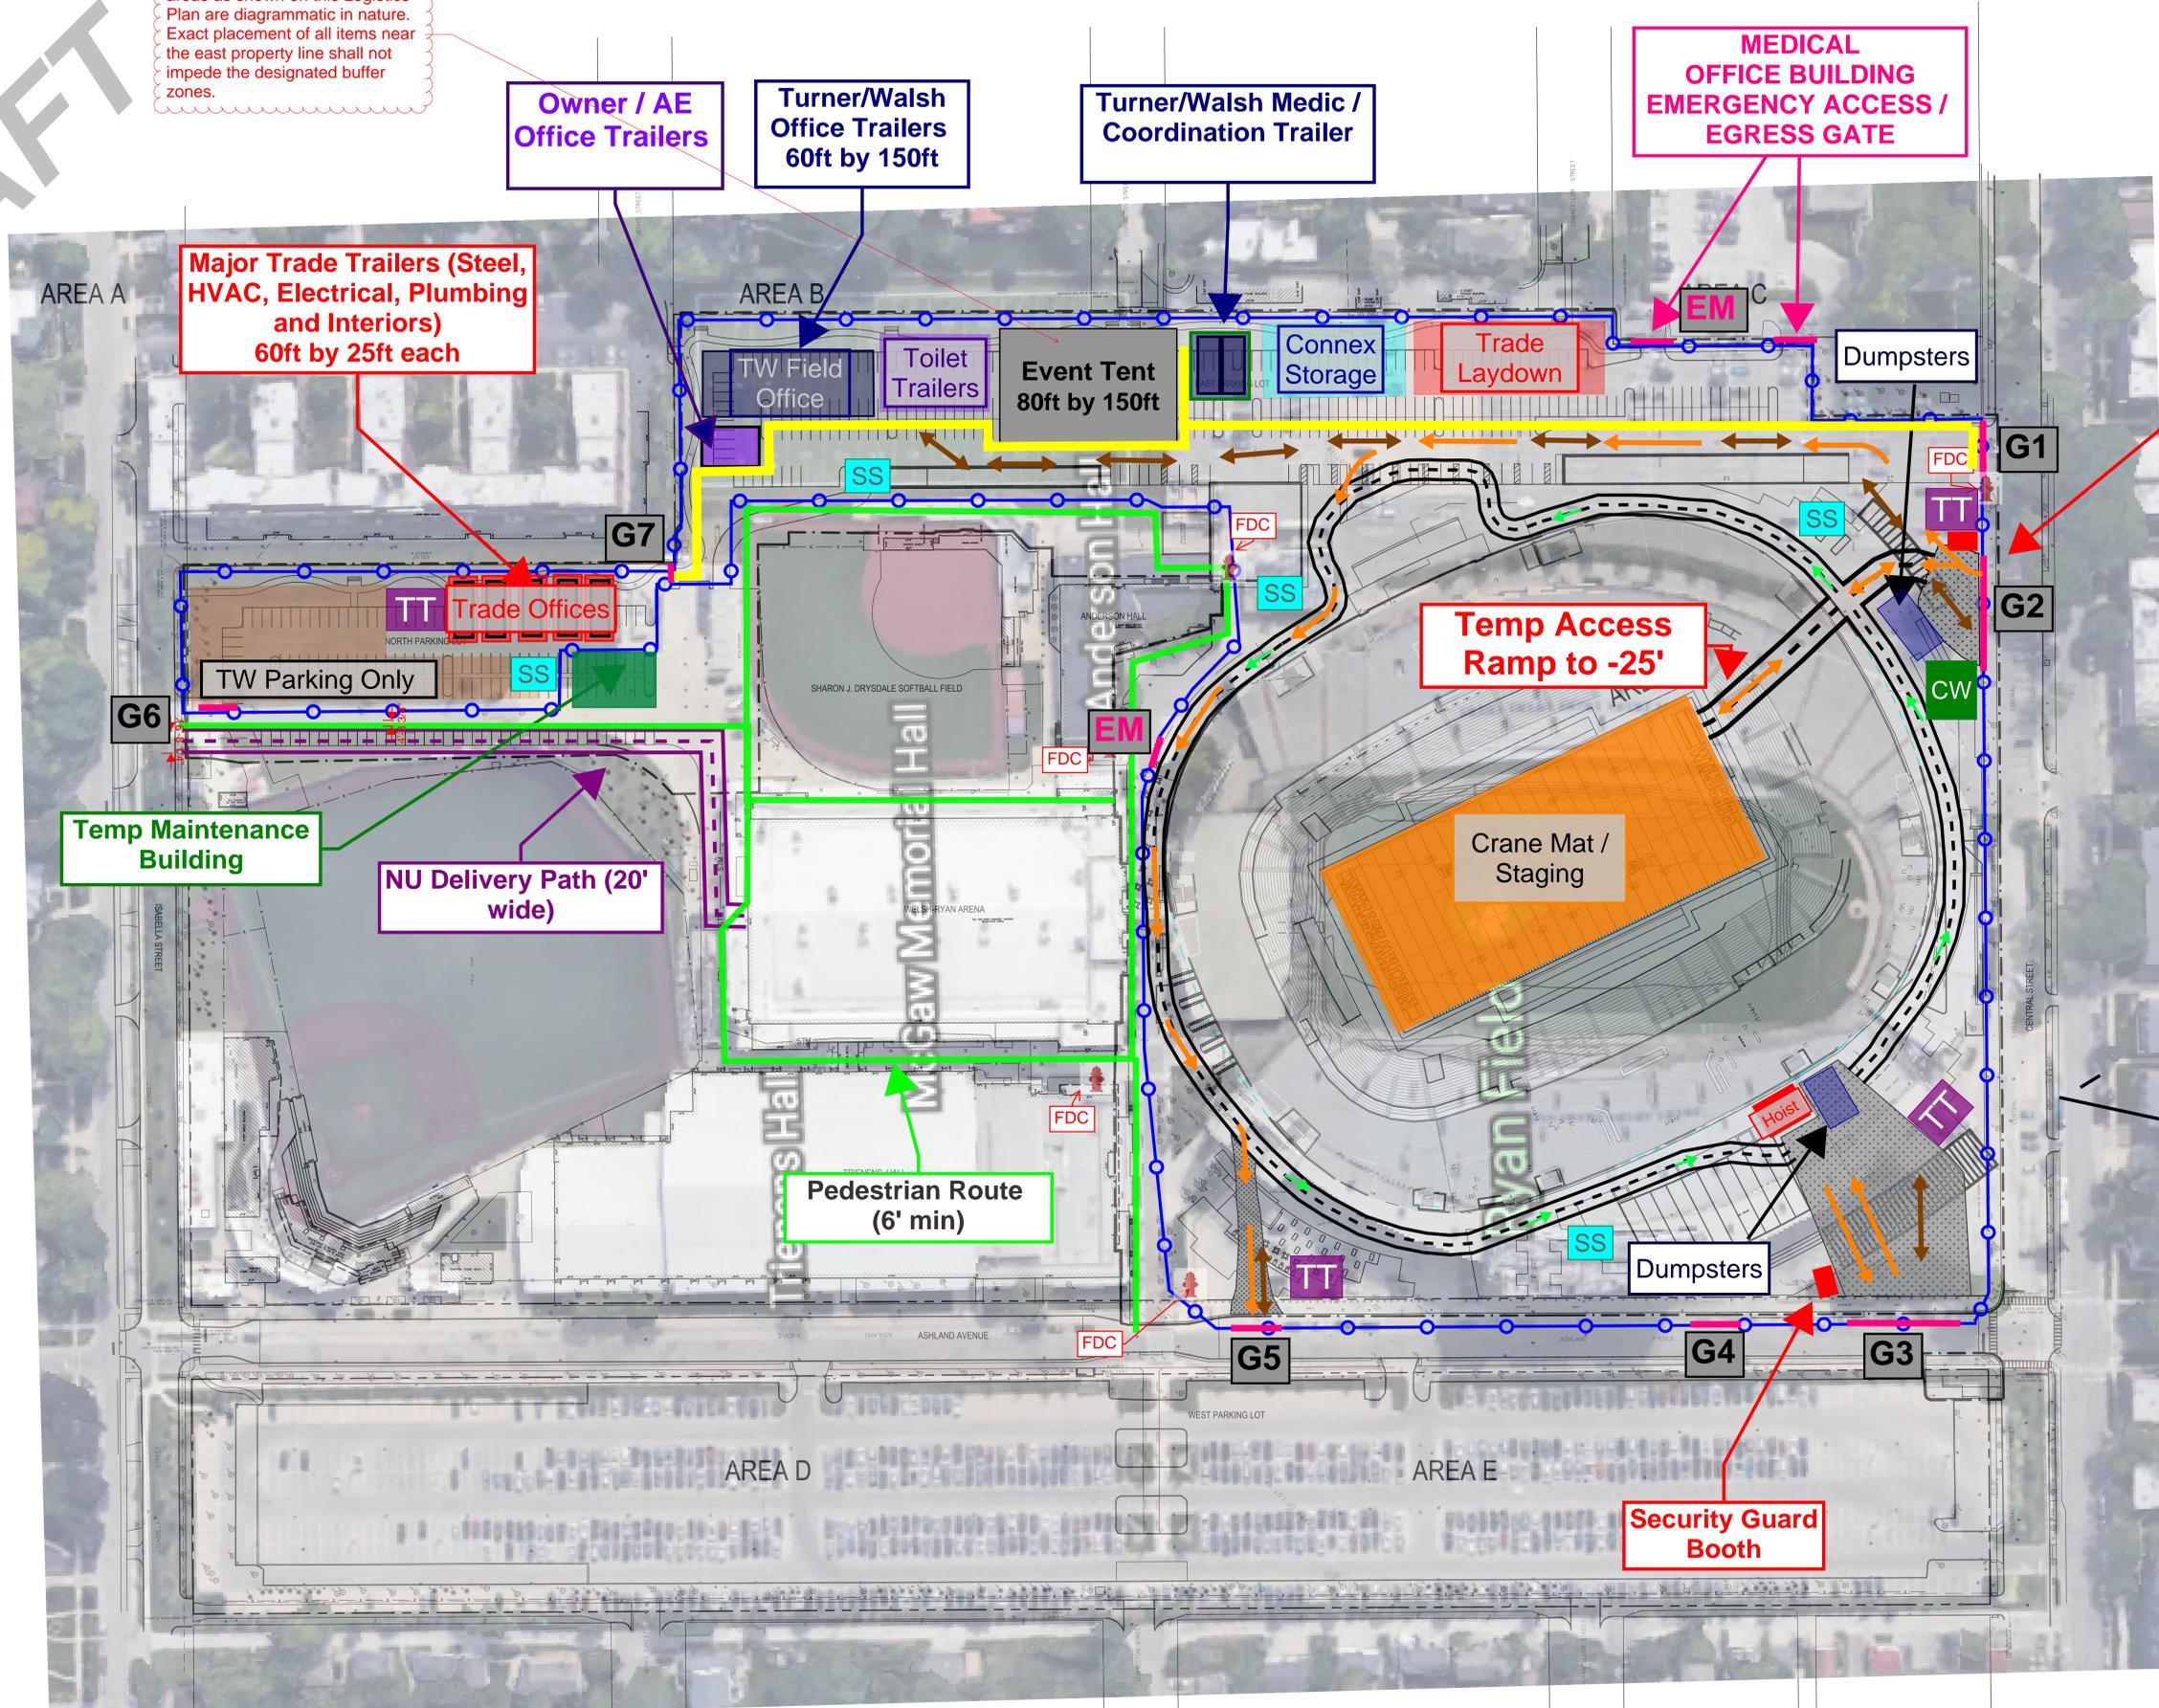
# RYAN FIELD REDEVELOPMENT SITE LOGISTICS PLAN

Placement of trailers and storage areas as shown on this Logistics Plan are diagrammatic in nature. Exact placement of all items near the east property line shall not impede the designated buffer zones.

**Site Security**

**\*NOTE: THE CONSTRUCTION FENCE IS A MINIMUM 20FT DISTANCE FROM ADJACENT BUILDINGS FOR VEHICLE ACCESS. WALKER WAY TO REMAIN ACCESSIBLE AT ALL TIMES.**

Refer to Site Logistics Plan in Attachment A. Temporary Field Offices, Worker Tent, Temporary Structures will be kept 35’ from the property line allowing for the required setback. Temporary storage area and

On site snow piling locations are shown on the Site Logistics Plan

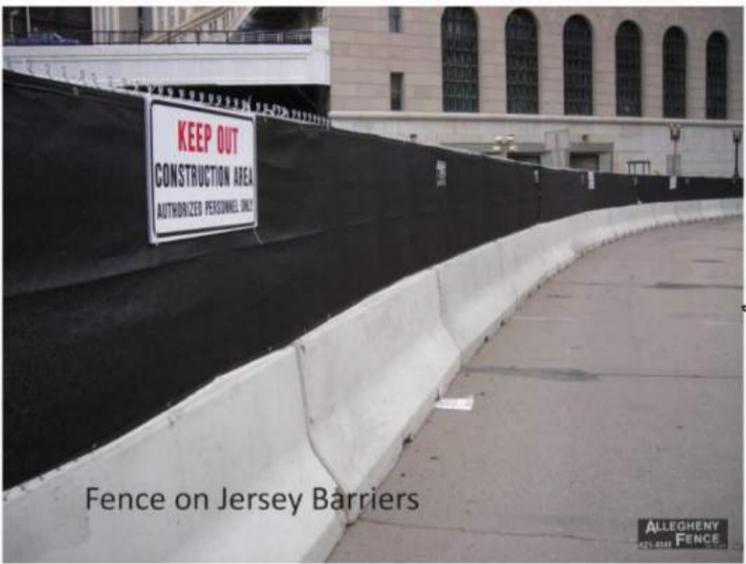
**BUS ROUTE AND PEDESTRIAN WALKPATH PLAN**

Alternate Pedestrian Walkway

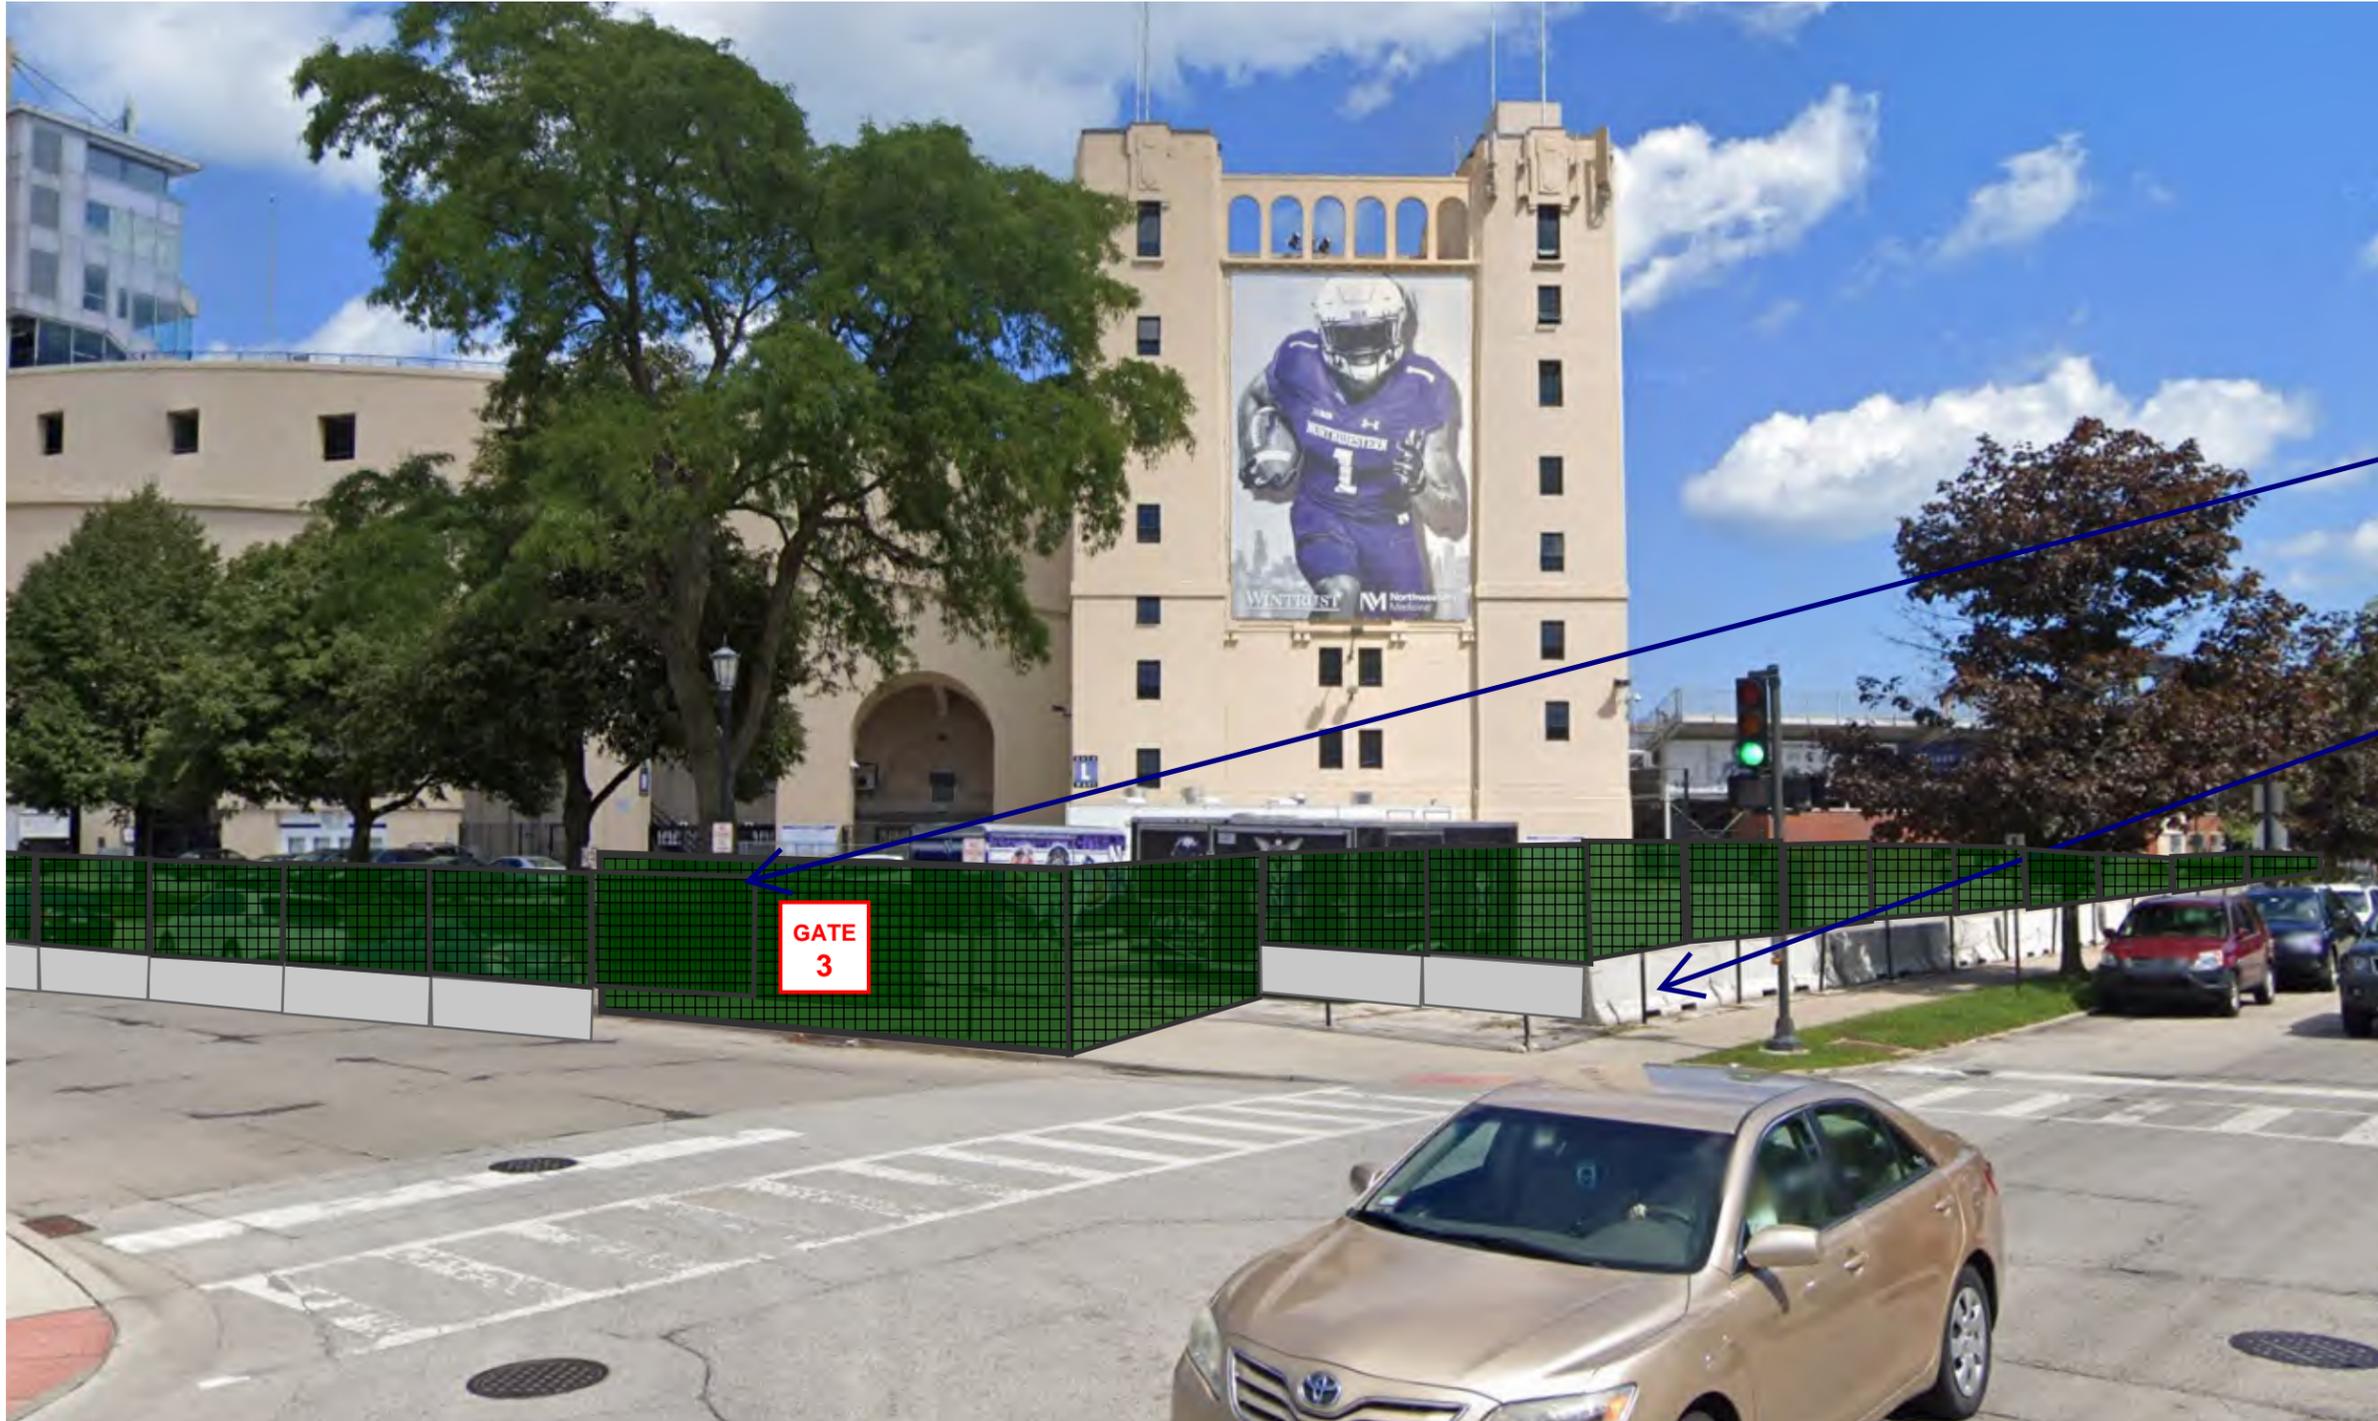
**RYAN FIELD REDEVELOPMENT ASHLAND & CENTRAL**  
**GATE 3 CLOSED**

The Gates Along  
Central and Ashland  
will be Cantilever  
Sliding Gates

Diagonal Fence  
Closing Off the Corner  
will Allow for Safe  
Pedestrian Crossing

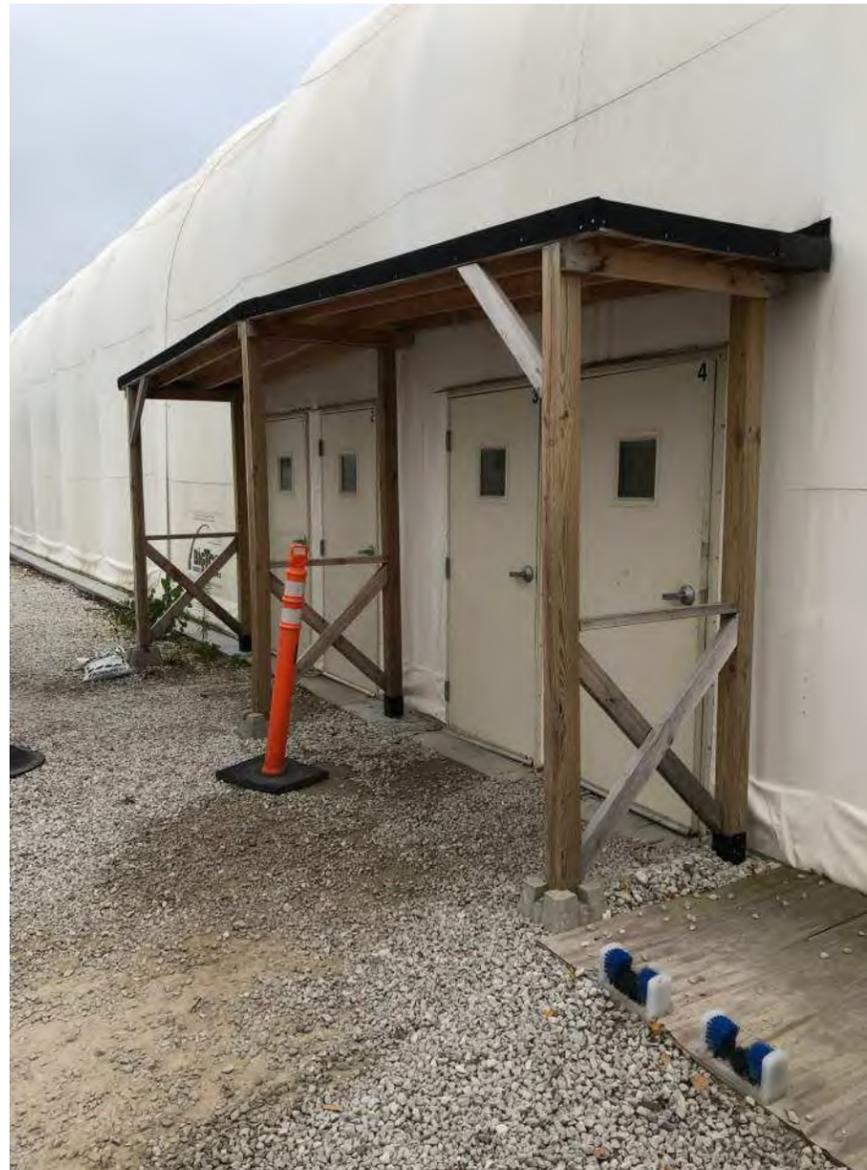
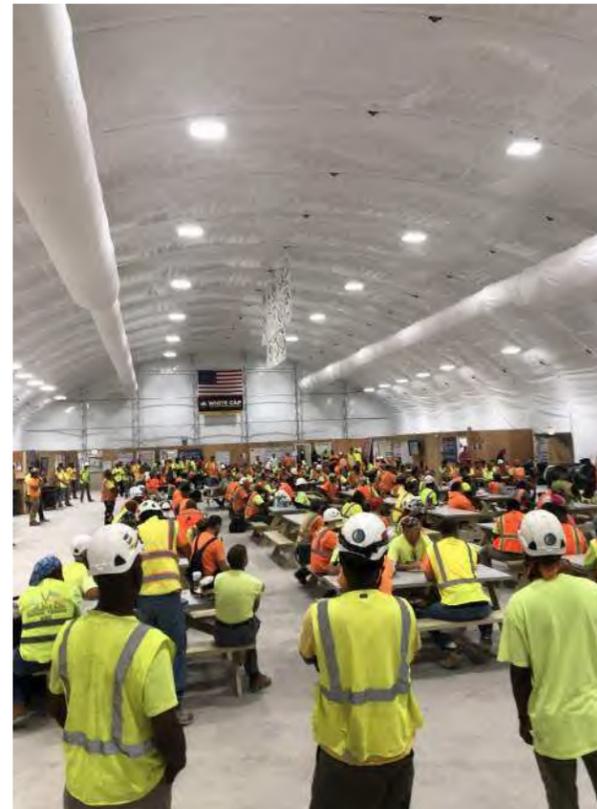
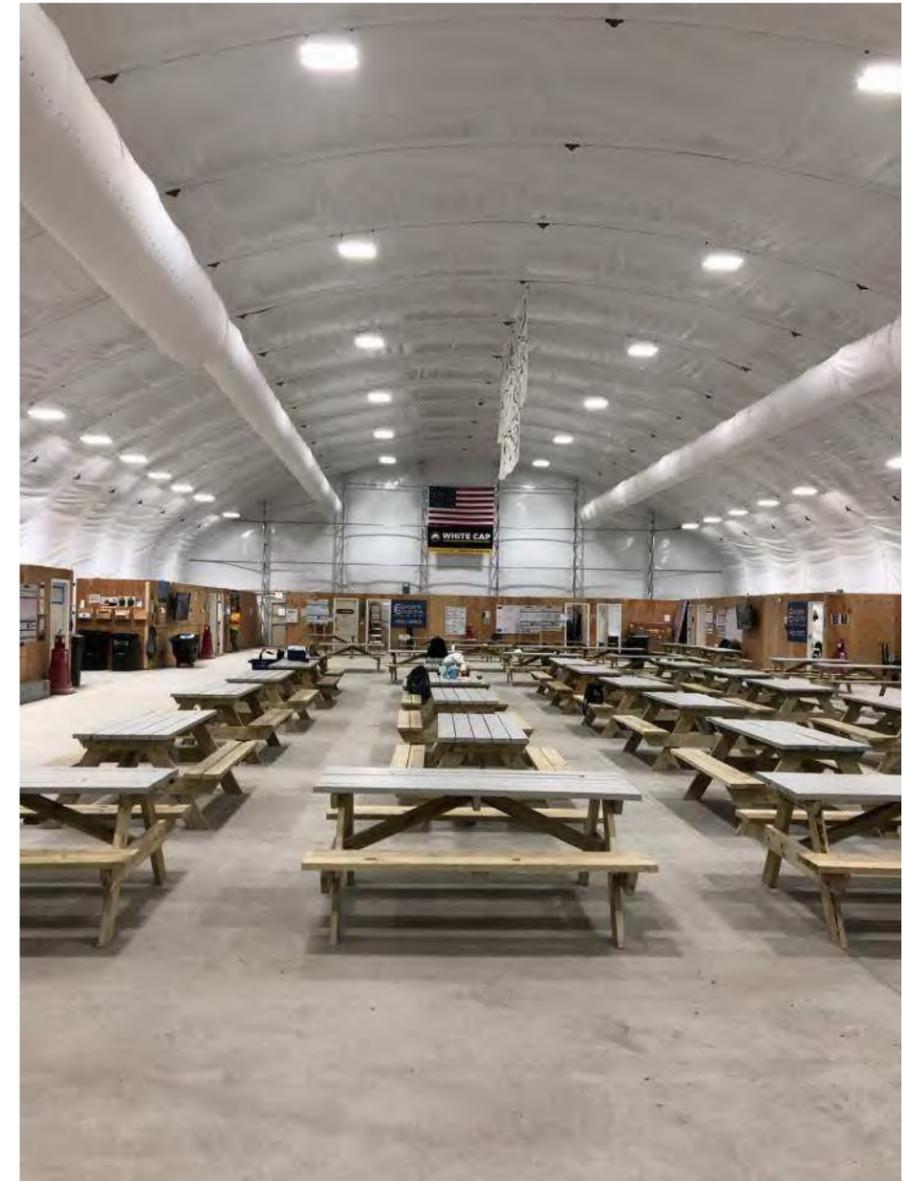
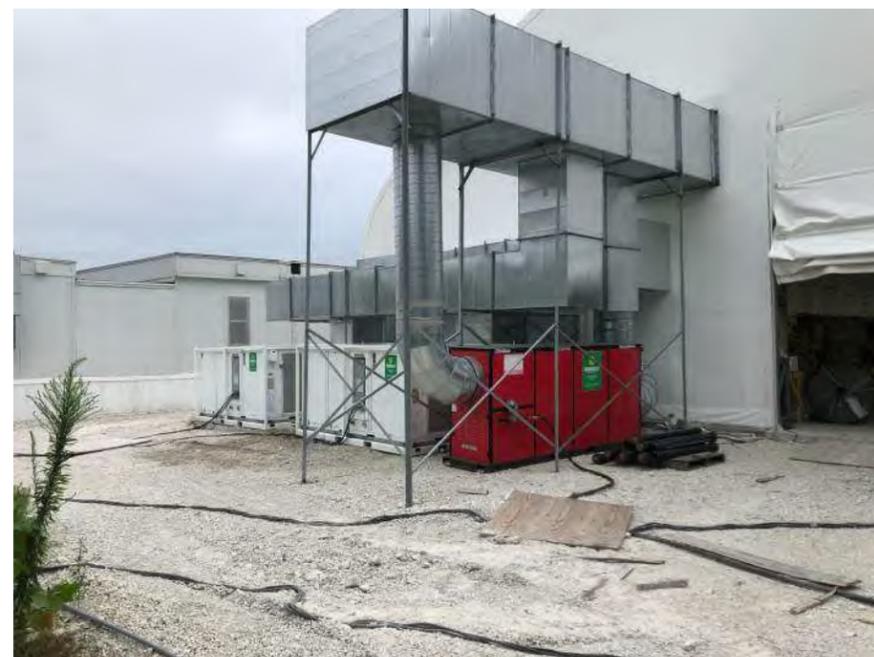
## RYAN FIELD PROPOSED WORKER TENT EXAMPLE

\* No generators will be utilized for power. All temporary power will be provide through ComEd services.

Documentation will provided outlining tent construction, exiting, and other safety previsions

Example photos of the proposed worker tent is included in Attachment O.

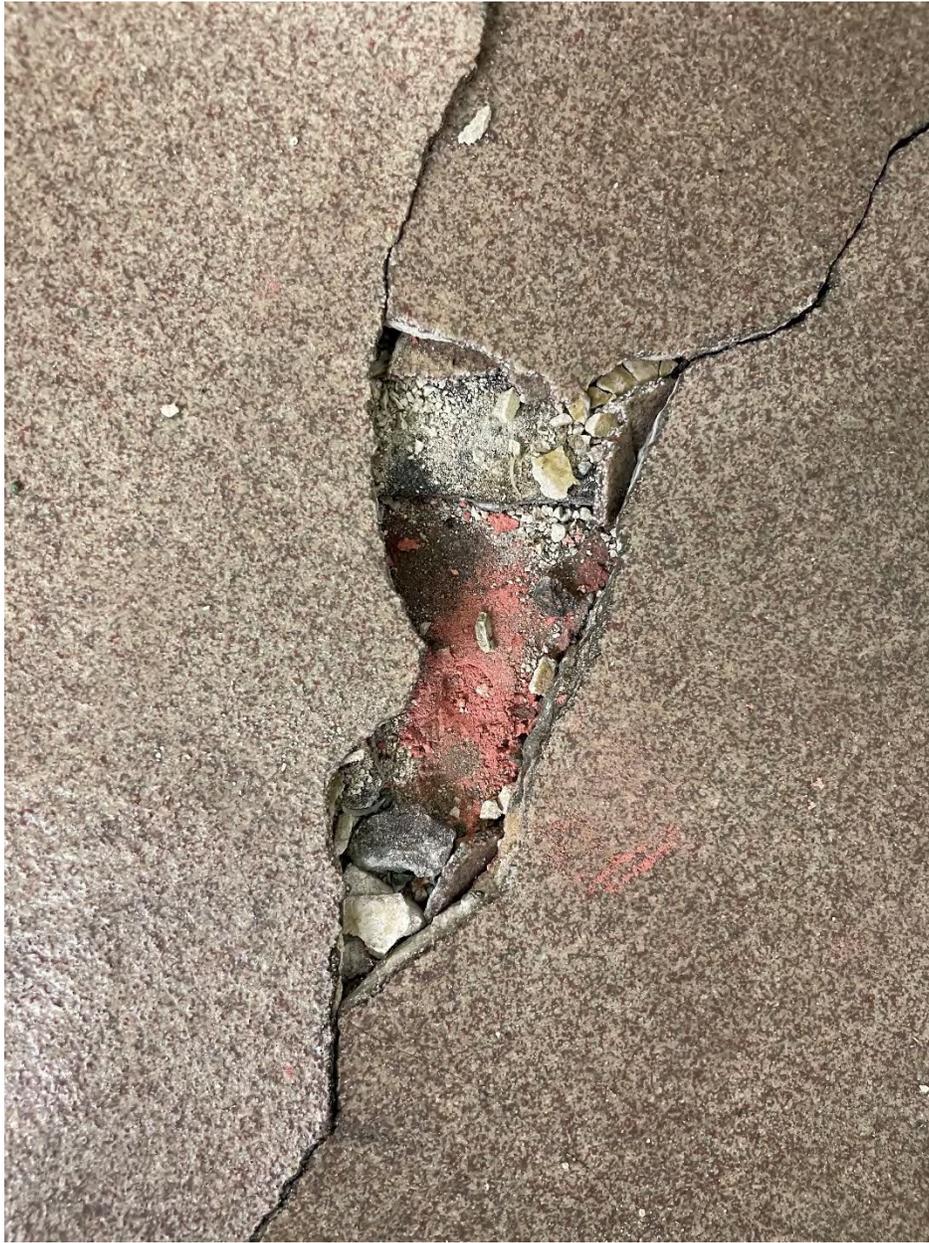
Photo 1 – Concrete Leveler – Pink (ACM) Restroom W203

Carnow Conibear recommends incorporating the data from this report into future demolition/renovation documents regarding the presence of asbestos-containing materials, lead-based paint, and construction/demolition debris. Remove asbestos containing materials and stabilize deteriorated lead-based paint prior to demolition. All future removal and/or demolition/renovation work involving asbestos-containing material or lead-based paint shall be conducted by a licensed contractor in accordance with the City of Evanston, Illinois Department of Public Health (IDPH), Illinois Environmental Protection Agency(IEPA), Environmental

- Asbestos-containing flooring materials were observed at the Aramark Press Tower, Ticket office, W203 restroom and the 1<sup>st</sup> Floor Southwest Men's bathroom.
- The black mastic in the 1<sup>st</sup> Floor Southwest Men's bathroom, the Aramark Offices, and the South Ticketing Office.
- Pink asbestos-containing flooring material in the W203 restroom and the 1<sup>st</sup> Floor Southwest Men's bathroom was found under floor leveler and an epoxy floor coating material. Coring samples were taken throughout to determine any other locations of this material. While it wasn't observed in any other areas, more may be discovered during demolition. If more areas of these materials are discovered, should be treated as ACM.

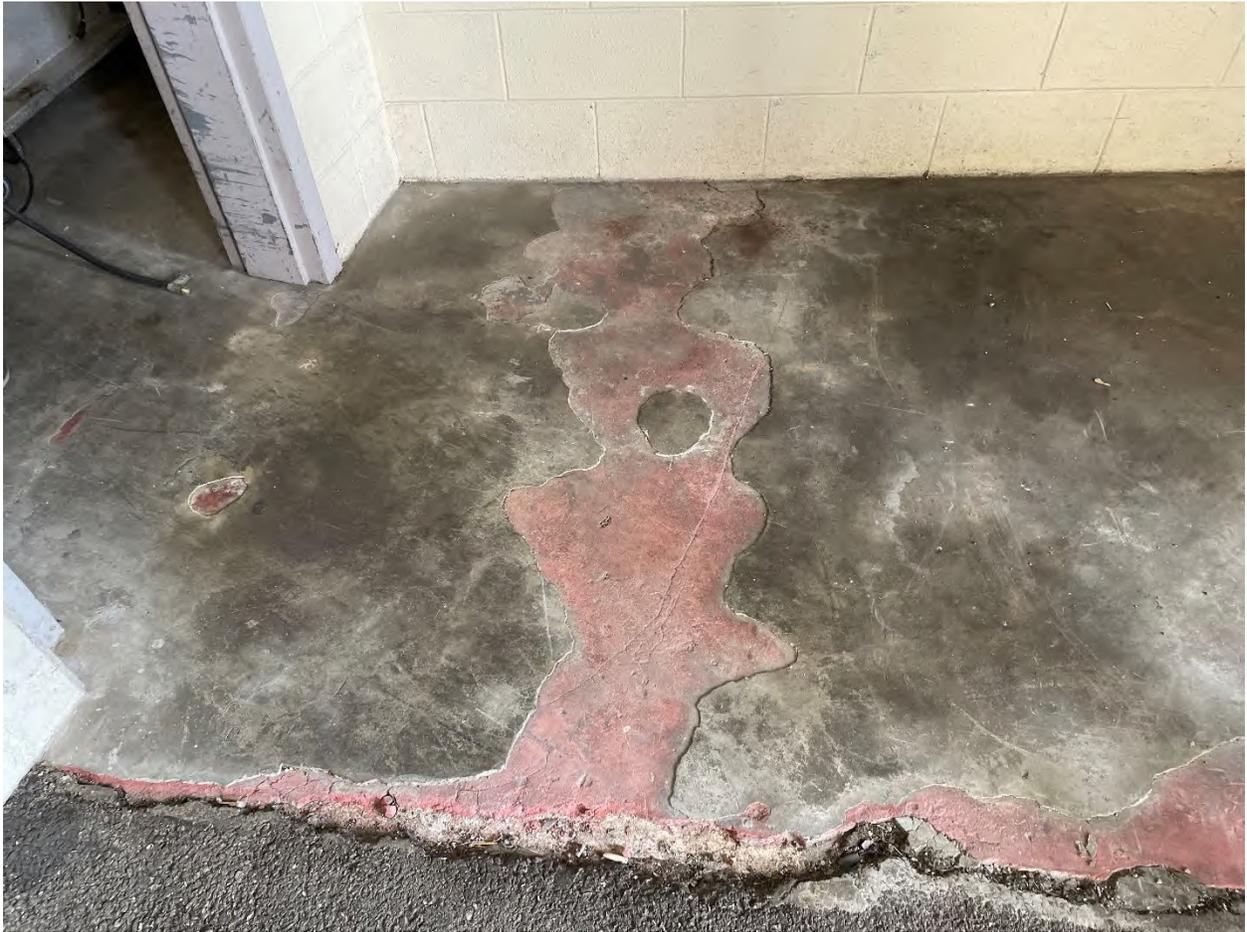
Photo 2 – Concrete Leveler – Pink (ACM) SW Men's Bathroom

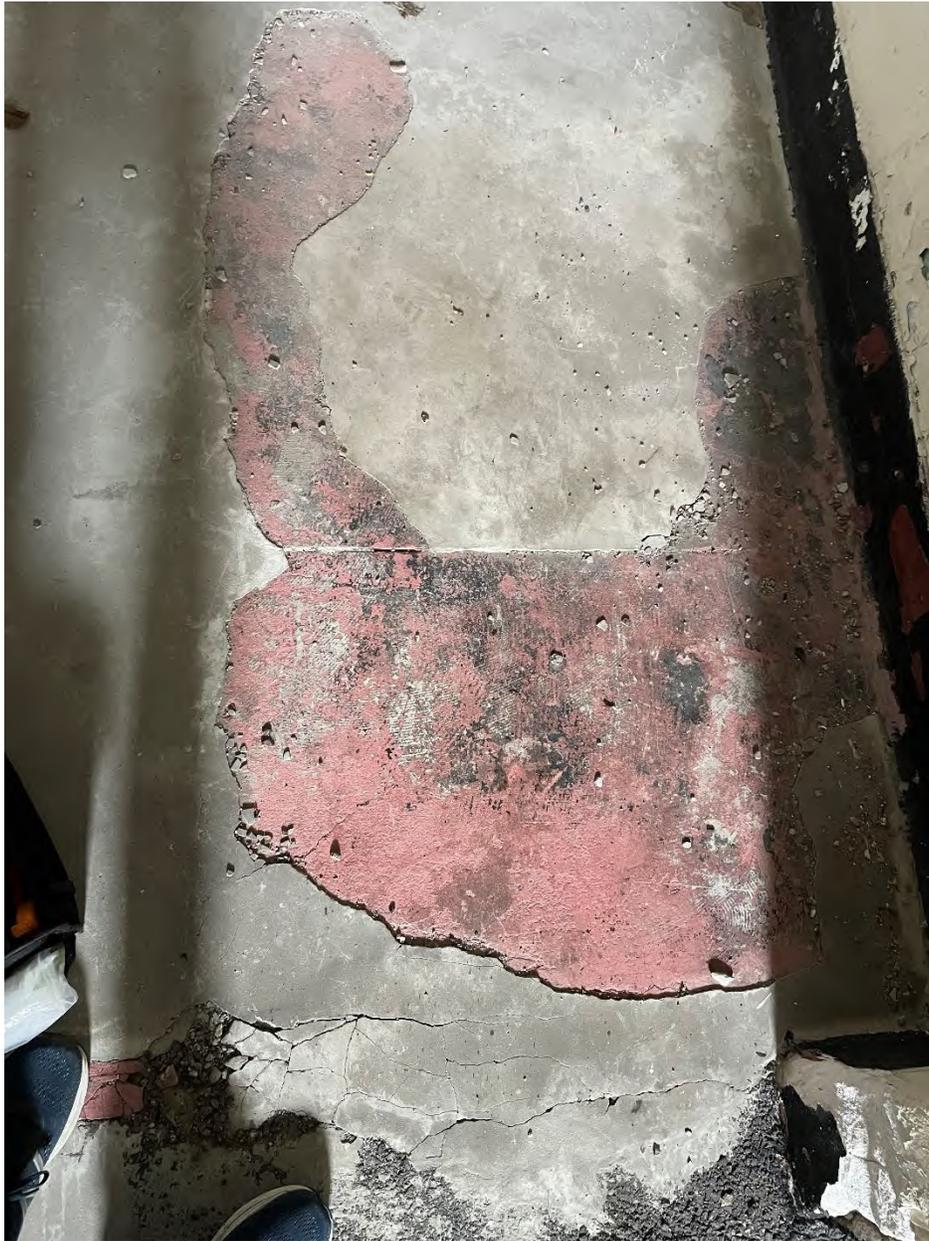
Photo 3 - Concrete Leveler – Pink and Black Mastic (ACM) SW Men's Bathroom

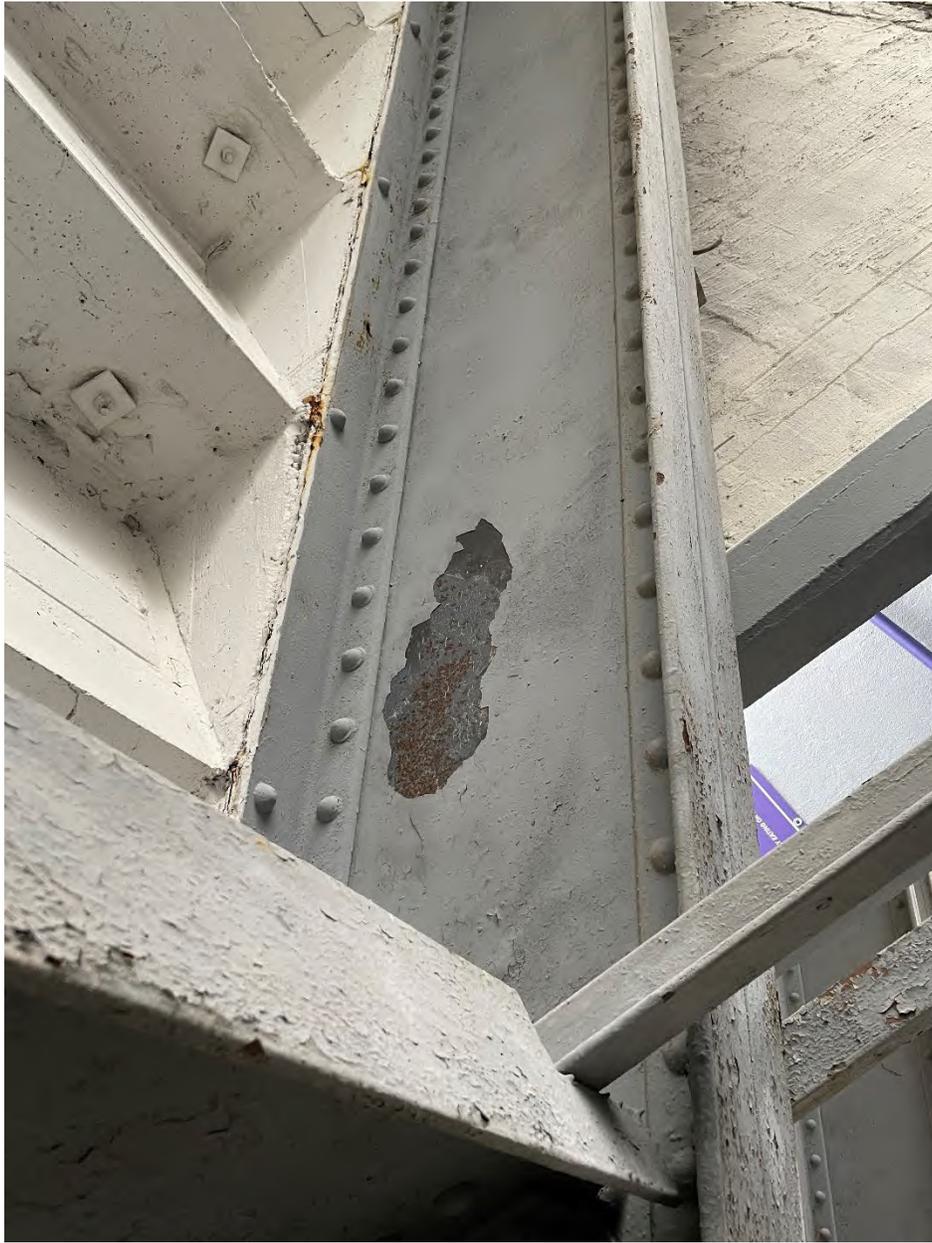
Photo 4 – Grey Metal Columns (LBP)

- Deteriorated lead-based paint was observed on grey metal columns. Stabilize or remove deteriorated lead-based paint before demolition.
- Intact lead-based paint was observed on metal pipes, and the metal door and frame in the Aramark mechanical room.
