EVANSTON GREEN HOMES PILOT PROJECT

FINAL REPORT

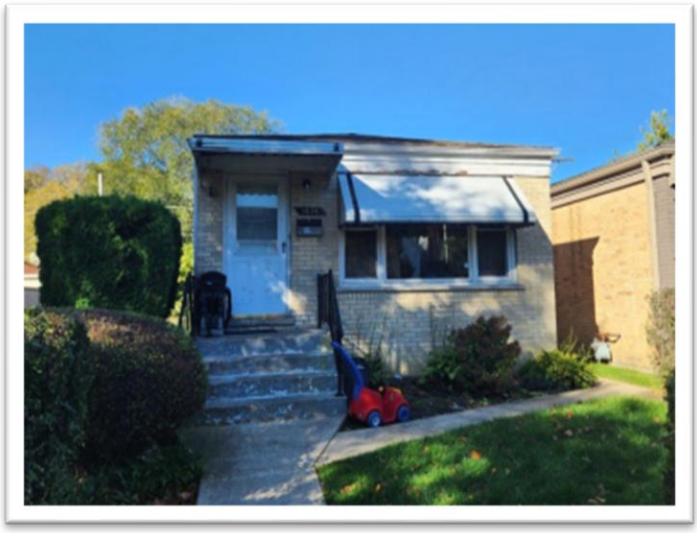
A) 1834 Hovland Court, Evanston, IL 60201[2]

1. Health and Safety
    a. Summary: Bathroom had moldy tiling surrounding the shower and tub. Moisture damage permeated bathroom floor resulting in damage observed in basement ceiling. Bathroom also had internal plumbing leak within the shower compartment coupled with general missing plumbing hardware.
    b. Work Completed: Mold identification and remediation comprised of entire surface removal or complete location overhaul. Shower tub was demolished and

disposed of as well as a damaged stud plate and subfloor removed. Installation of new drywall, shower tub, and was paired with mold fungicide and sealer to avoid mold regrowth.

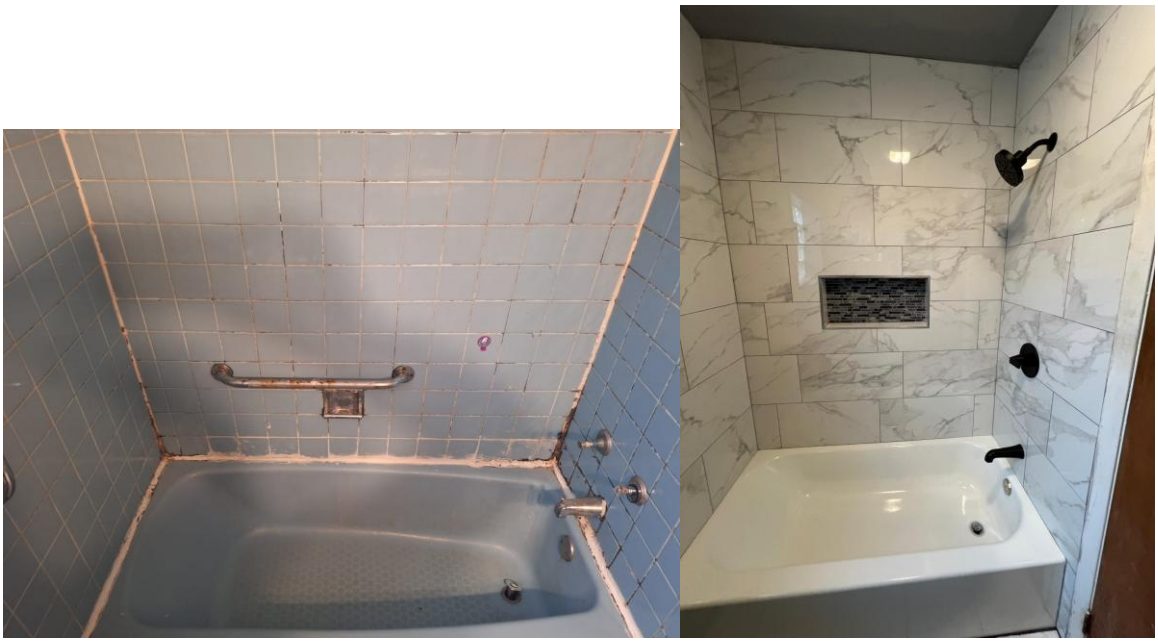
Image Caption: Mold identification and remediation comprised of replacing bathtub and bathroom tile.

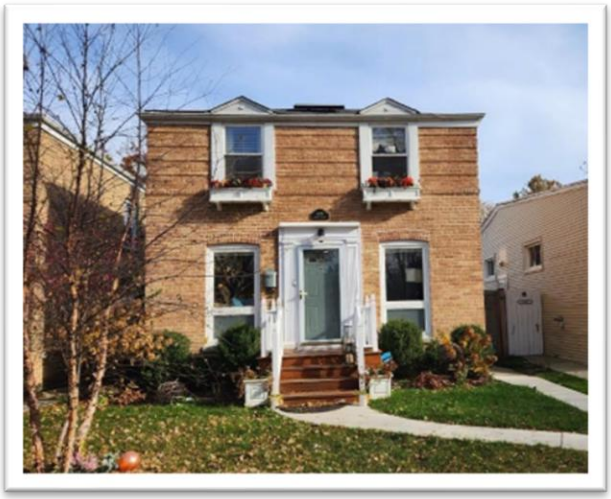
Picture caption: The gas-fueled water heater was replaced with a heat pump water heater.

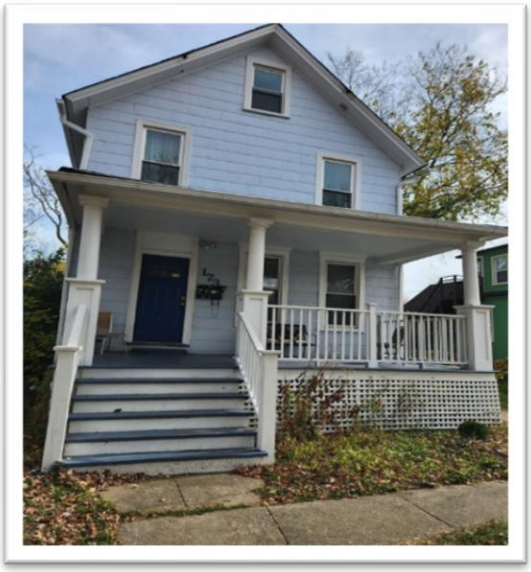
2. Electrification
    a. Summary: The property had a gas-powered furnace.
    b. Work Completed: The gas furnace was removed and replaced with an electric Energy Start Heat Pump furnace.

Image Caption: The gas furnace was removed and replaced with an electric Energy Start Heat Pump furnace.

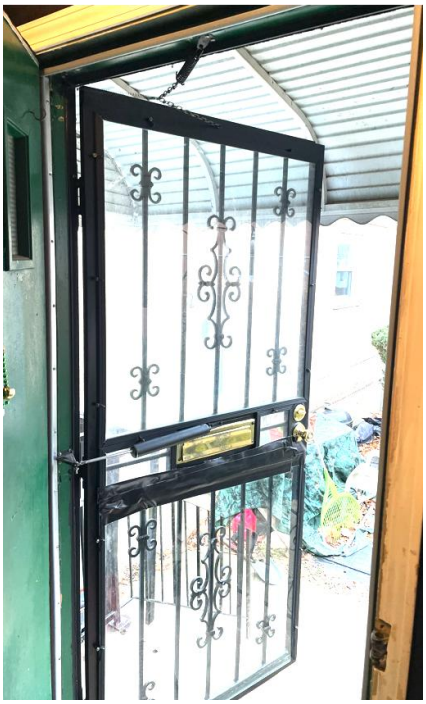
4. Energy Efficiency
    a. Summary: The exterior doors' stripping and sweeps were either missing or damaged.
    b. Work Completed: Weather strips and sweeps were installed to all exterior doors and sealed around the edges of the door to prevent airflow.
    c. Cost: $200

Image Caption: Weather strips and sweeps were installed to all exterior doors and sealed around the edges of the door to prevent airflow.
