Altura Solutions
ACCESSIBILITY CONSULTANTS

# 2022 CITY OF EVANSTON ADA TRANSITION PLAN

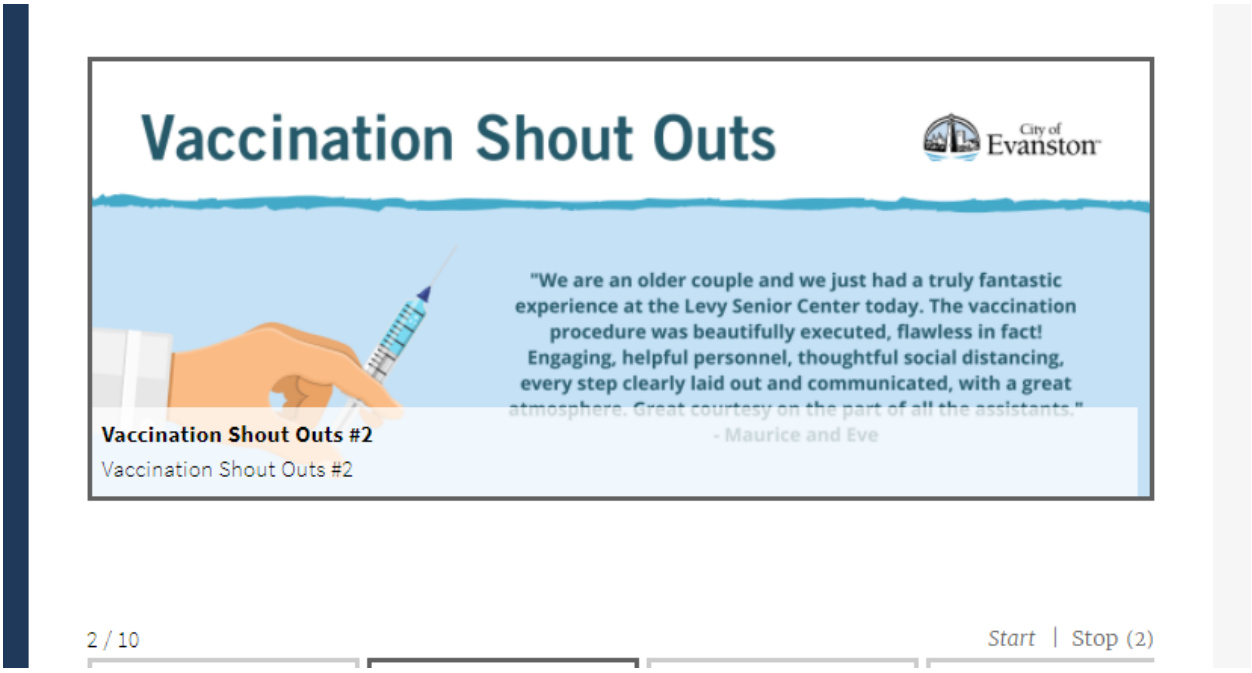
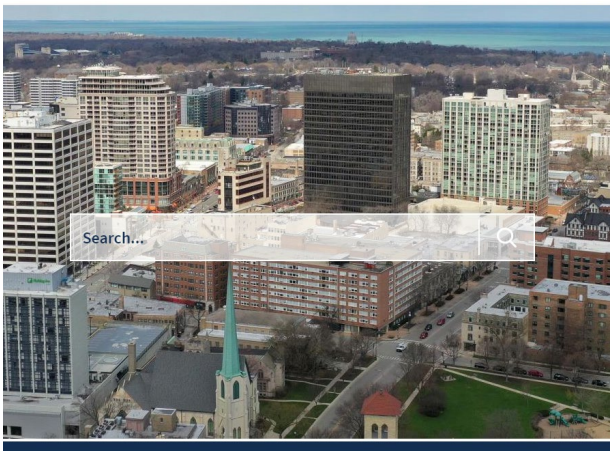
Issue: The graphics are images of text that should be implemented with HTML, or have matching alt text values

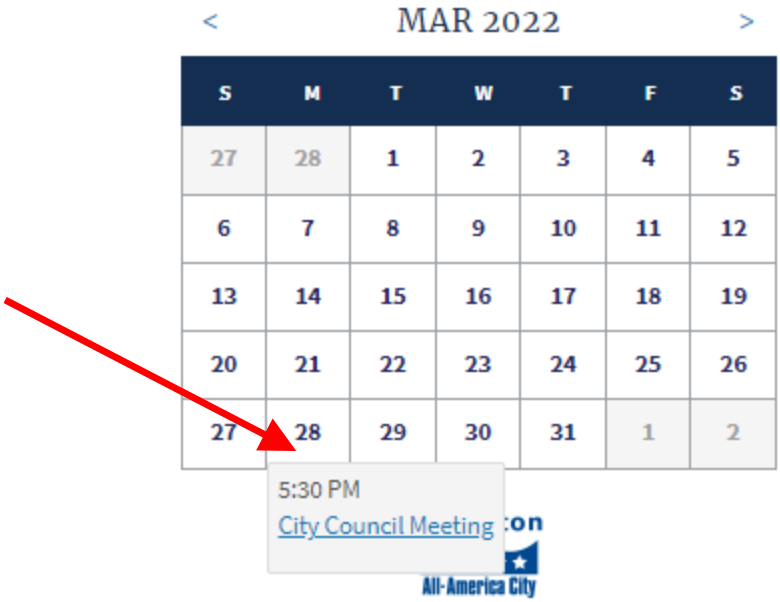
Issue: Calendar filter fields lack accessible label values. All fields require properly associated label values using top-level label attribution.

Issues: Calendar filter fields submit on user selection. User cannot filter the calendar content by multiple dimensions in a single page load.

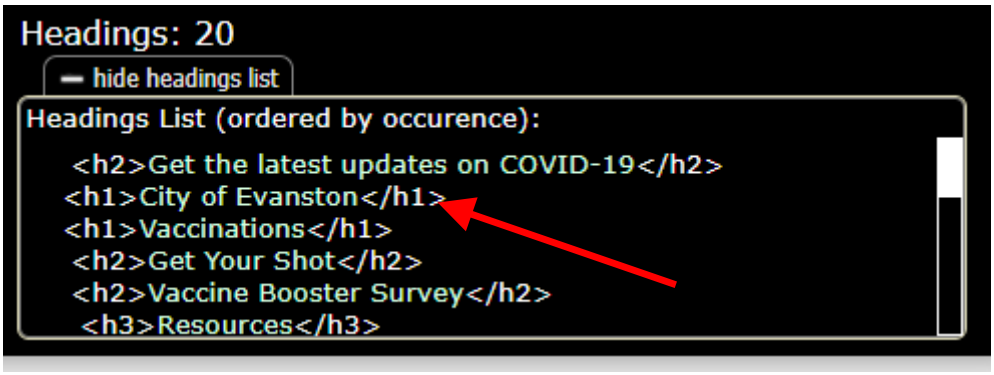
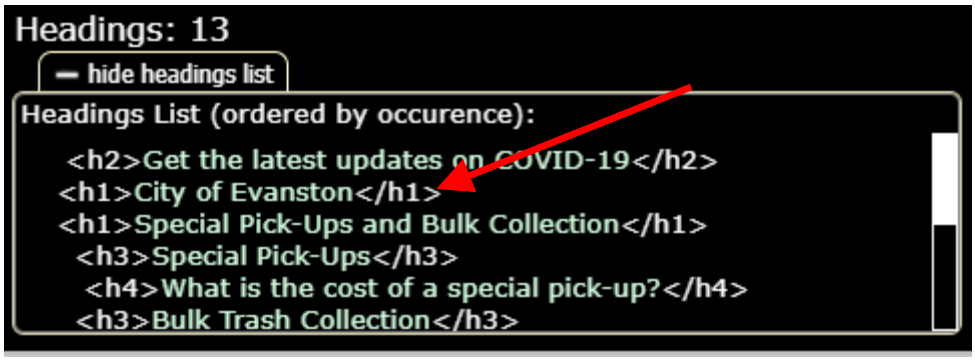
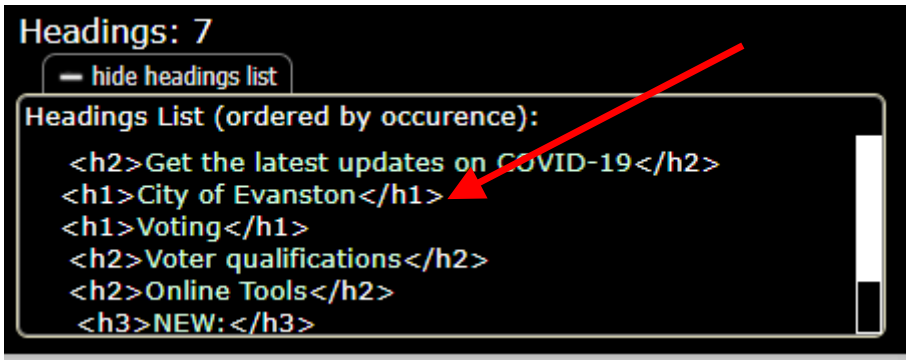
Issues: Empty heading level elements appear in some pages. Headings should contain descriptive content regarding the content following it.

Issues: Most pages have multiple heading level one elements. A visually hidden heading level one element exists in the site header and most pages have an additional visible heading level one.

It is recommended that developers remove the visually hidden heading level one element that exists in every page in the page header. It should remain on the frontpage, which lacks an in-content heading level one, but should be removed on all internal pages that have a visible heading level one element.

Site content managers should review source input in WYSIWYG editors for extraneous HTML markup. Copy and pasted content may contain hidden HTML markup from other programs. Additionally, WYSIWYG editors may insert empty HTML markup on editing heading markup.

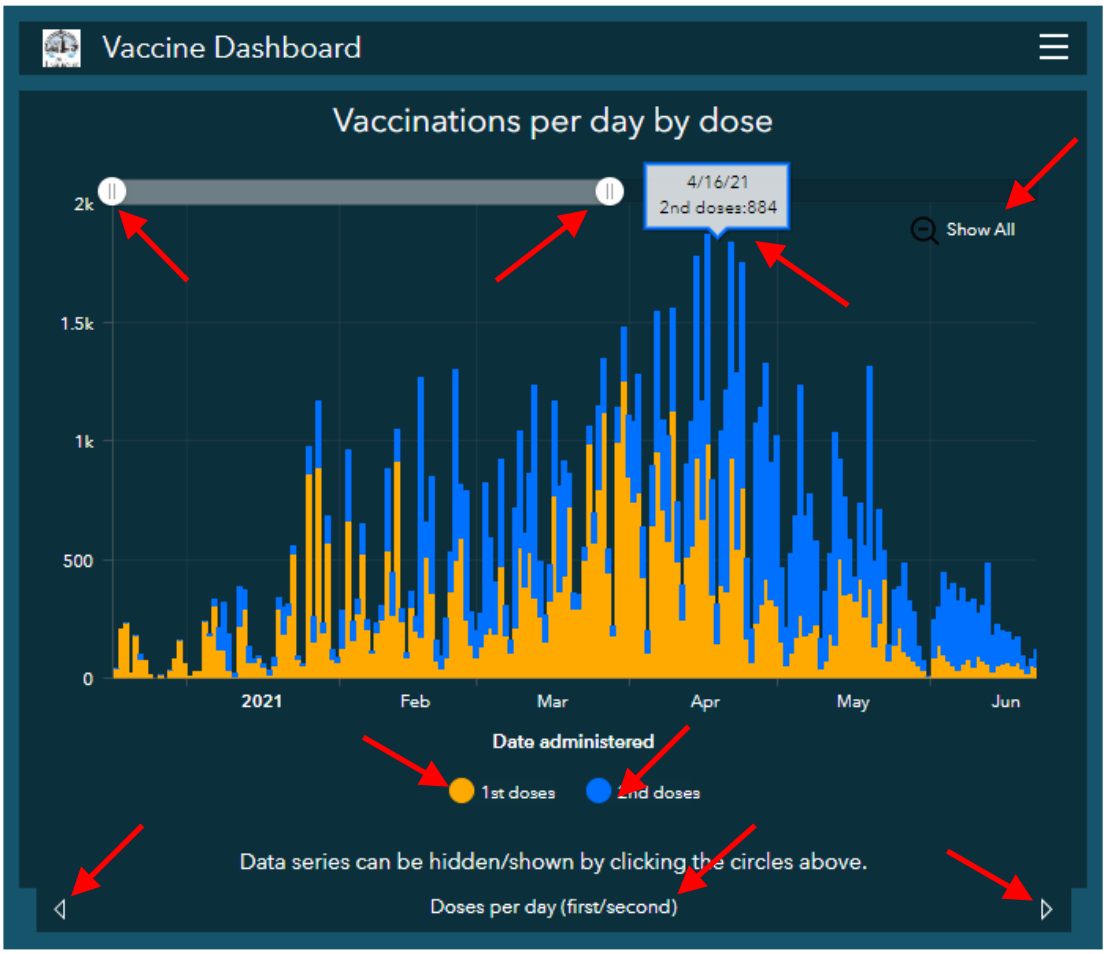
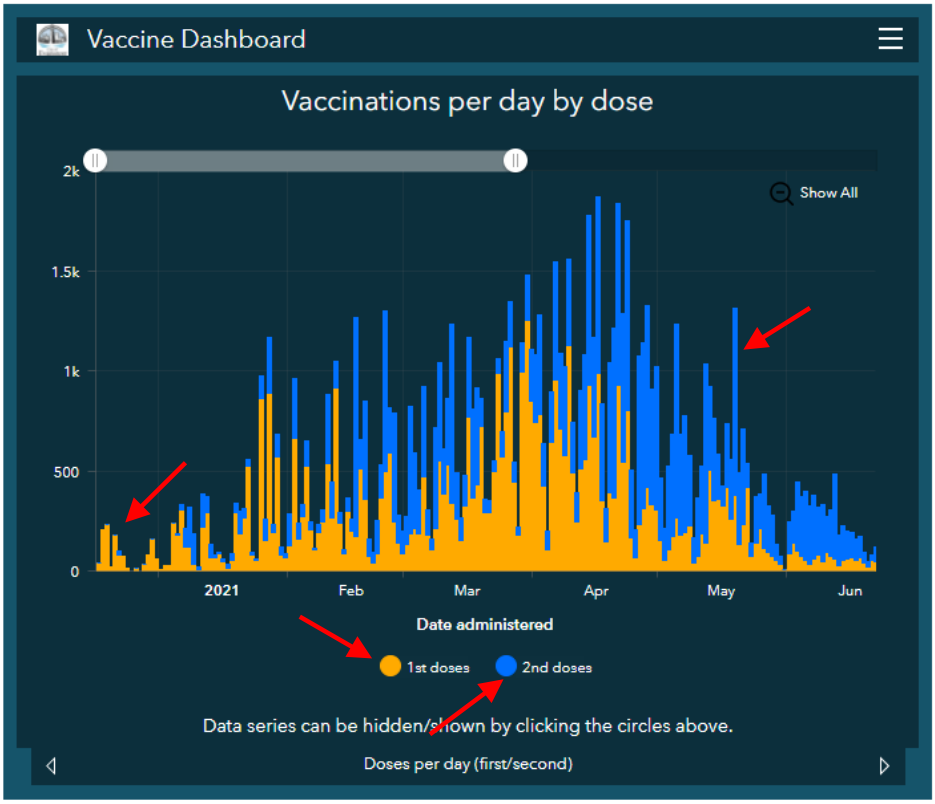
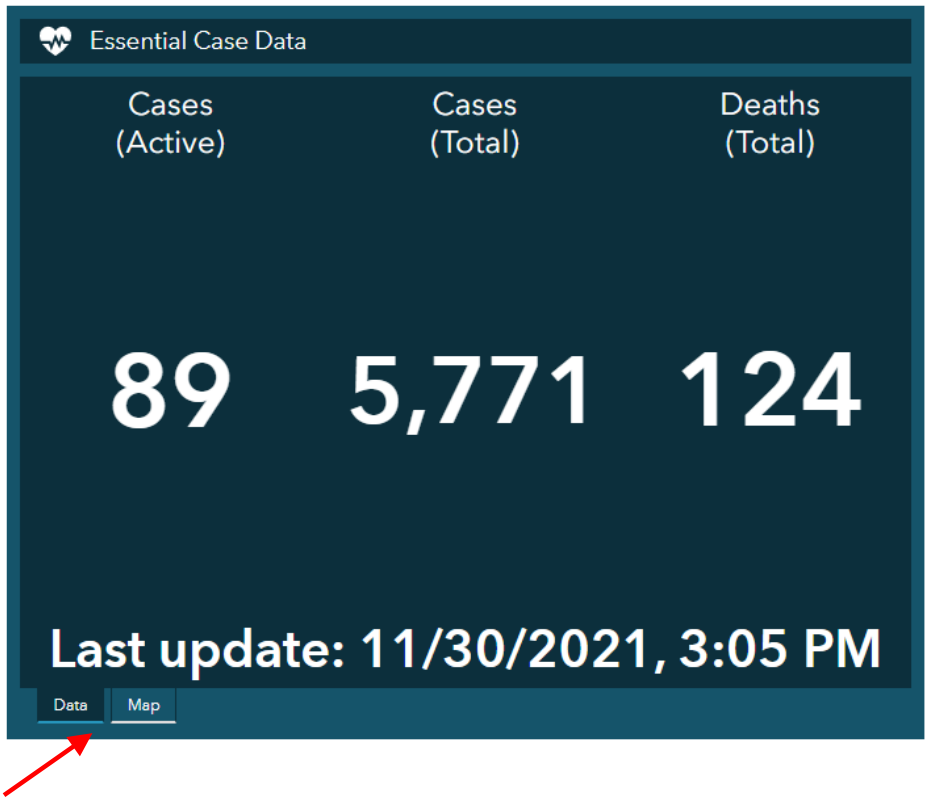
Issues: Some dashboard controls are not keyboard operable. Many of the controls (menu toggle, pager controls, in chart slider controls, hover tooltips, etc.) are composed of <svg> child elements that have click event handlers implemented to allow interactivity. Assistive technology users would not be able to fully operate the dashboard content.

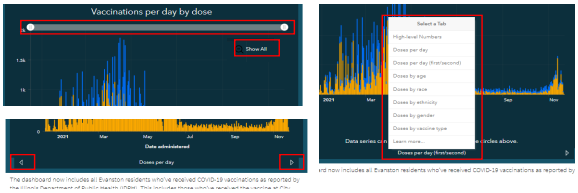
Issues: Dashboard content lacks visible focus indication. Non-pointer users rely on visible focus indication to show the current element that would be activated.

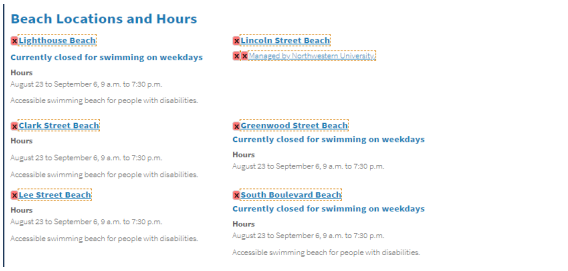
| COE-047 | Most content links have negative tabindex values | City-Council | The majority of the links in the page content have a tabindex attribute value of -1. This removes the links for the normal tab order, making them non-navigable by keyboard users. Non-zero tabindex values should generally not be used in directly writing HTML content. | Remove the tabindex values from the links page content. | 2.1.1 Keyboard | A | High | |

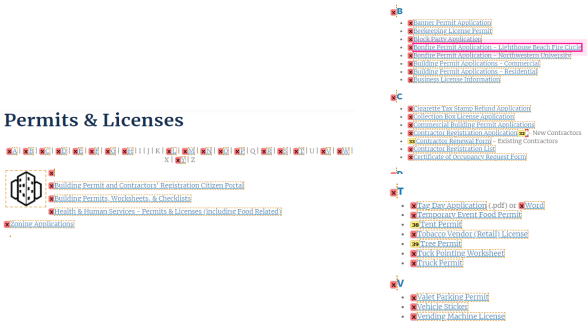
| COE-109 | Two content links have a negative tabindex value | Wheel-Tax | There are two links in the main page content that have a tabindex attribute value of -1. This removes the link for the normal tab order, making it non-navigable by keyboard users. Non-zero tabindex values should generally not be used in directly writing HTML content. | Remove the tabindex value from the links. | 2.1.1 Keyboard | A | High |
