CITY OF EVANSTON
REQUEST FOR PROPOSAL

NUMBER: 25-29

Sherman Plaza Parking Garage Structural Assessment

May 15, 2025

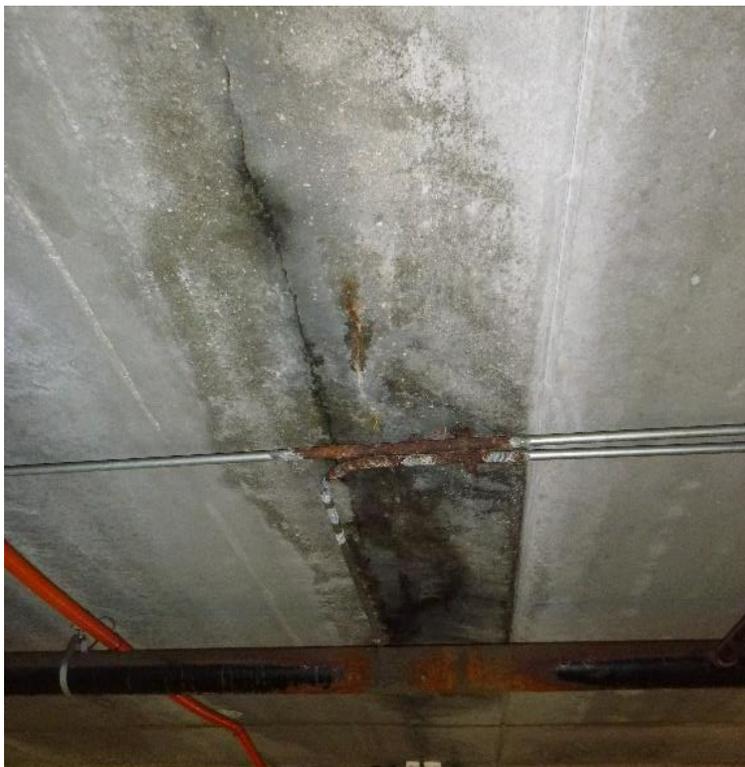
- Leaks through the ground floor deck into the basement were observed at several locations, with an example shown in Figure 2.3. These leaks were generally located along column lines and at joints between precast planks, and coincided with cracks in the traffic-bearing membrane and debonded topping on the deck top surface. In general, minimal corrosion staining was observed on the concrete at these locations.

Figure 2.3. Leak through the ground floor deck

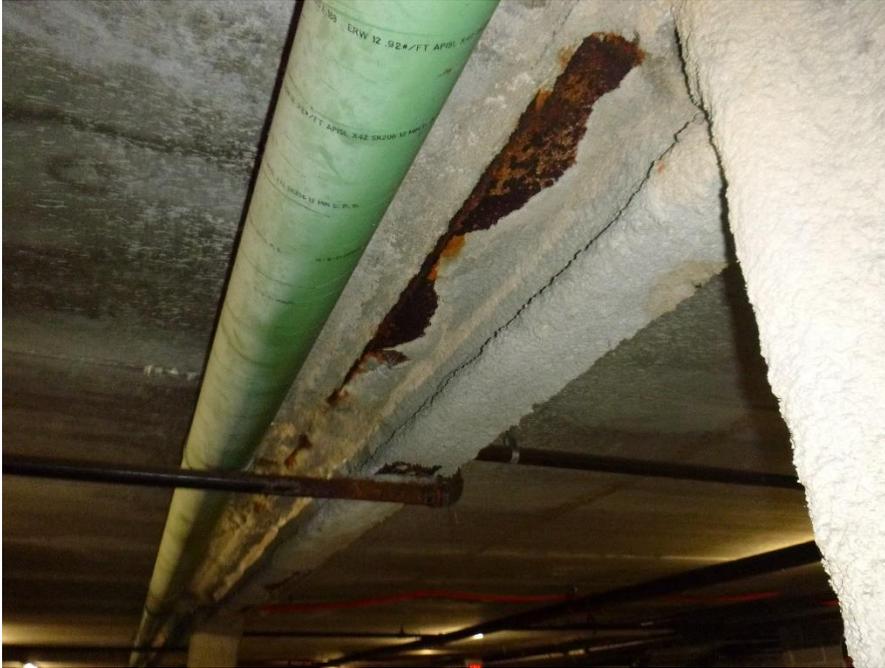
- Failed fireproofing was observed on the underside of the second floor (Figure 2.5) and the ground floor (Figure 2.6). The steel beams were generally corroded at these locations. Approximately 200 linear feet of failed fireproofing was observed on the underside of the second floor, with approximately 100 linear feet of failed fireproofing on the underside of the ground floor.

Figure 2.6. Failed fireproofing on a ground floor steel beam, exposing a corroded section of steel

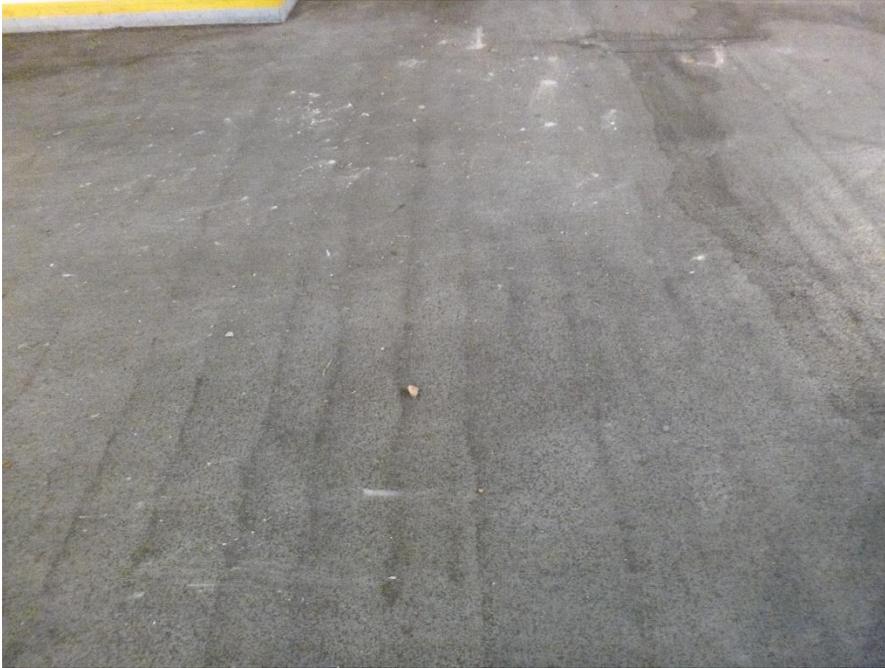
- The traffic-bearing waterproofing membrane was debonded or completely failed for total area of approximately 10 square feet. An example of this condition around a floor drain is shown in Figure 2.7. Additionally, the surface of the waterproofing membrane was heavily worn in some areas as shown in Figure 2.8.

Figure 2.8. Worn membrane on the ground floor deck

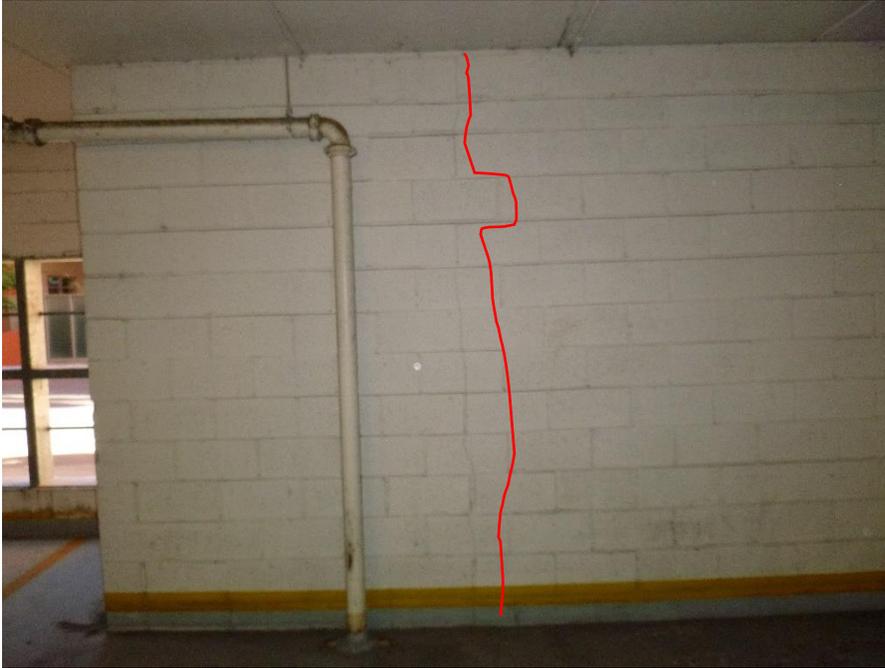
- Cracks in the mortar joints were observed in the partition walls for the stairwells and along the building perimeter. Approximately 300 linear feet of cracks in the mortar joints were observed. An example of a crack in such a wall is shown in Figure 2.10.

Figure 2.10. Crack in CMU wall, highlighted in red

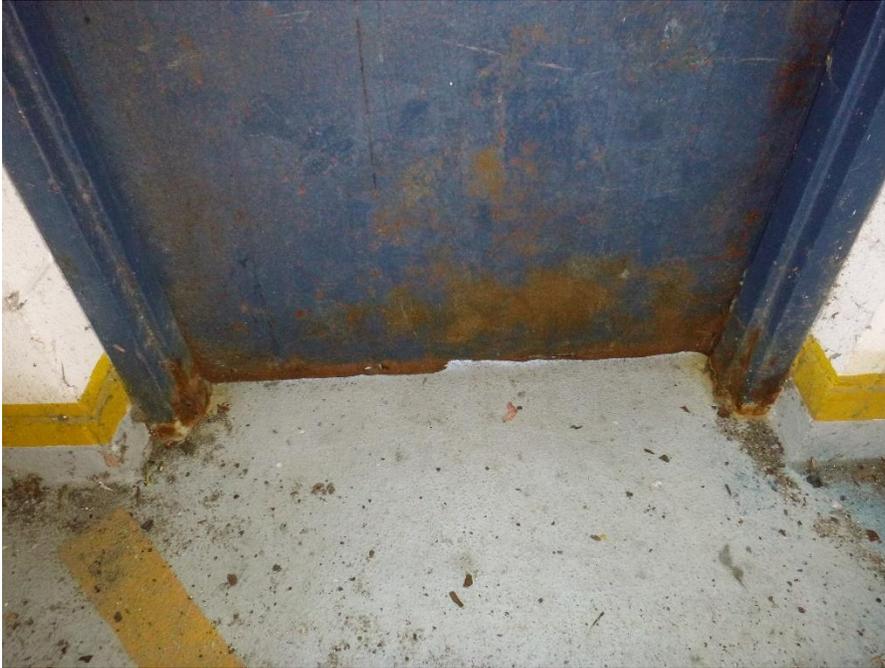
- The pedestrian doors on the north side of the garage were heavily corroded at their bases and did not easily open. One of the bases of these doors is shown in Figure 2.12.

Figure 2.12. Corroded door and door frame at pedestrian entrance on the north side of the garage

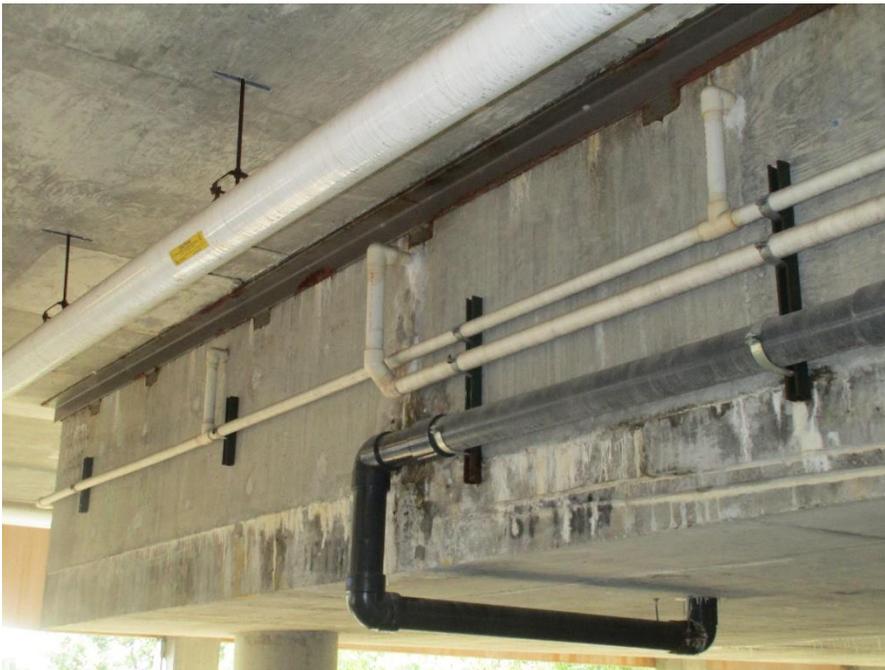
- Efflorescence and mineral deposits were observed along the perimeter of the Level 6 pool at the wall/slab construction joints (see Figure 3.3), and at cracks in the underside of the pool bottom (see Figure 3.4). There are signs of leaking from Level 6 at twelve additional locations of soffit staining or failure, with multiple examples visible in Figure 3.5. Signs of leaking through the Level

Figure 3.3. Efflorescence and mineral deposits leaching from the construction joint in the south vertical face of the Level 6 swimming pool.

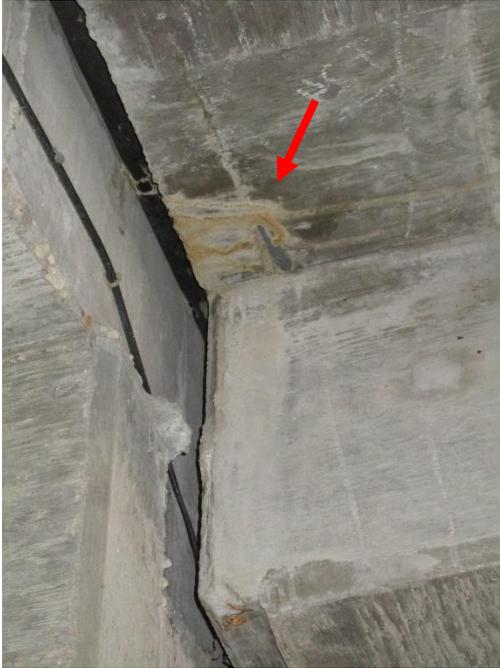
6 expansion joints were observed at six locations, an example of which is shown in Figure 3.6, and leaking was also observed between the Level 6 slab edge and the facade panels intermittently along the entire perimeter (see Figure 3.7 for an example). In addition, ten locations of cracking and efflorescence were observed on the underside of Level 6. While the City of Evanston is not responsible for this portion of the structure, deleterious materials passing onto the Level 5 deck below can negatively affect the service life of the City-owned portion of the structure.

Figure 3.6. Water staining (indicated with red arrow) coming from an expansion joint in the Level 6 slab.

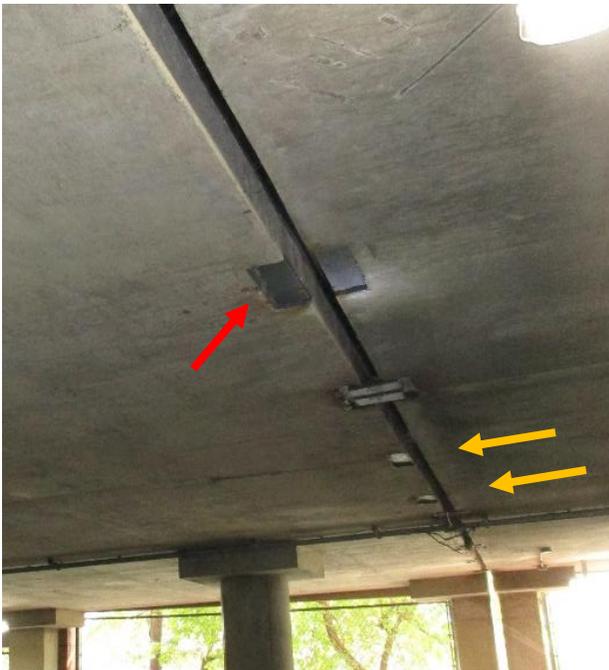
- Beneath the northern east-west expansion joints across the East Bay of Level 2 and Level 3, multiple plate connectors and embedded plates were observed to be missing, as shown in Figure 3.9.

Figure 3.9. Underside of expansion joint with missing shear transfer plates (indicated by red arrow) and locations of missing embedded plates (indicated by orange arrows).

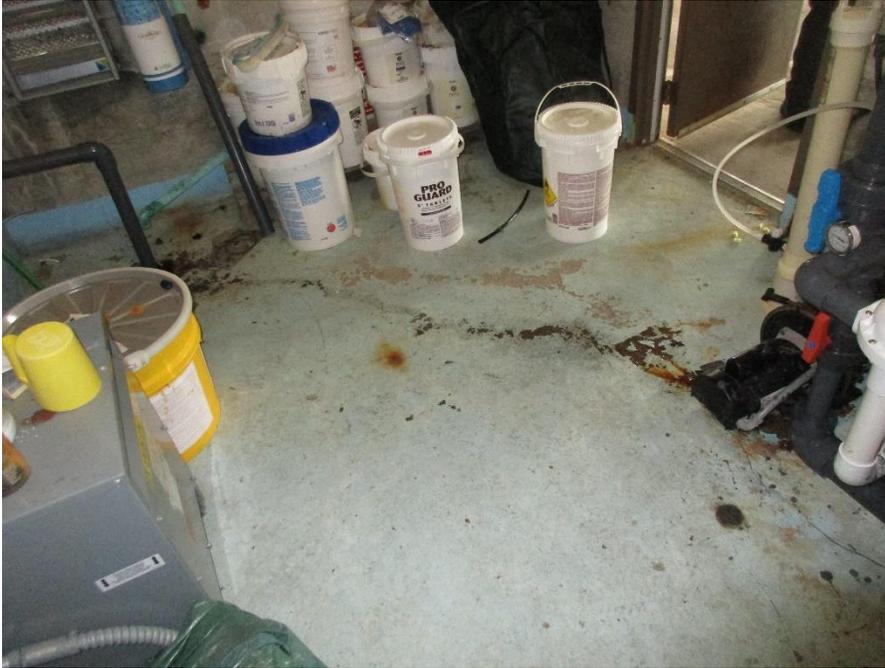
Figure 3.12. Worn membrane on the floor of the Level 5 Pool Mechanical Room.

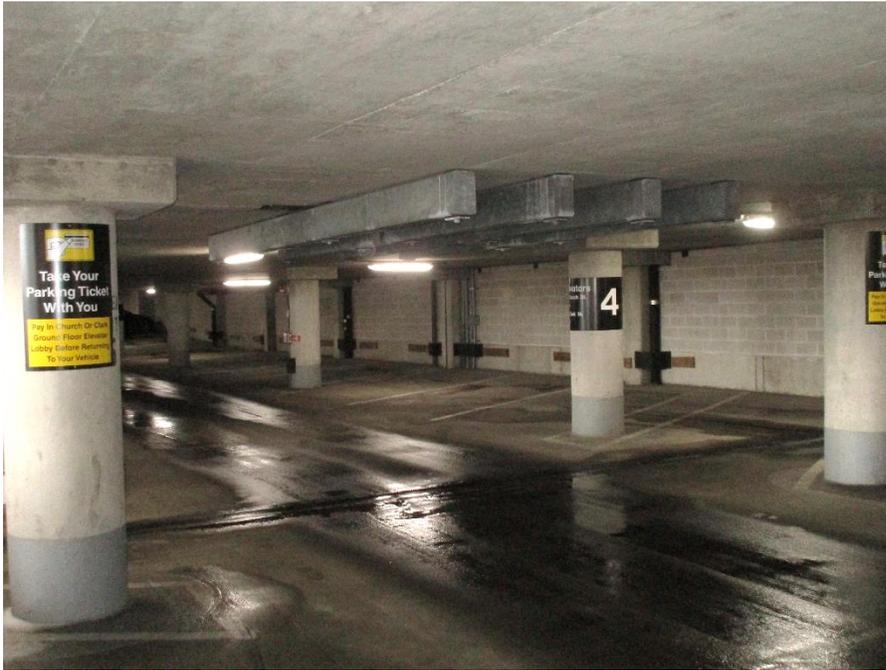
Figure 3.14. Shear transfer retrofit tubes installed beneath the southwest expansion joint of Level 5.

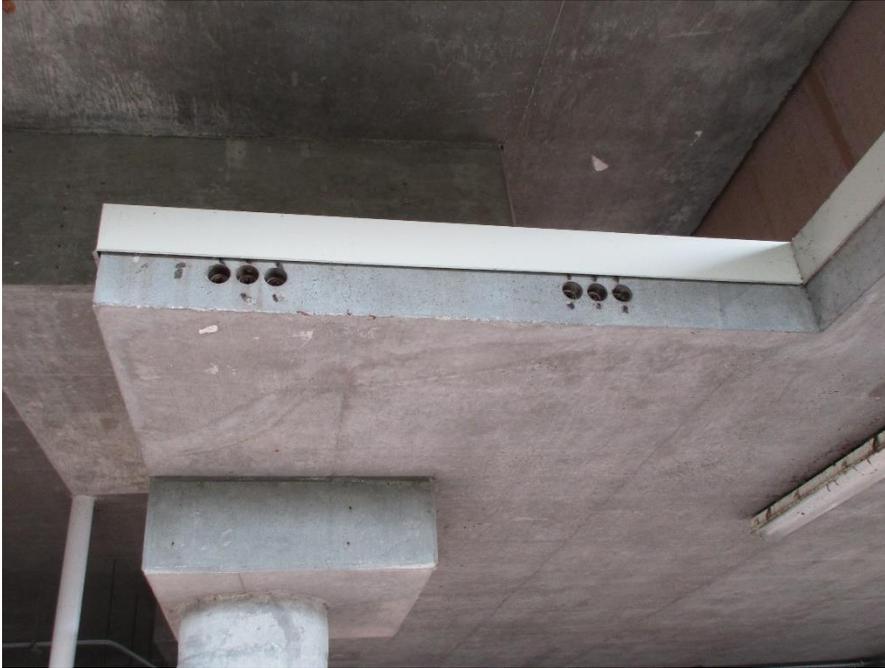
Figure 3.16. Ungrouted stressing pockets for slab post-tensioning tendons at the edge of the City-owned roof structure at the northeast corner of the garage.

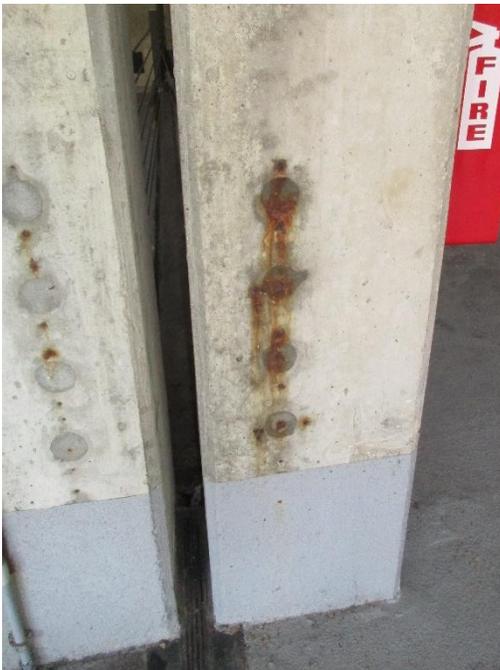
Figure 3.17. Corrosion staining at grout pockets over Level 2 traffic barrier cable anchors at Column PG/P48.2.

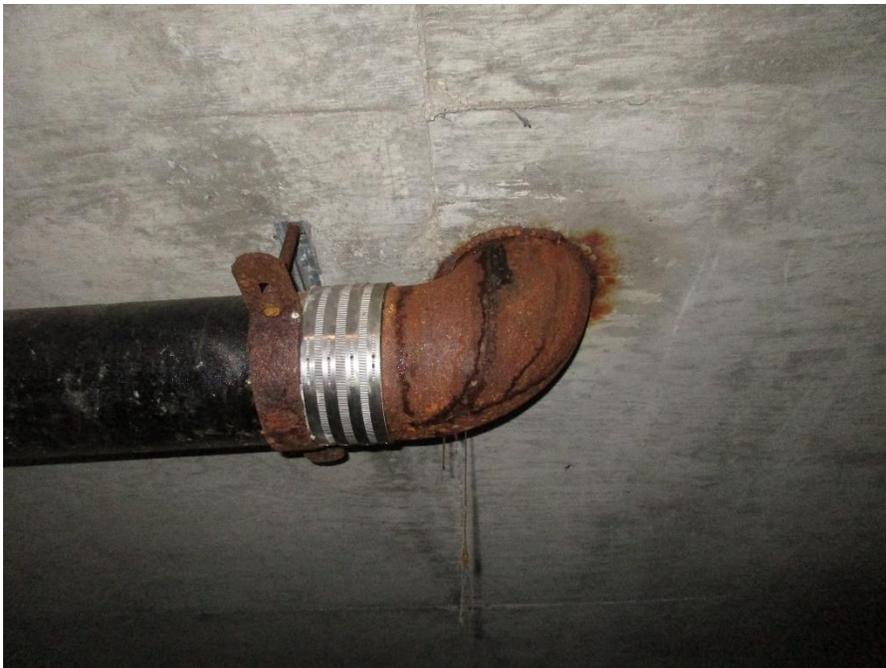
Figure 3.19. Corroded and leaking floor drain pipe.

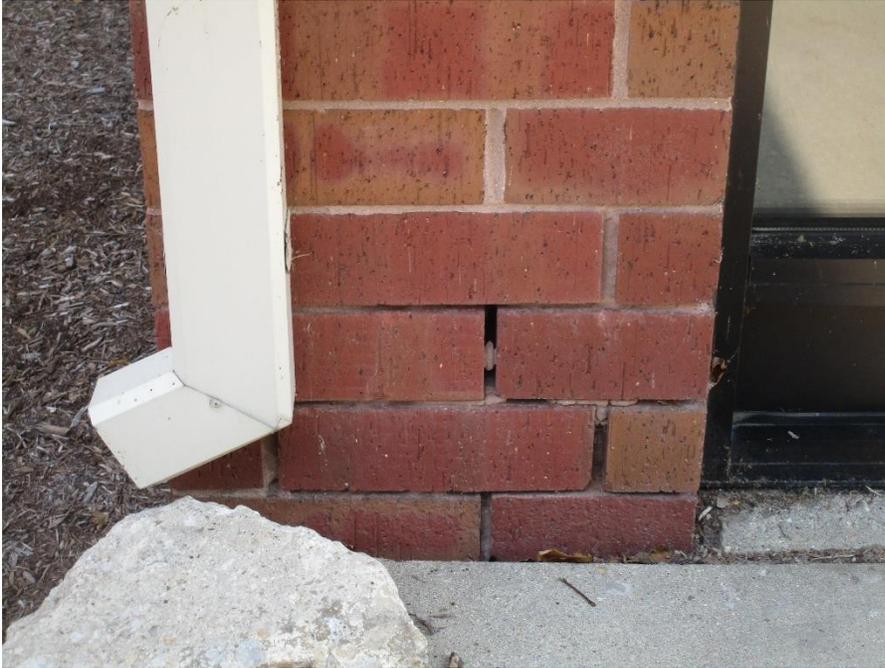
Figure 3.24. Failed mortar in masonry facade at the base of the southeast stairwell.

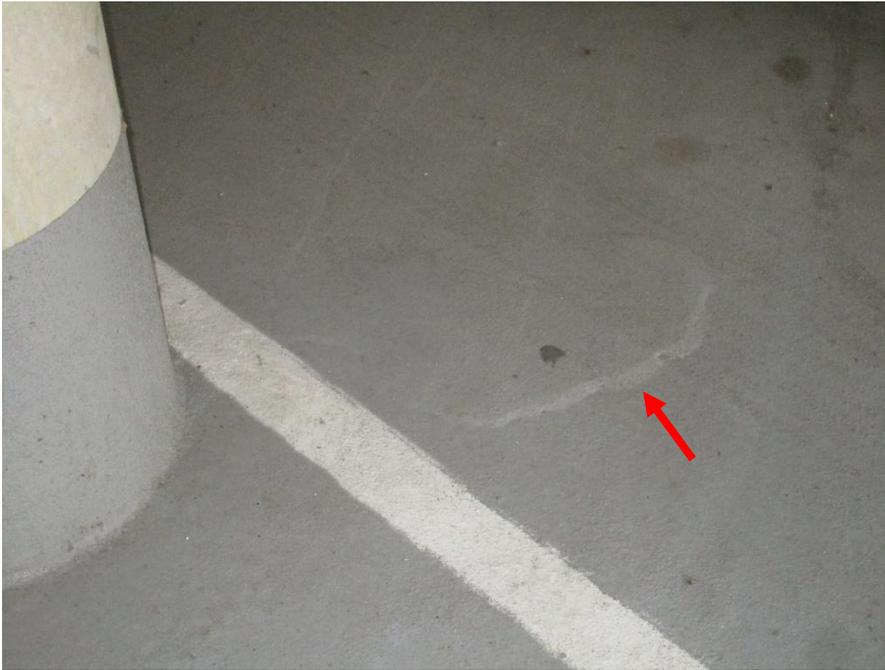
Figure 3.26. Top surface concrete delamination with perimeter showing through waterproofing membrane on Level 2 (indicated with red arrow).

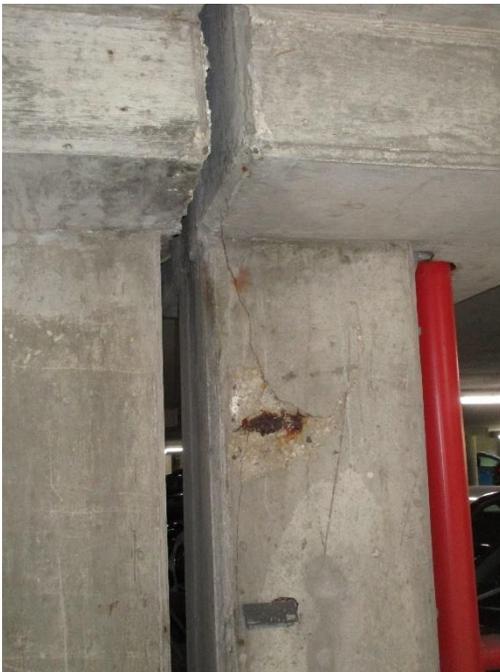
Figure 3.27. Delamination, cracking, and corrosion staining of the vertical concrete surface on Column PF/P1.8 on Level 4.

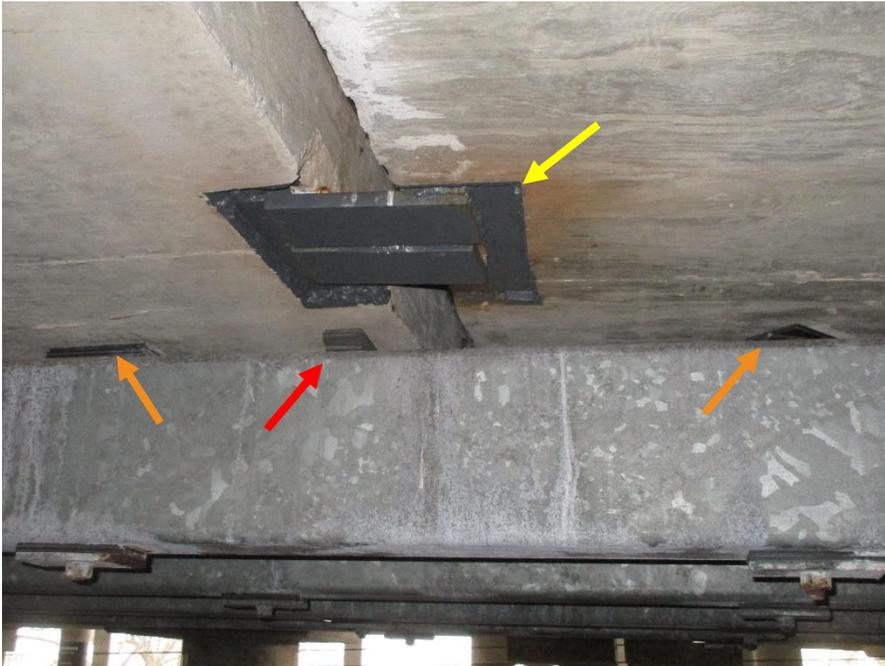
Figure 3.28. View of westernmost shear transfer tube showing shims between tube and the Level 5 deck at the anchor locations (indicated by orange arrows) and on one side of the expansion joint (indicated by red arrow). The original shear transfer plates are present in front of the retrofit repair (indicated by yellow arrow).

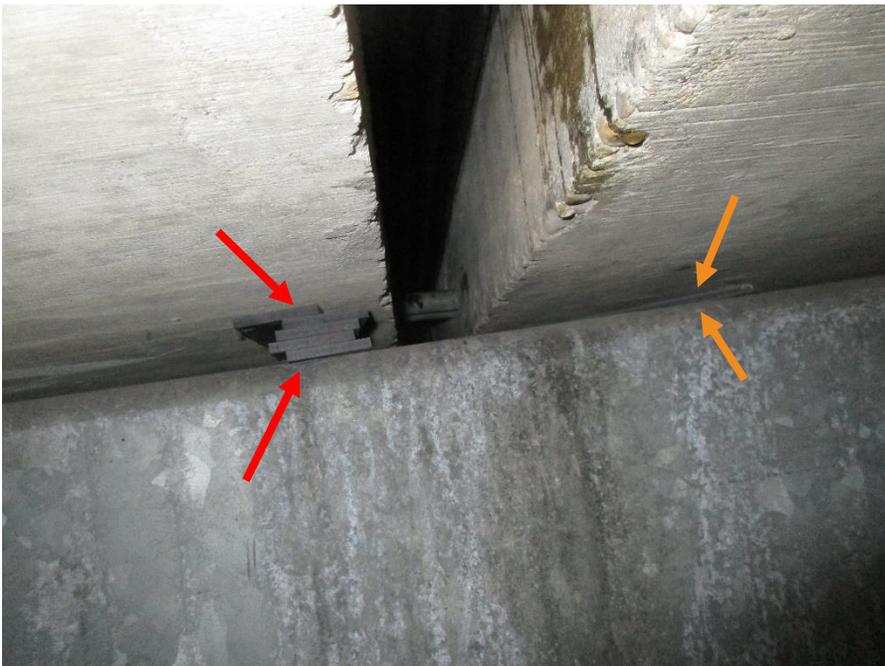
Figure 3.29. Top of shear transfer tube with a shim stack in full bearing on one side of the expansion joint (indicated between red arrows) and a loose shim stack on the other side (indicated between orange arrows).

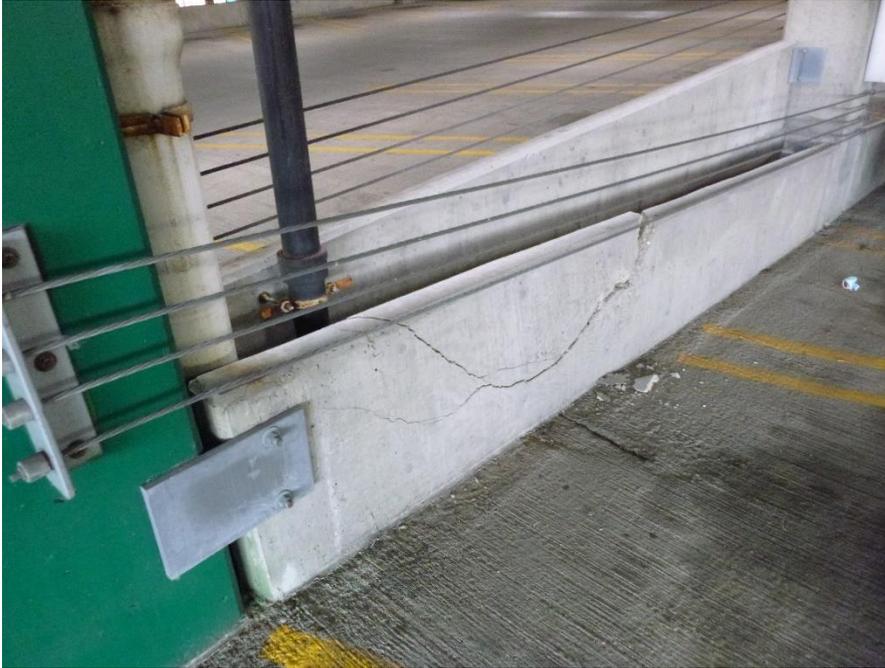
Figure 4.2. Impact damage to barrier wall

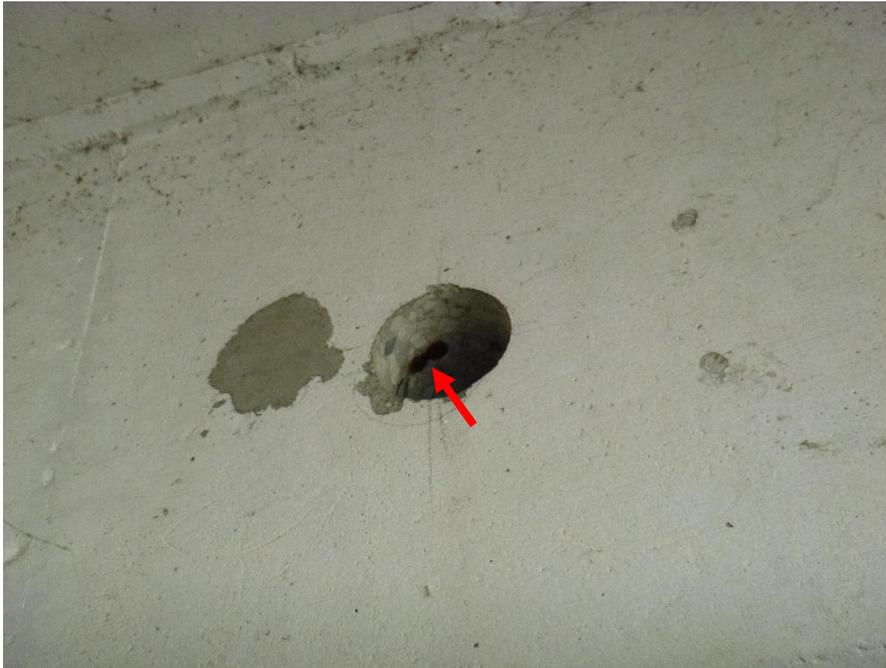
Figure 4.4. Core holes through beam with cut shear reinforcement (indicated by red arrow)

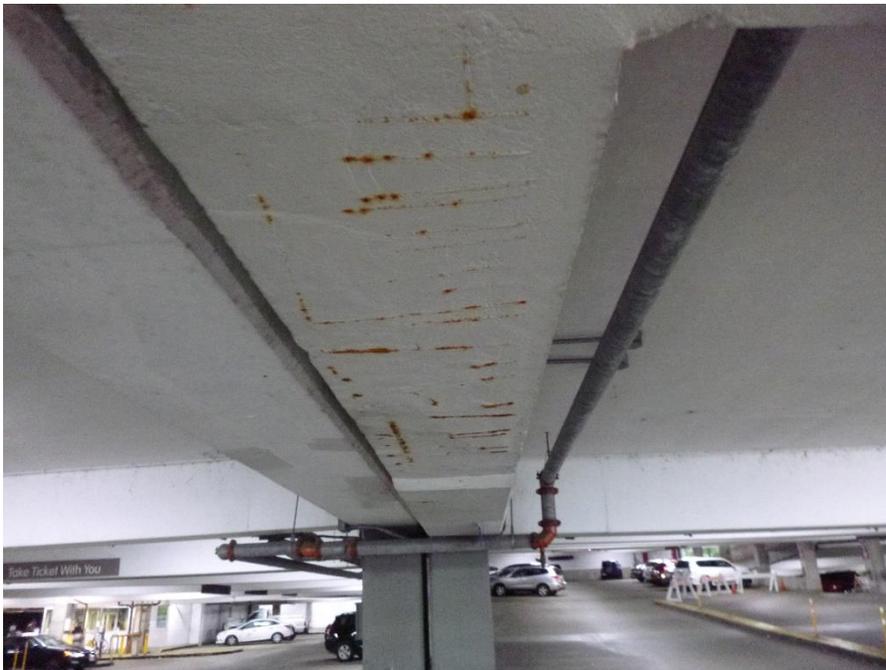
Figure 4.5. Reduced section beams with cut shear reinforcement

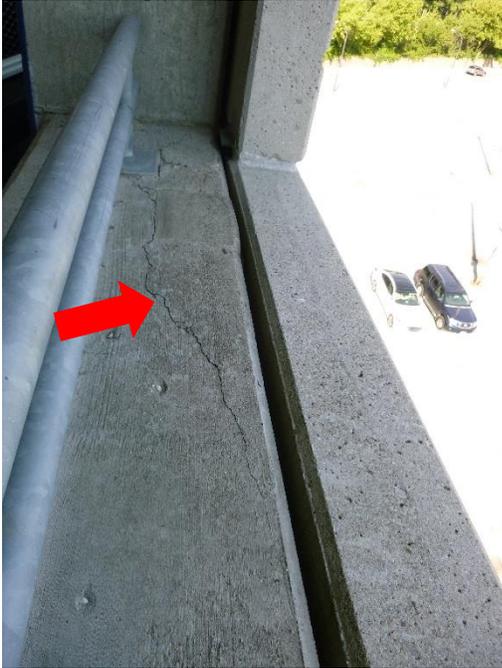
Figure 4.6. Delaminated concrete at façade panel to spandrel beam connection

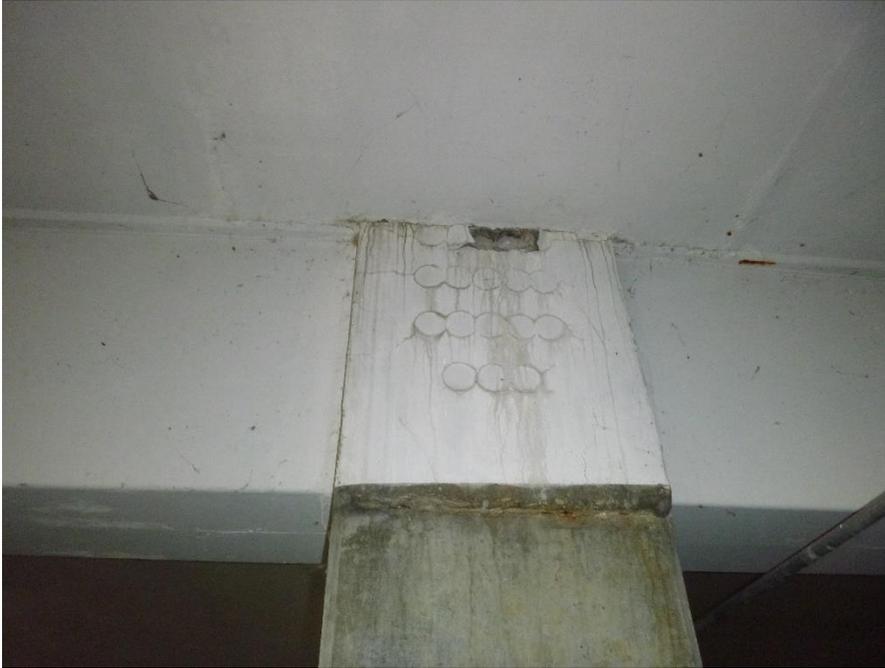
Figure 4.10. Post-tensioning tendon grout pockets loose, debonded, requiring repair

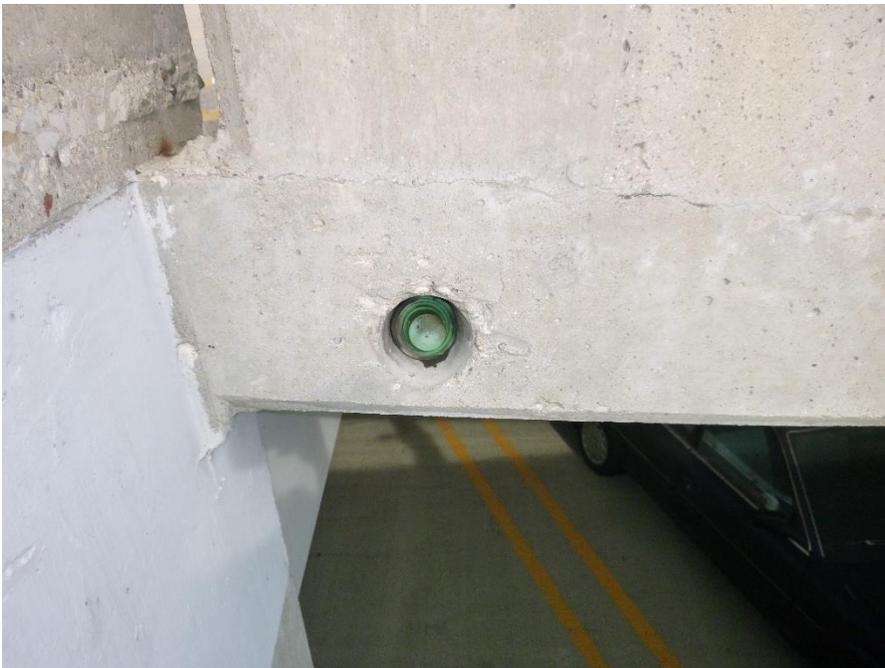
Figure 4.11. Post-tensioning tendon stressing pocket missing grout, requiring repair

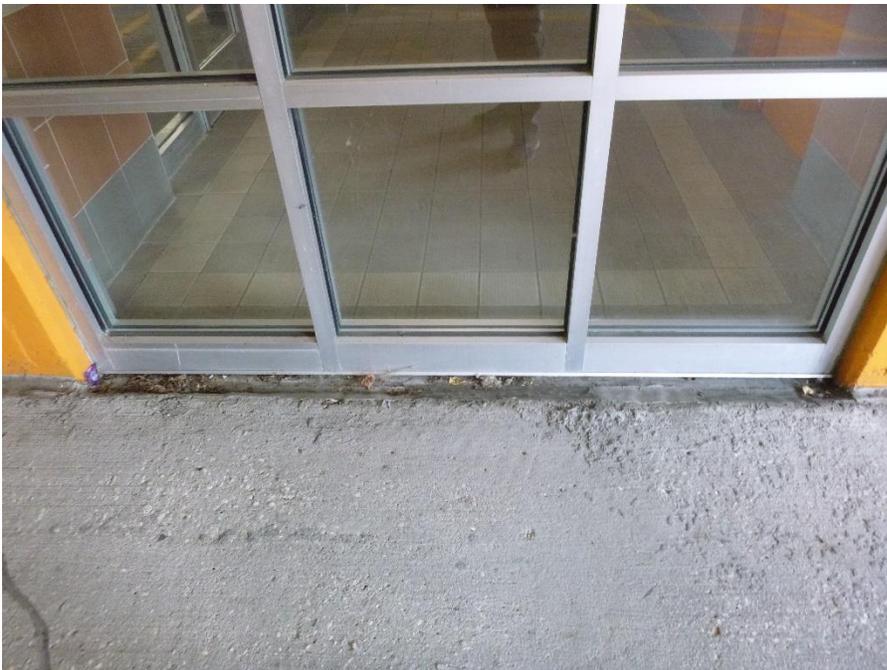
Figure 4.15. Top surface of deck and sealant slope down to storefront system at northeast elevator lobby on the fourth floor

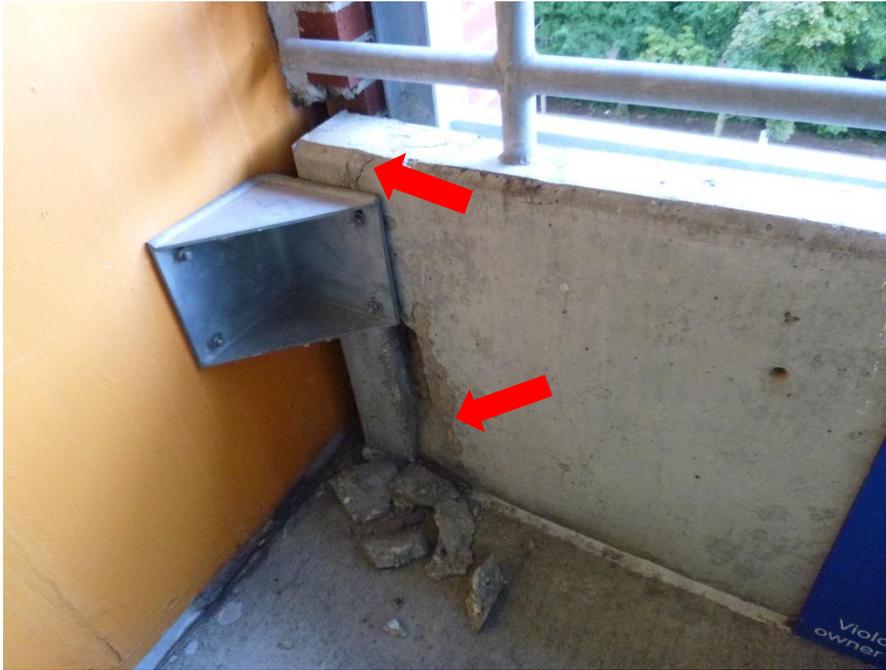
Figure 4.16. Delaminated grout at façade panel connections

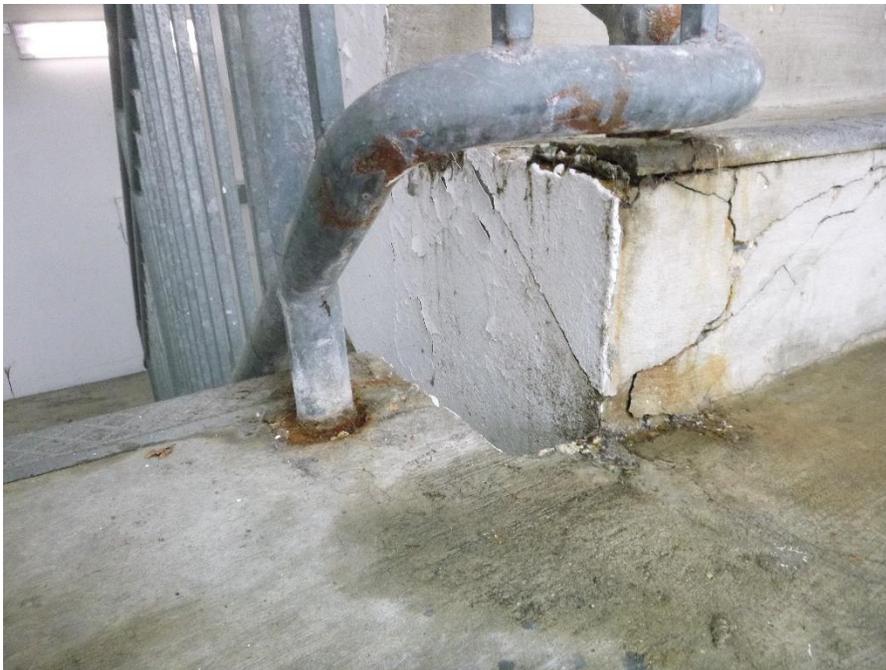
Figure 4.17. Stair tread - corner delaminated concrete

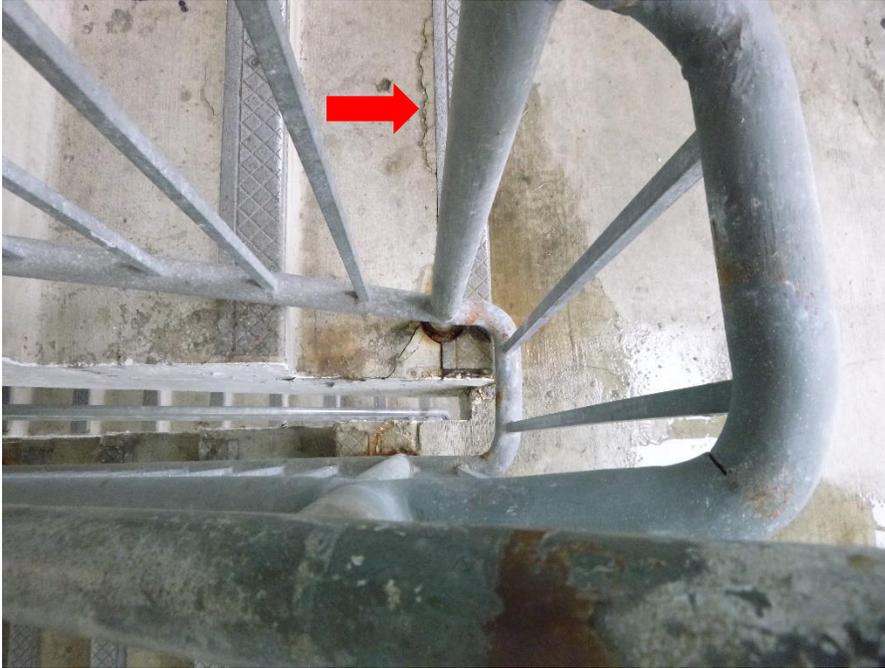
Figure 4.18. Stair tread - delaminated concrete at nosing

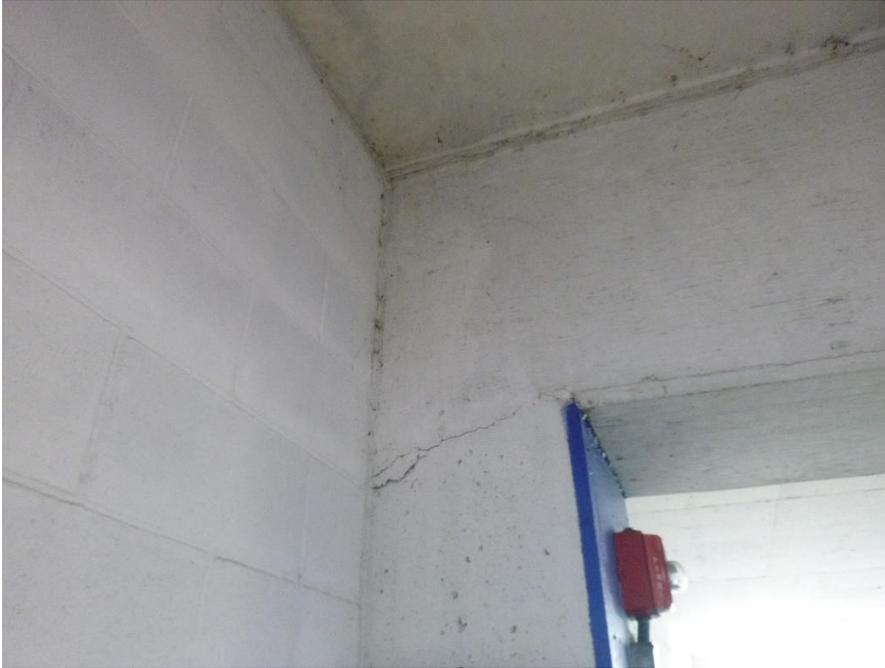
Figure 4.20. Crack at top of column

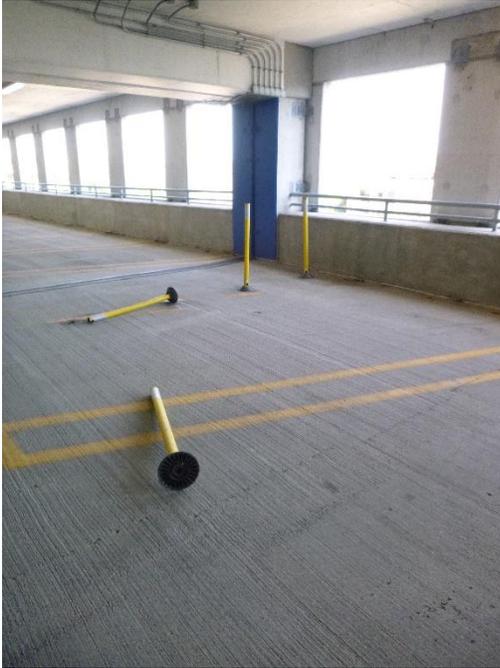
Figure 4.22. Loose bollards

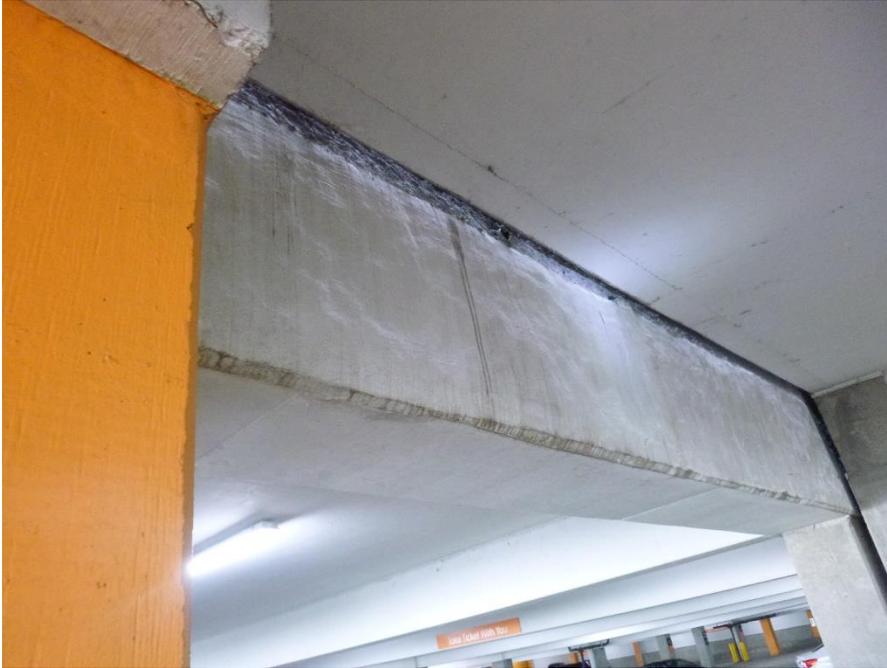
Figure 4.24. Delaminated parge coat on vertical surface of beam

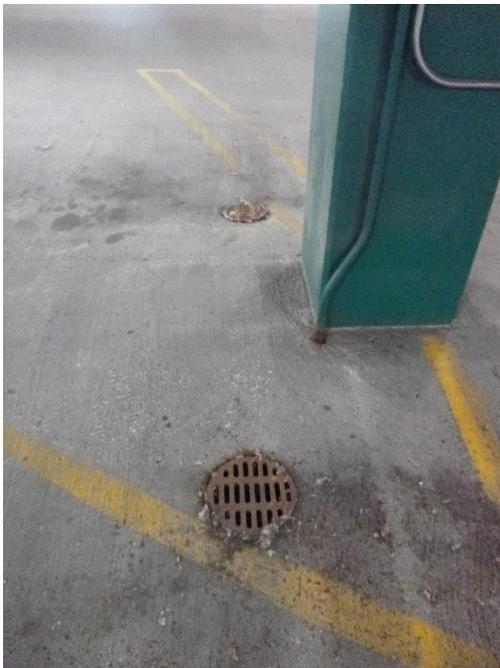
Figure 4.27. Drain grate not flush with top surface of concrete

The clogged drain should be cleared out to prevent damage to the pipes from freezing water and to allow for water to clear from the surrounding area. Additionally, missing grates and grates that do not sit flush with the top of the drain pose tripping hazards should be addressed. These items are of low priority.

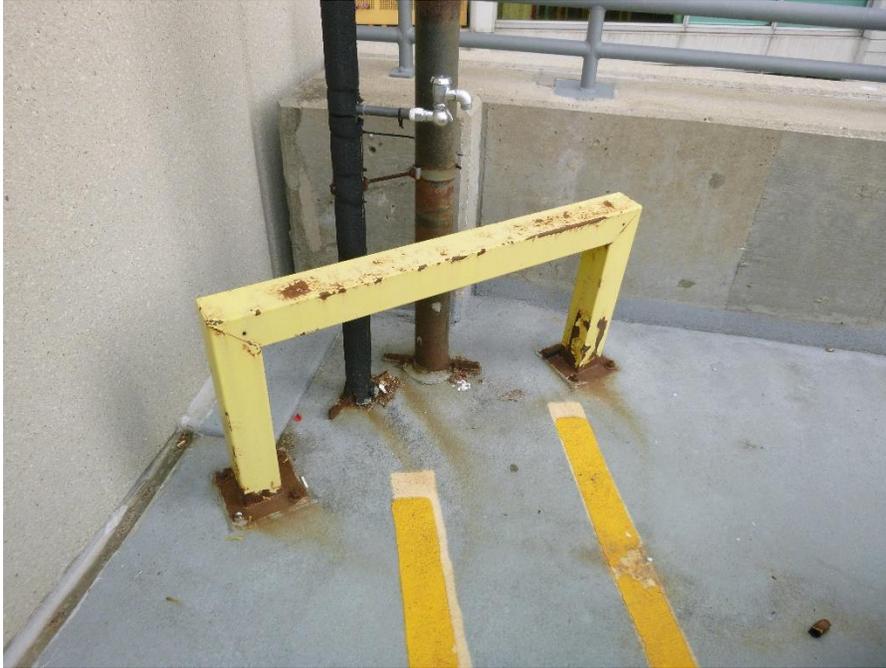
Figure 4.28. Corrosion of exposed steel barrier/pipe guard

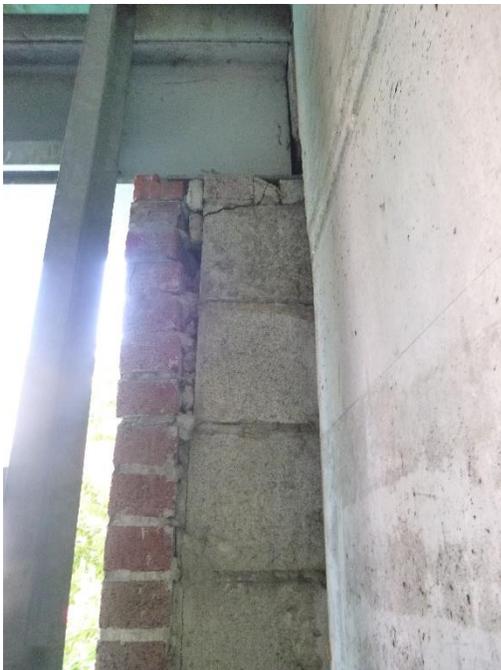
Figure 4.29. Cracked CMU block and displaced brick

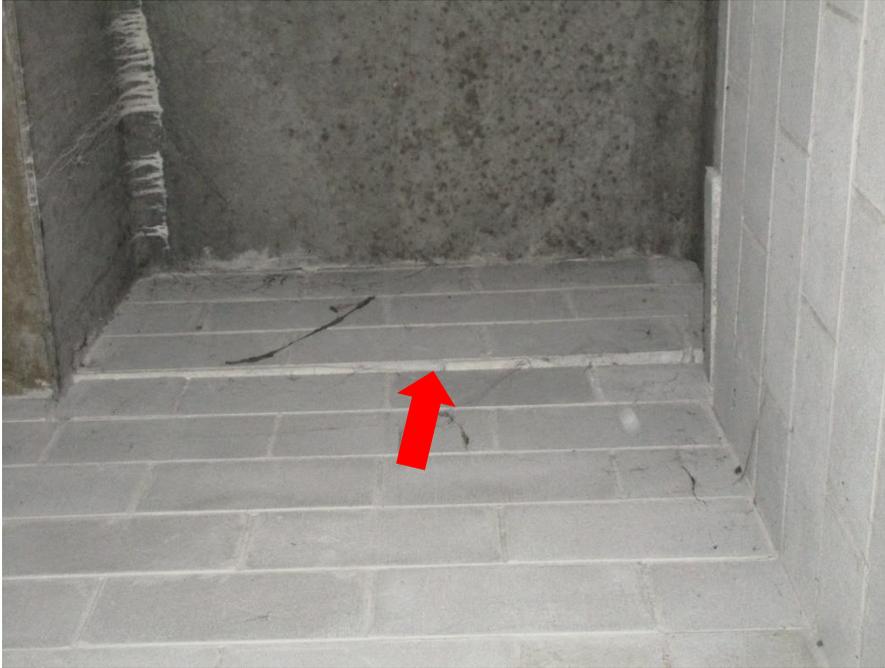
- Up to about 1 inch of movement was noted in the east CMU partition wall of the vestibule between Column A/D8 and Column A/D9, as shown in Figure 5.3.

Service Center Building D Garage is in good condition, as should be expected given its recent repair project in 2018. The most notable finding was the shifting of the CMU partition wall in three locations, which could pose a safety issue if the affected units continue to move until they dislodge and fall to the ground. It is our understanding that the City may have already taken action to address some of these conditions. The other deterioration items noted do not affect the structural integrity of the building, but should be monitored until addressed by a future repair program.

Figure 5.3. Shifting of the top three courses of the CMU at the east partition wall of the vestibule between Column A/D8 and Column A/D9.

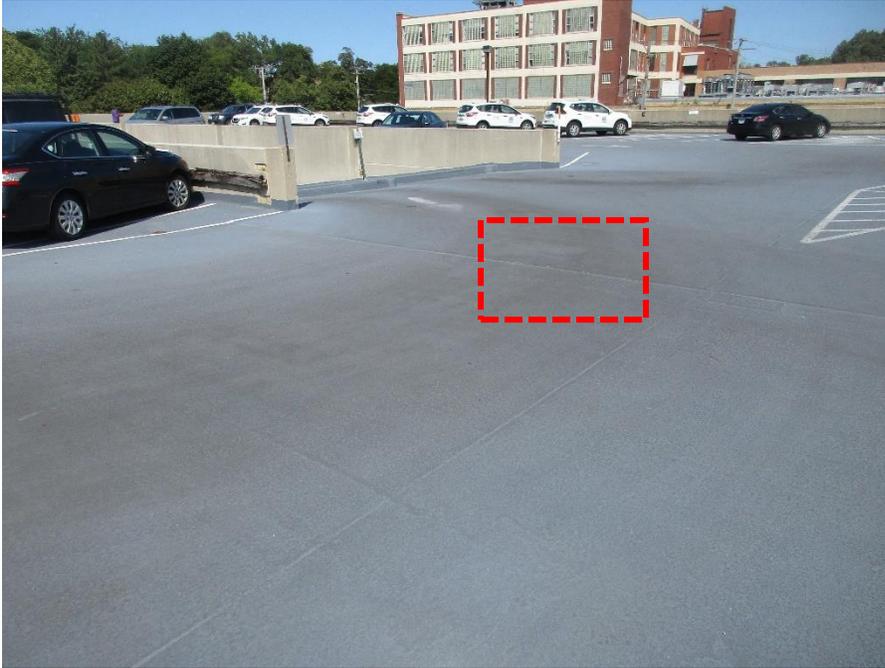
- One face shell was observed to have failed in the CMU partition wall near Column F/D15, as shown in Figure 5.4.
- At the top of the ramp and at the turns at the north and south ends of the rooftop parking deck, aggregate in the top coat of the waterproofing membrane was observed to have worn off or pulled out, and full membrane failure was observed at intermittent locations at concrete joints, as shown in Figure 5.5 and Figure 5.6.

Figure 5.5. Overall condition of the waterproofing membrane on the rooftop parking deck at the top of the ramp. A close-up view of the red box region is shown in Figure 5.6.

The condition of the waterproofing membrane should continue to be monitored. The membrane is particularly susceptible to wear at locations where vehicular traffic changes direction and speed, such as at the top of the ramp and at turns. Membrane wear was also observed along a topping slab repair joint where minor changes in elevation are present. Under normal conditions, recoating of the waterproofing membrane should be anticipated to be needed every five to ten years to extend the life of the overall waterproofing system.

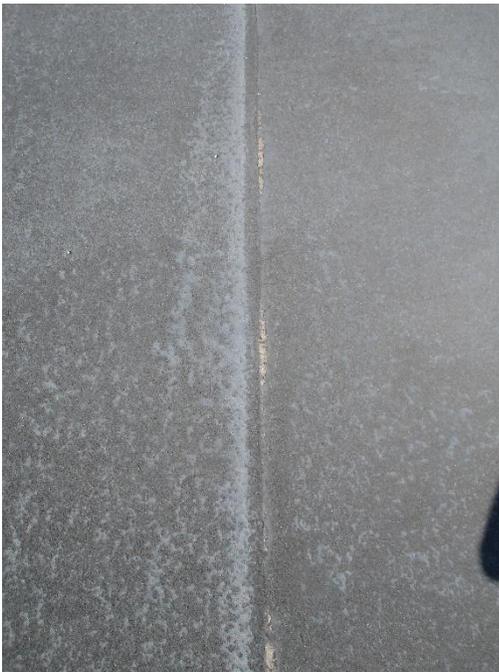
Figure 5.6. Close-up view of the waterproofing membrane on the rooftop parking deck at a joint in the deck topping near the top of the ramp.

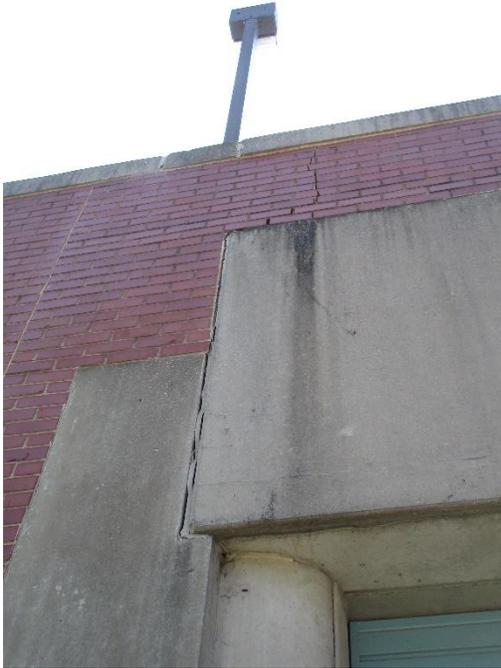
- Masonry brick cracking, sealant debonding, and efflorescence was observed on the exterior facade at the north end of the structure near base of the ramp, as shown in Figure 5.7 and Figure 5.8.

Figure 5.7. Cracking in the clay brick facade and sealant debonding at the north exterior over the base of the ramp.

The facade deterioration items noted above likely existed prior to the 2018 repairs, as the focus of that project was restoration of critical structural deficiencies. While the facade items do not pose any structural concern, they should be addressed in order to prevent water intrusion and to improve overall appearance.

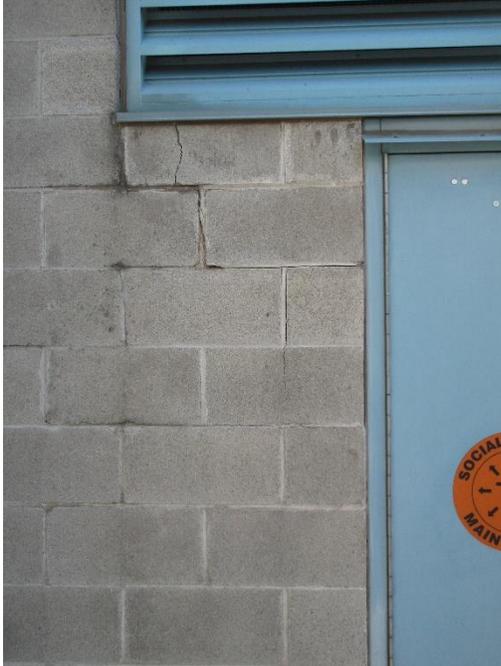
- Some CMU cracking and mortar joint deterioration and cracking was noted in the exterior wall around and near the stairwell, as shown in Figure 5.9 and Figure 5.10.

Figure 5.9. CMU and mortar joint cracking in the exterior wall adjacent to the southwest stairwell.
