CITY OF EVANSTON
REQUEST FOR PROPOSAL

NUMBER: 25-29

Sherman Plaza Parking Garage Structural Assessment

May 15, 2025

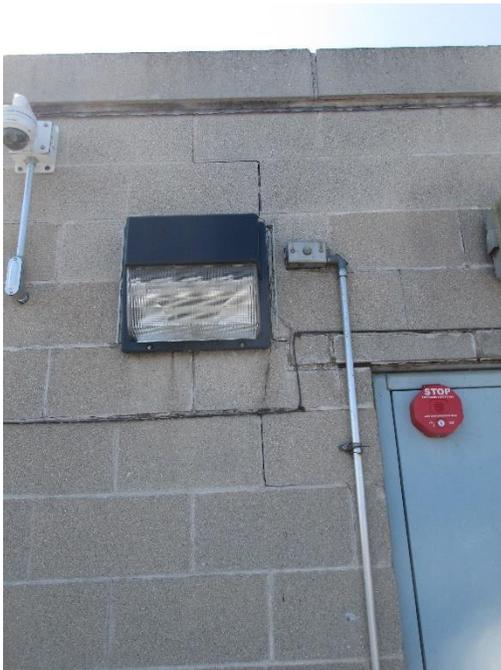
- Some CMU cracking and mortar joint deterioration and cracking was noted in the exterior wall around and near the stairwell, as shown in Figure 5.9 and Figure 5.10.

Figure 5.10. Mortar joint cracking and deterioration in the exterior wall of the southwest stairwell.

The facade deterioration items noted above likely existed prior to the 2018 repairs, as the focus of that project was restoration of critical structural deficiencies. While the facade items do not pose any structural concern, they should be addressed in order to prevent water intrusion and to improve overall appearance.

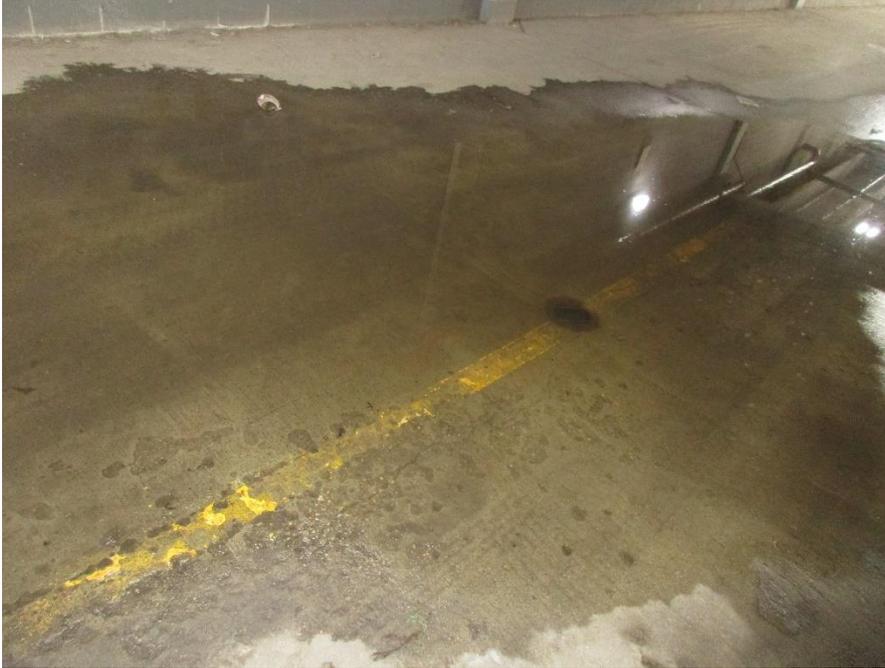
- The ground level floor drain at the east end of Bay D5-D6 was observed to be clogged, as shown in Figure 5.11.
- Four floor drains throughout the site were observed with missing drain grates.

Figure 5.11. Clogged floor drain with sitting water at the east end of Bay D5-D6.

The clogged drain should be cleared out to prevent damage to the pipes from freezing water and to allow for water to clear from the surrounding area. Additionally, missing grates and grates that do not sit flush with the top of the drain pose tripping hazards should be addressed. These items are of low priority.

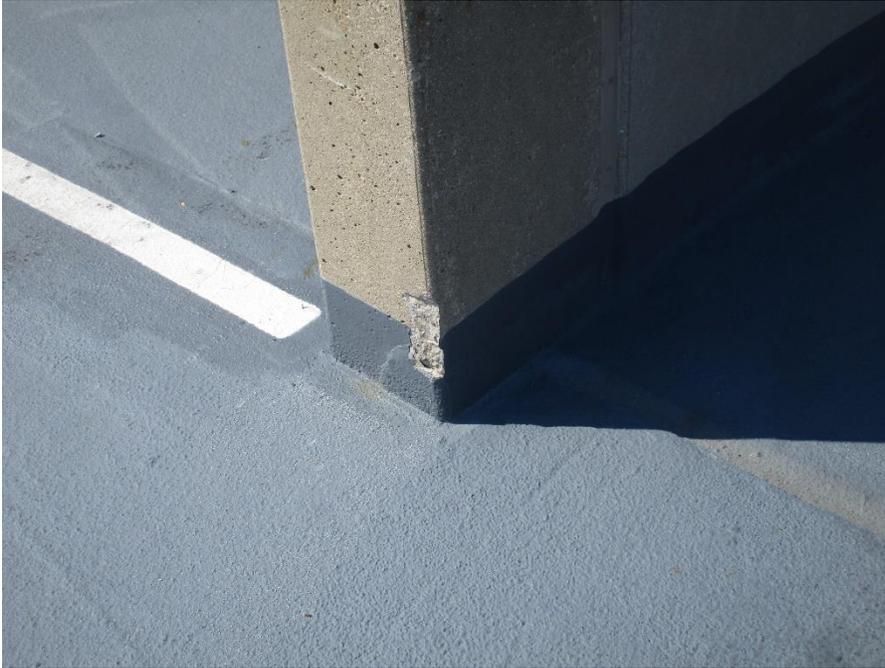
As noted above, WJE performed a delamination survey of the top surface of the rooftop parking deck via chain drag to identify locations of delaminated concrete, as well as a delamination survey of vertical and overhead surfaces in select accessible locations via hammer tapping. As the deck had been recently repaired in 2018, only approximately 3 square feet of delaminated concrete was found on the top surface of the rooftop parking deck. Several column bases were noted to have delaminated concrete, an example of which is shown in Figure 5.12, and a few precast spandrel panels have minor spalls, with an example provided in Figure 5.13. Overall, approximately 15 square feet of spalls and delaminations were identified on vertical concrete surfaces. Approximately 40 square feet of possible overhead delaminations were identified on the underside of the rooftop parking deck, though some of these locations may have been previously evaluated up-close during the recent repair project and deemed acceptable. These quantities include the damage and deterioration noted in WJE's July 2020 letter report, which appeared unchanged since the June 2020 inspection, and are as shown in Figure 5.14 and Figure 5.15.

Figure 5.15. Spall in wall at the top of the ramp at Column E/D7, which appeared unchanged since WJE's inspection in June 2020.

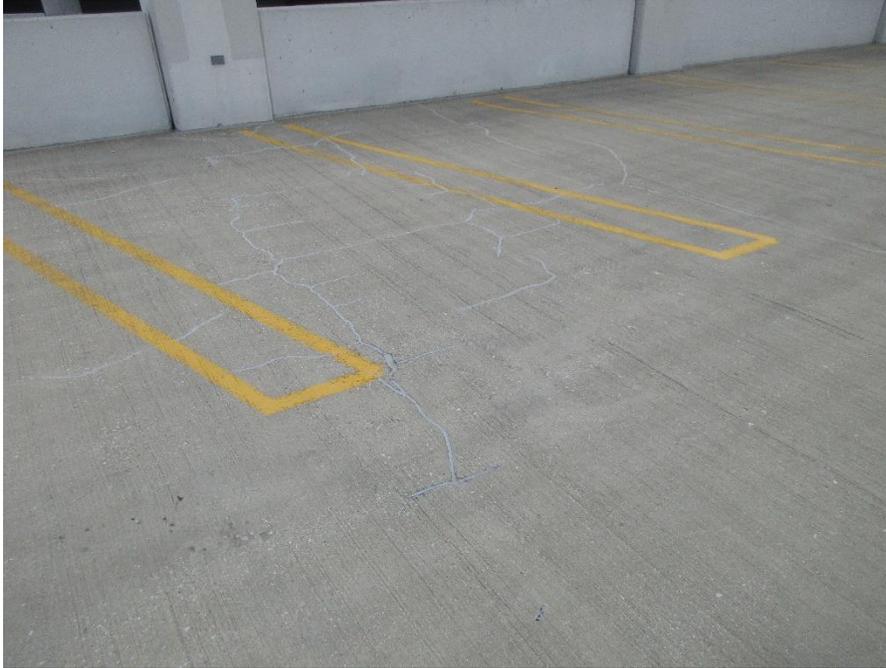
- Distributed cracking was observed on the top and bottom surfaces of the rooftop deck (Level 12), an example of which is provided in Figure 6.2), with most of the top surface cracks already sealed. Through-cracking was observed in the northeast corner of the Level 12 slab, with a view of the underside cracking presented in Figure 6.3. Cracking and corrosion staining was also observed on the bottom of Beam PP/P7-P10, as shown in Figure 6.4.

Figure 6.2. Distributed deck cracking on top surface of rooftop (Level 12) deck.

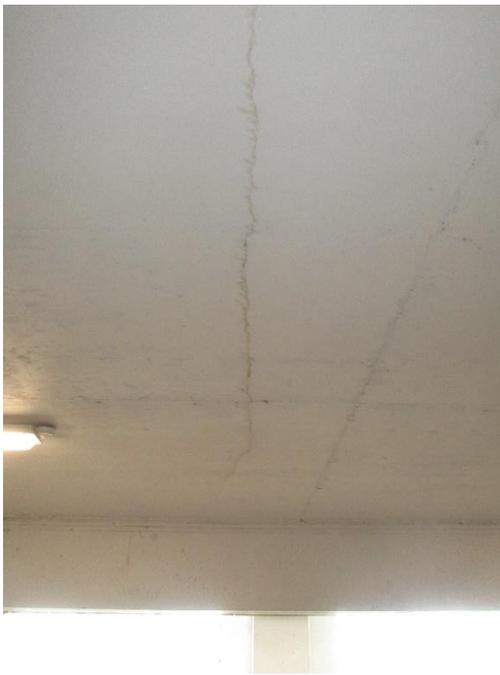
Figure 6.3. Underside of through-cracking observed in the northeast portion of the Level 12 slab.

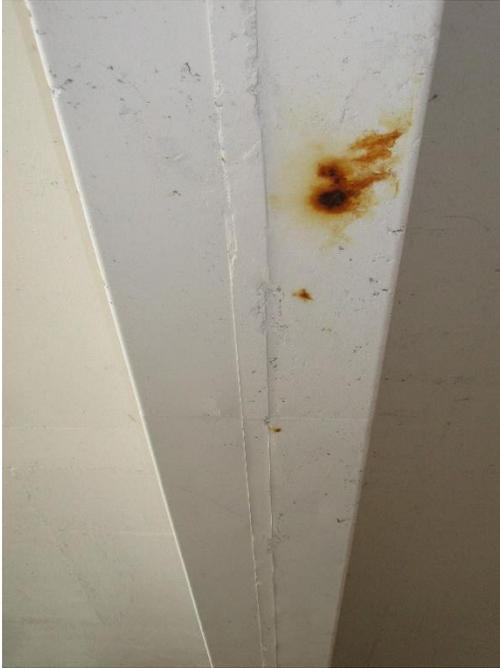
Figure 6.4. Corrosion staining and cracking on the underside of Beam PP/P7-P10 beneath the northeast corner of Level 12.

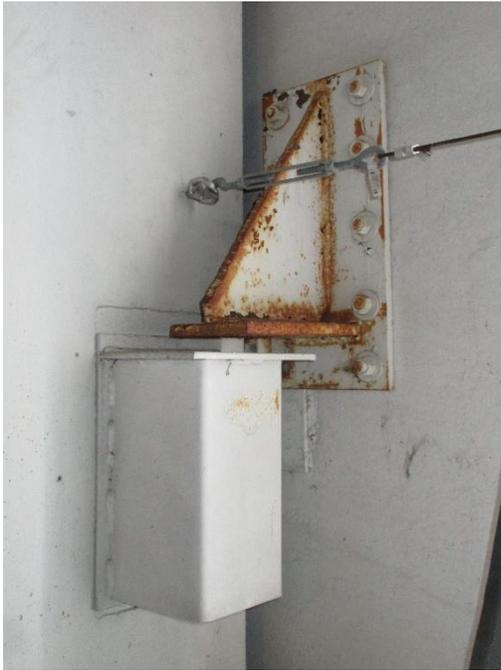
- The facade panel vertical support on Level 5 at Column PD/P1 was observed to be missing a shim plate, and thus is ineffective (see Figure 6.8).
- Six facade panel bearing connections were observed to feature flame-cut bearing plates that resulted in either point-bearing (see Figure 6.9) or edge bearing (see Figure 6.10) support conditions.

Figure 6.8. Facade panel vertical support missing requisite shim plate to bear on at Column PD/P1 on Level 5.

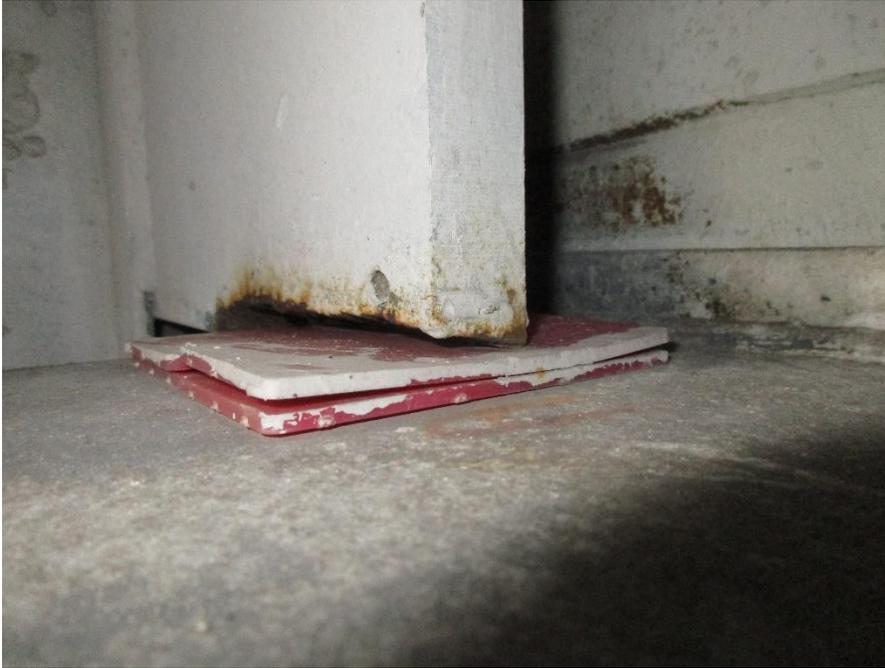
Figure 6.10. Facade panel bearing connection with edge bearing along parts of the flame-cut bearing plate.

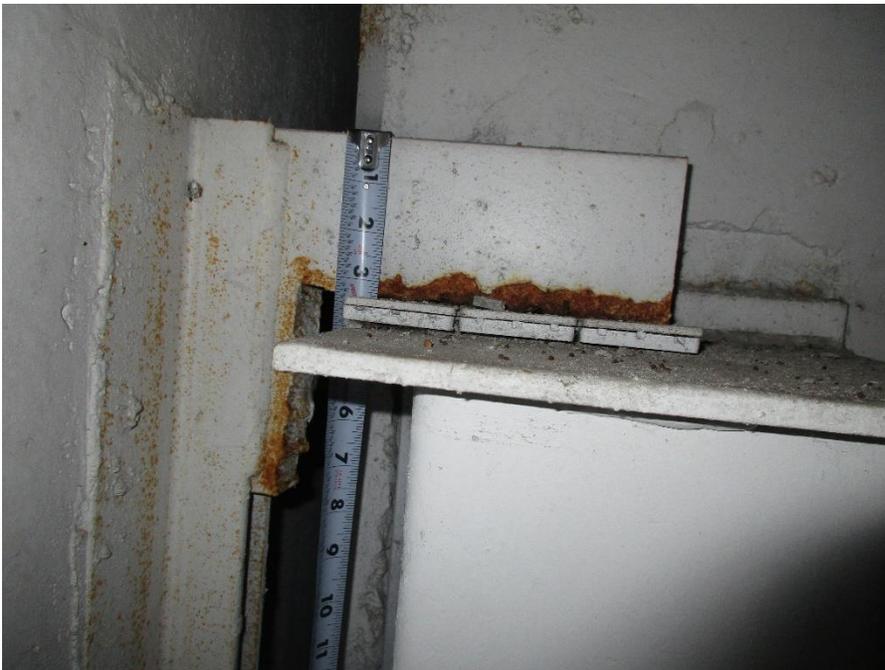
- The facade panel bearing plate at Column PQ/P1 of Level 11 was observed to have been flame-cut to less than half of its original height, as shown in Figure 6.11.

Figure 6.11. Significant flame-cutting of the facade panel bearing plate at Column PQ/P1 of Level 11.

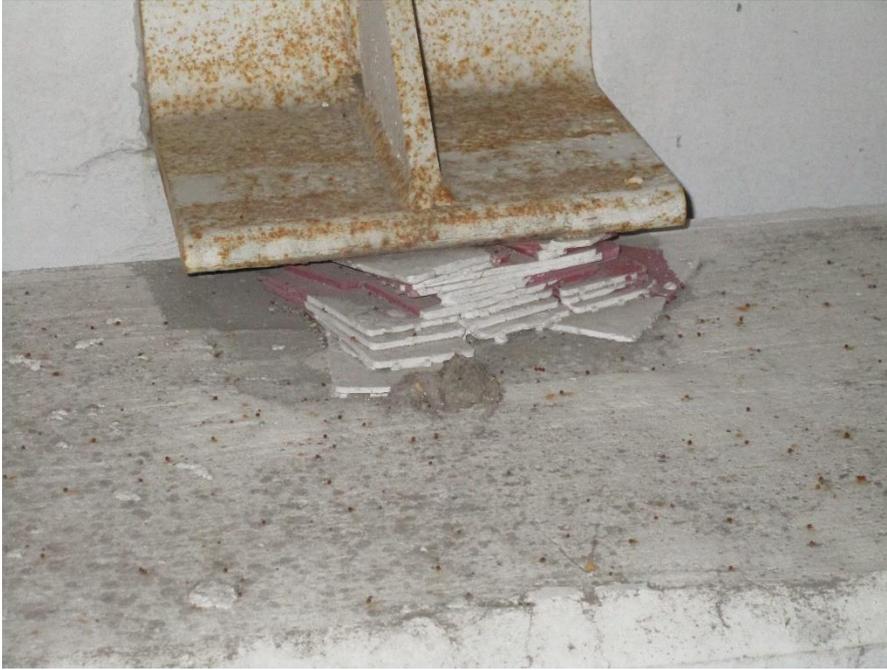
- Significant movement of shims beneath two facade panel bearing connectors was observed, as shown in Figure 6.12 and Figure 6.13.
- A failed traffic barrier cable was observed near Column PJ/P7 on Level 6, which is shown in Figure 6.14.

Figure 6.12. Splaying of shim stack at facade panel connection near Column PQ/P1 on Level 7.

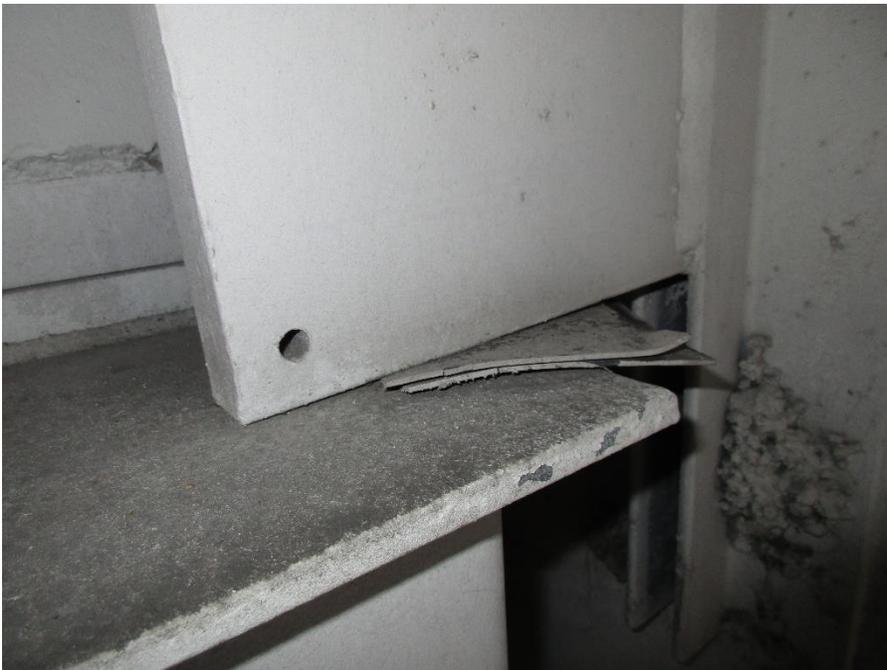
Figure 6.13. Walkout of shim plates at facade panel connection near Column PQ/P1 on Level 8.

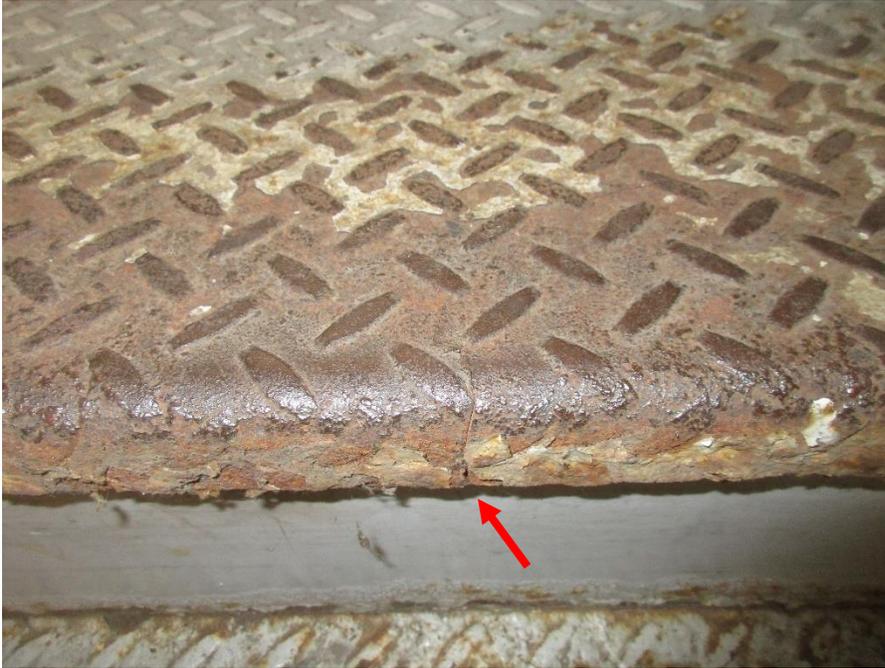
Figure 6.16. Failed tread in the southeast stairwell. The crack (indicated by red arrow) extends from a failed weld that previously affixed the tread to the supporting riser.

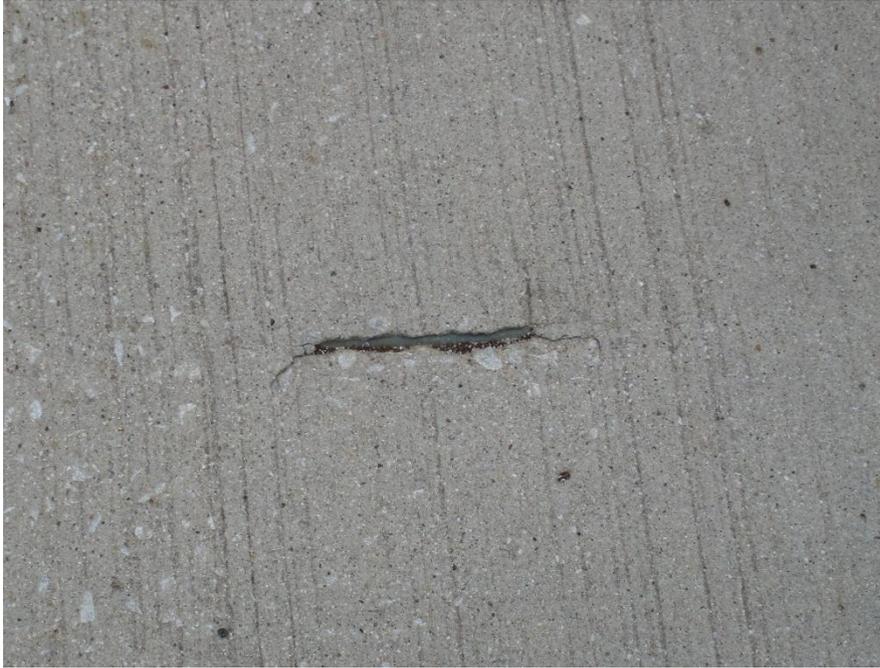
- Exposed or poorly protected post-tensioning tendon sheathing was observed on the top surface of the deck at three locations in the garage, with an example provided in Figure 6.18.

Figure 6.18. Post-tensioning strand sheathing exposed on top of the Level 12 deck near the south end of the Middle Bay.

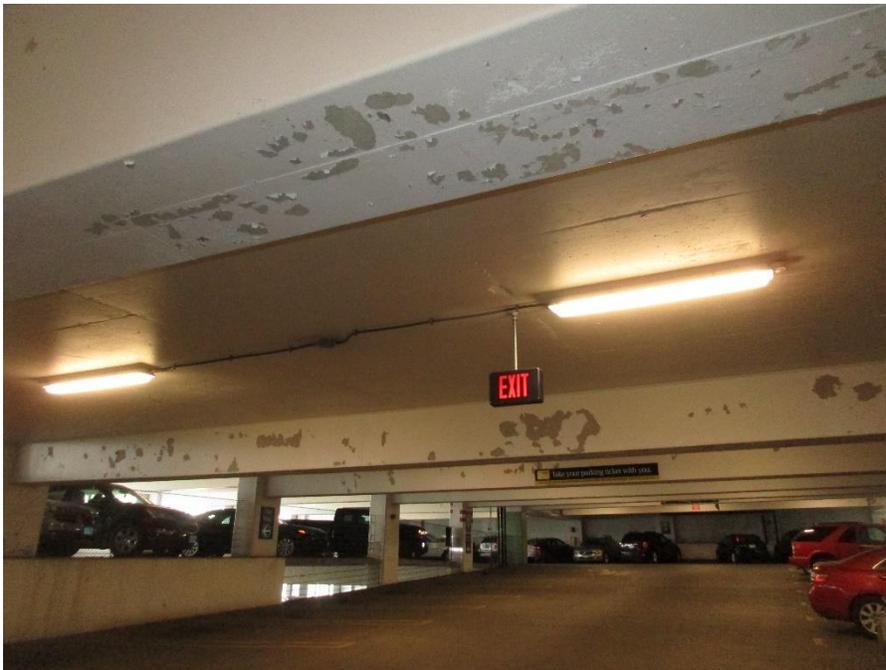
Figure 6.21. Paint peeling from the sides and bottoms of multiple beams in the Middle Bay of the Level 5 deck.

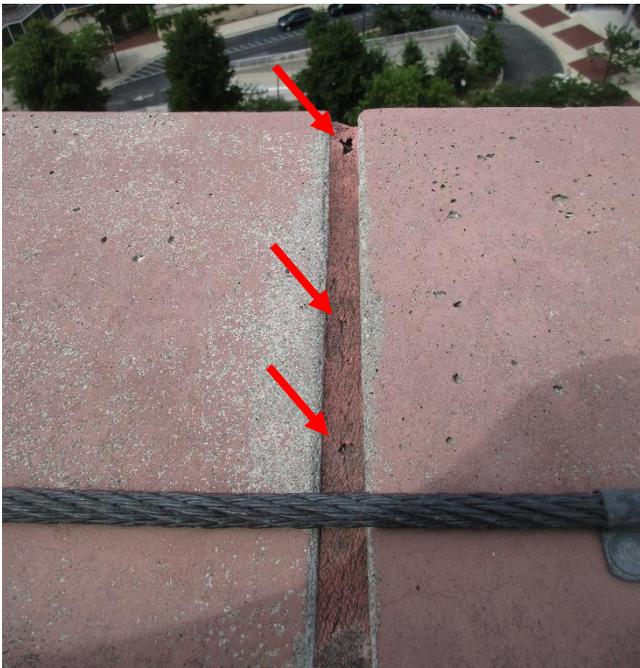
Figure 6.23. Sealant between the tops of facade panels at Column PH/P1. Note the alligator cracking pattern and local failures in the sealant indicated with red arrows.

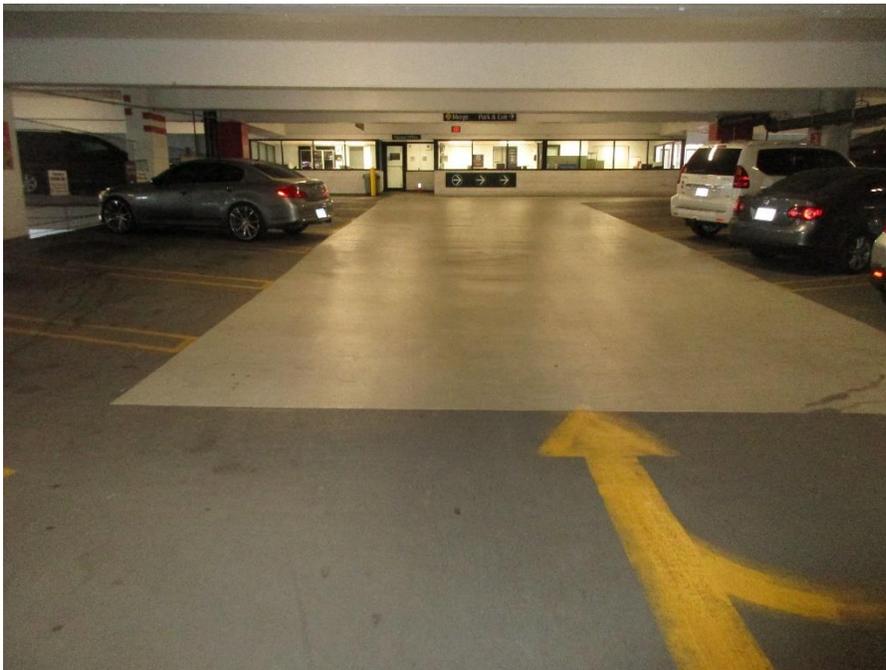
Figure 6.25. Waterproofing membrane on the Middle Bay slab ramping up from Level 2 to Level 3 beyond Column Line PK, featuring a newer top coat in good condition.

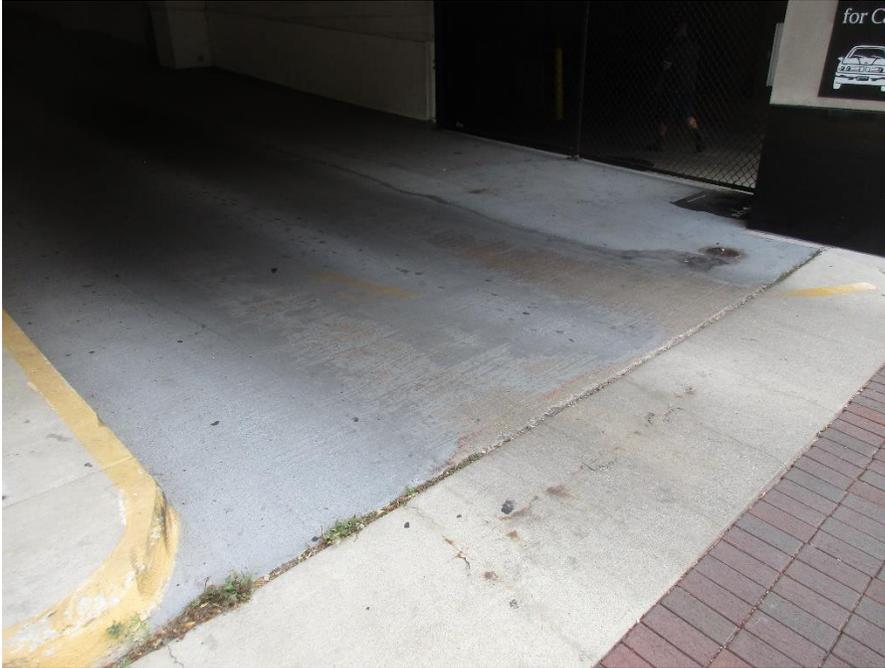
Figure 6.26. Davis Street entrance ramp, showing membrane wear through to the concrete deck.

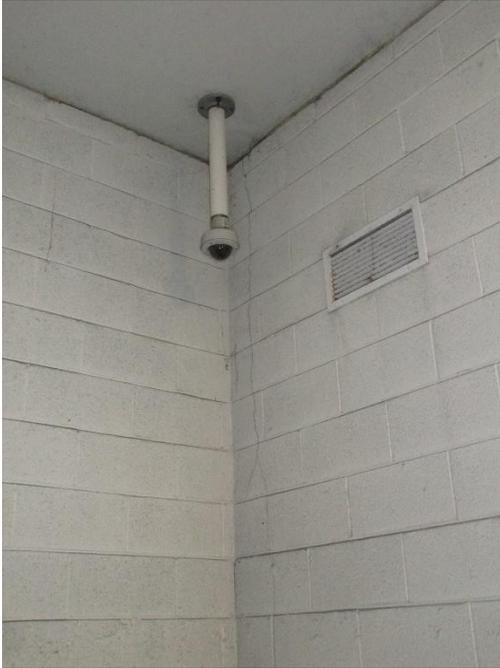
Figure 6.30. CMU partition wall cracking observed on Level 3.

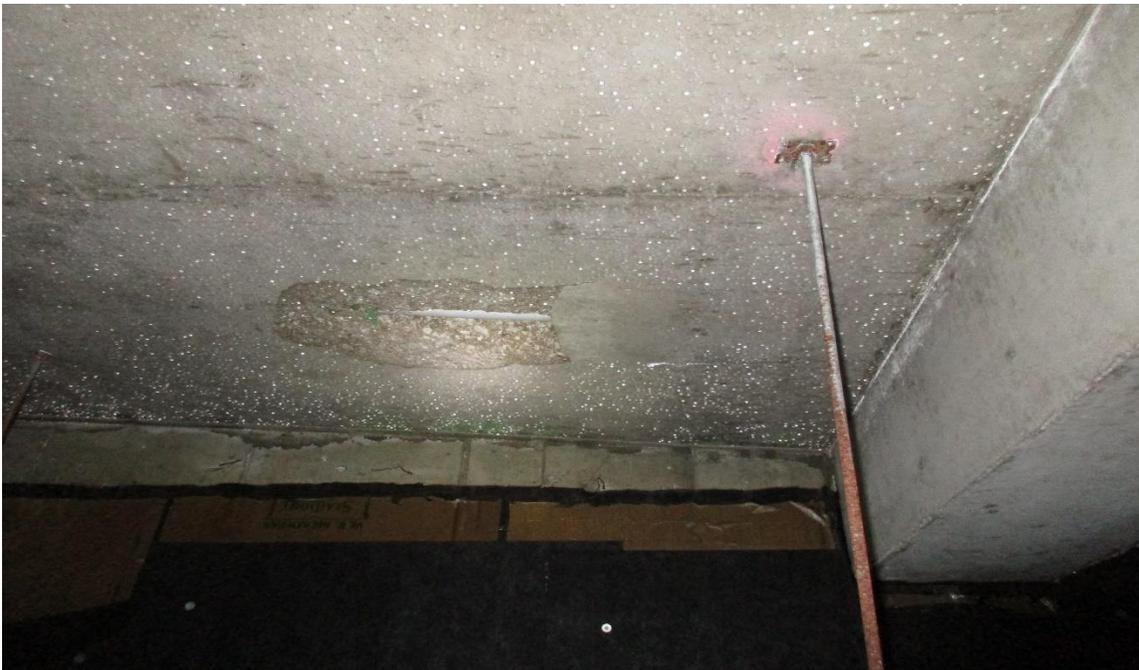
Figure 6.35. Concrete delamination on the underside of the ramp slab beneath embedded electrical conduit.

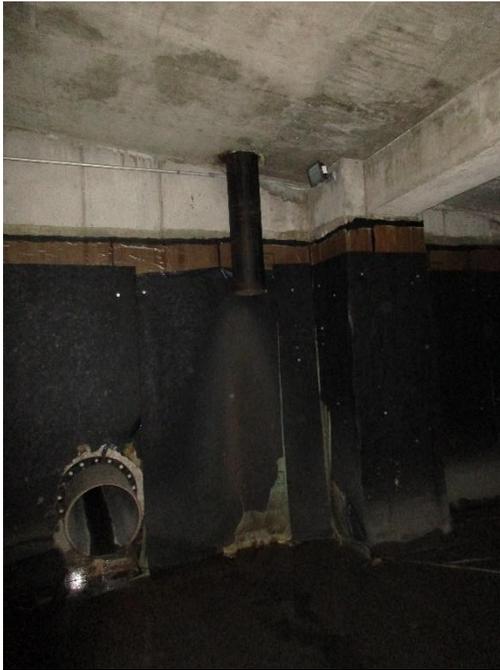
Figure 6.36. Drain above the debonded waterproofing liner next to Column PC/P7.

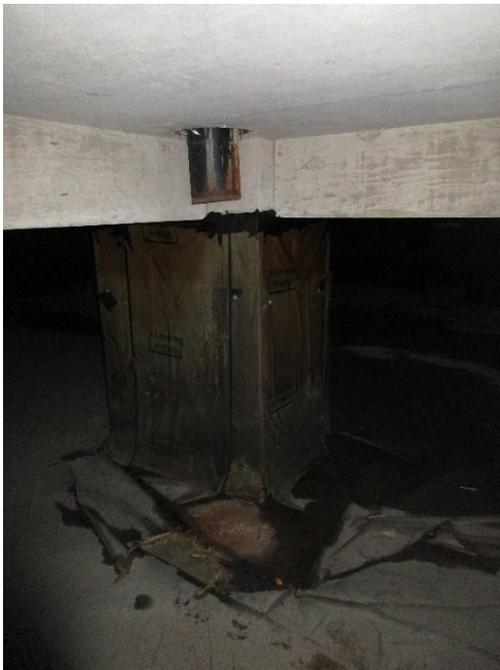
Figure 6.37. Drain and debonded waterproofing liner next to Column PC/P4.

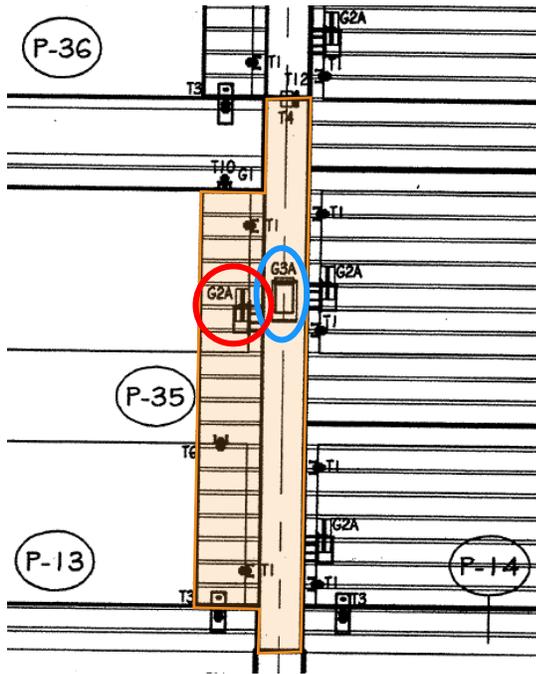
Figure 6.38. Original drawing elevation of the facade panel (shaded and outlined in orange) with missing vertical support (circled in red) observed at Level 5 Column PD/P1. The blue oval indicates the other vertical support for this facade panel piece.
