## Roof Evaluation - Various City Facilities

### Recycling Center

Location: 2222 Oakton Year Built: 1990 Rehabbed: N/A Overall rating: Fair

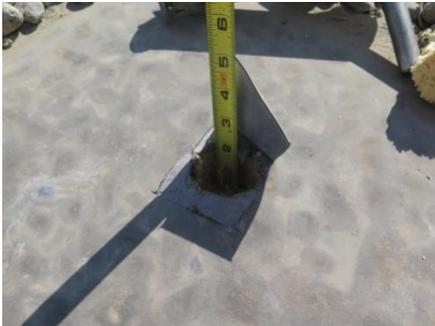
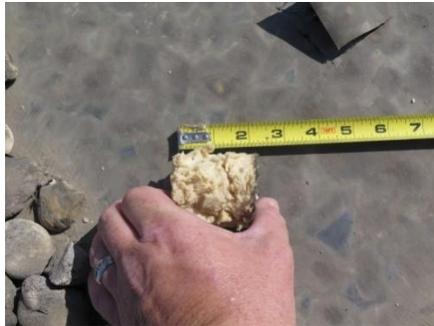
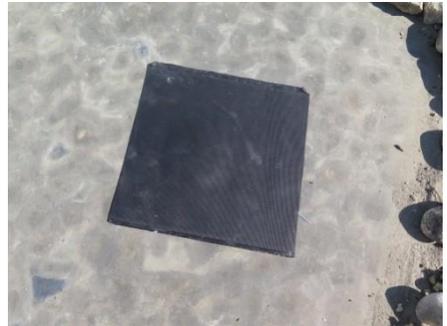
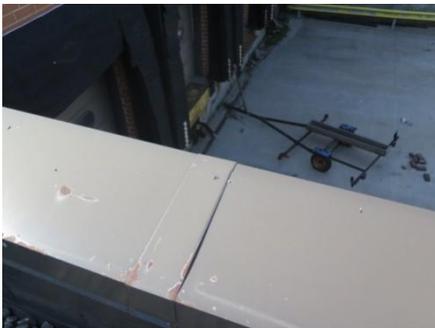
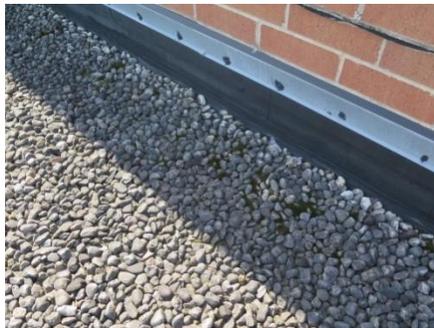
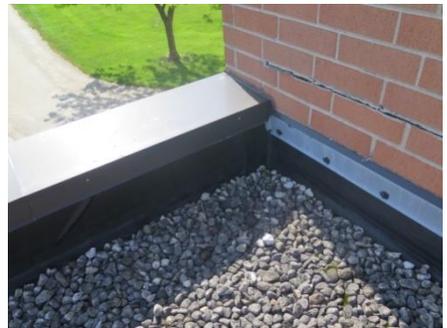
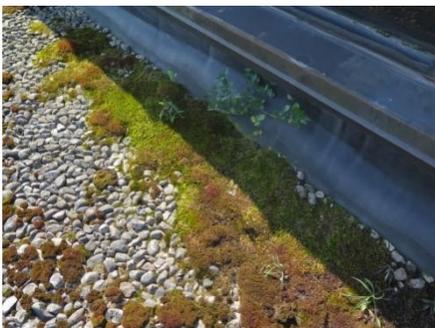
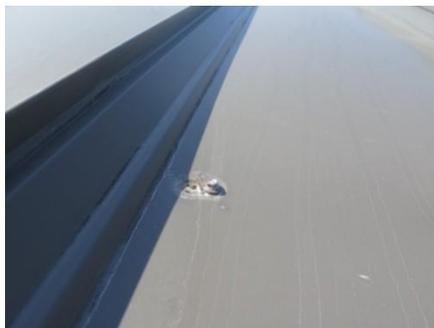
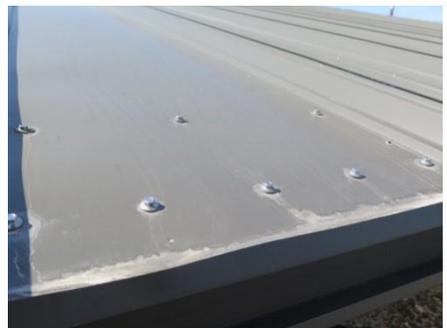
**Current condition:** Per observation, the coping and flashing appeared to be in good condition. However, vegetation was present and this needs to be removed, to prevent further growth and existence of unwanted material.

**Recommended Strategy:** Maintenance
