# Mechanical Systems Assessment

## Lorraine H. Morton Civic Center

### August 26, 2019

MECHANICAL SYSTEMS ASSESSMENT AND  
REVIEW OF UPGRADE ALTERNATIVES

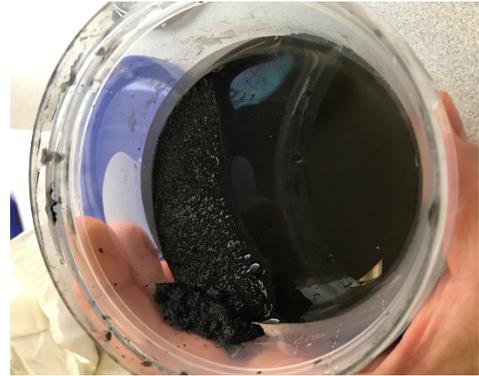
The heat pumps, piping, pumps, boilers, and controls are currently in poor condition and require significant time and effort from the building's operations staff to remain in service. This situation is exacerbated due to the condition of the circulating water system associated with the heat pumps. It is reported that water treatment of this system was neglected for many years. The system is currently treated with inhibitor and biocide, but the years of neglect have resulted in severe internal corrosion of the piping and significant quantities of precipitated products of corrosion which cause fouling of the heat pumps' internal heat exchangers.

**Figure 1 - Sediment taken from heat pump condenser coil**

As part of this study, G/BA commissioned testing of a sample of the neutral water system and also had an evaluation performed on the composition of the sediment taken from one of the blocked heat pumps. This testing confirmed that the present condition of the water is good. The sediment was found to be composed of precipitated products of corrosion.

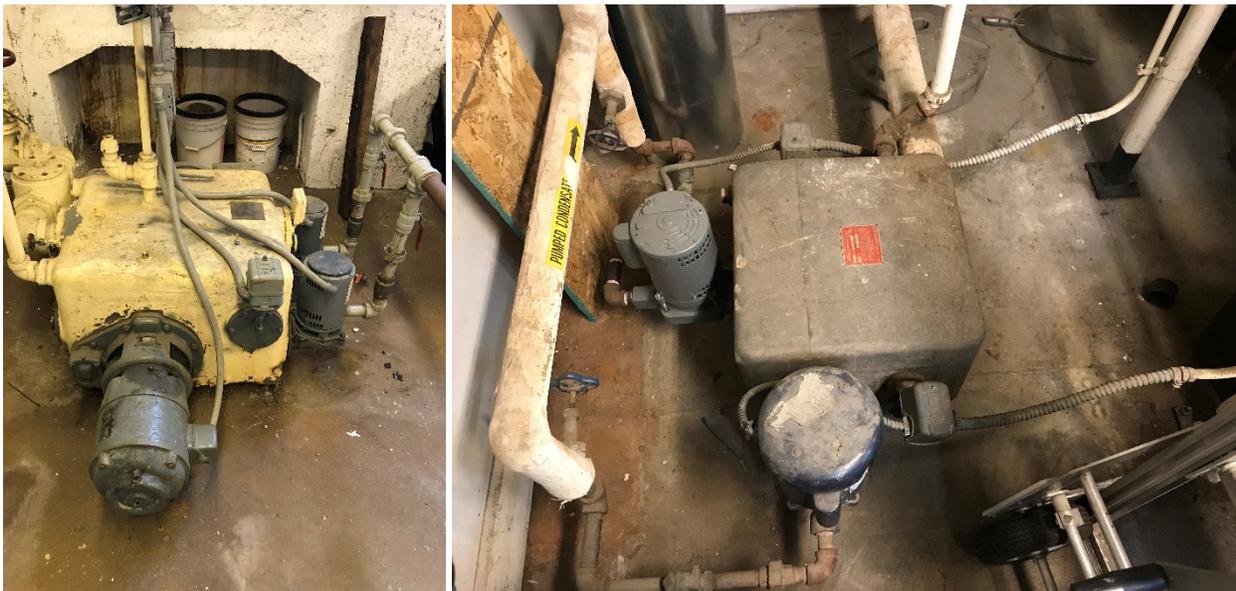
**Present Condition:** Condensate transfer units can last many years. The point of failure is typically the transfer pumps, which can be readily replaced by facility maintenance staff. The vacuum receiver/transfer set is approaching the end of its service life and should be replaced in the near future. The boiler feed water tank has recently failed due to severe corrosion of the tank. An emergency replacement of the tank prior to the next heating season is underway.

**Figure 2 - Condensate Vacuum/Transfer Pump Sets**

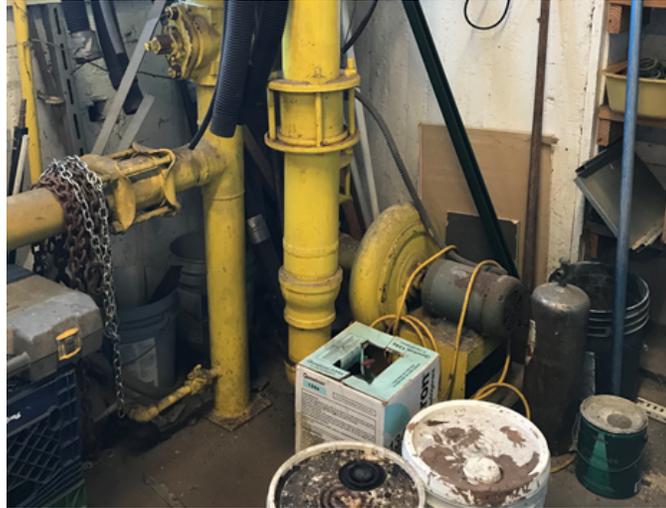
**Present Condition:** On a recent 20°F day, a pressure gauge on the gas piping to the south boiler indicated a reading of 7 inches w.c. This is at the low end of what would be acceptable for a new high performance burner. The existing gas booster is very old and would be a candidate for replacement. However, it appears that the gas service connection to the building provides higher pressure but is reduced by a regulator prior to the gas meter located outside the boiler house. Replacement of the pressure reducing valve would likely eliminate the need for a booster.

**Figure 3 – Gas Pressure Booster Fan**

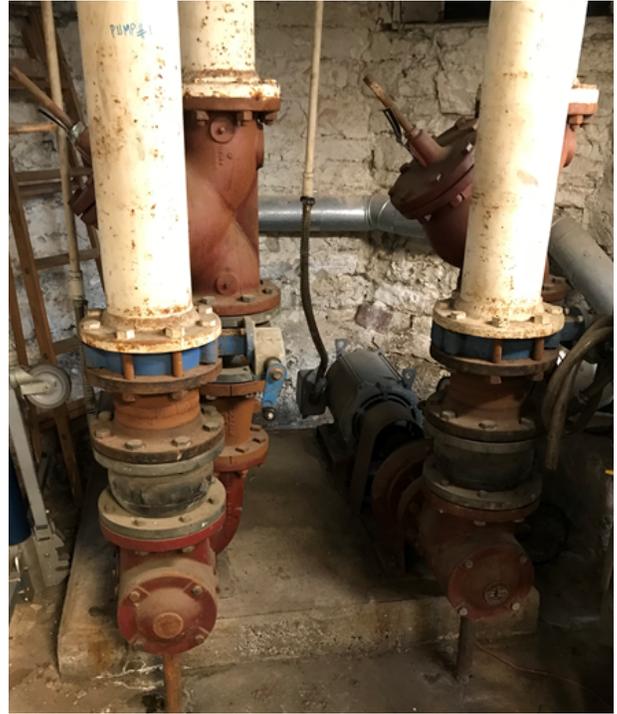
The neutral water circulation pumps were installed in 1978 and have exceeded their expected service life.

**Figure 4 - Neutral Water Pumps**

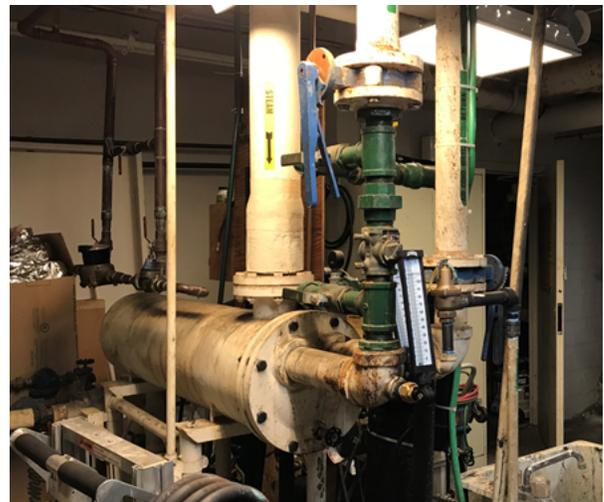
**Figure 5 - Steam to Neutral Water Heat Exchanger**

**Present Condition:** The steam heat exchanger is a shell and tube type heat exchanger. The internal tube bundle of this converter was replaced in 2018. However, the heat exchanger is piped in a manner that does not lend itself to accurate control of loop temperature.

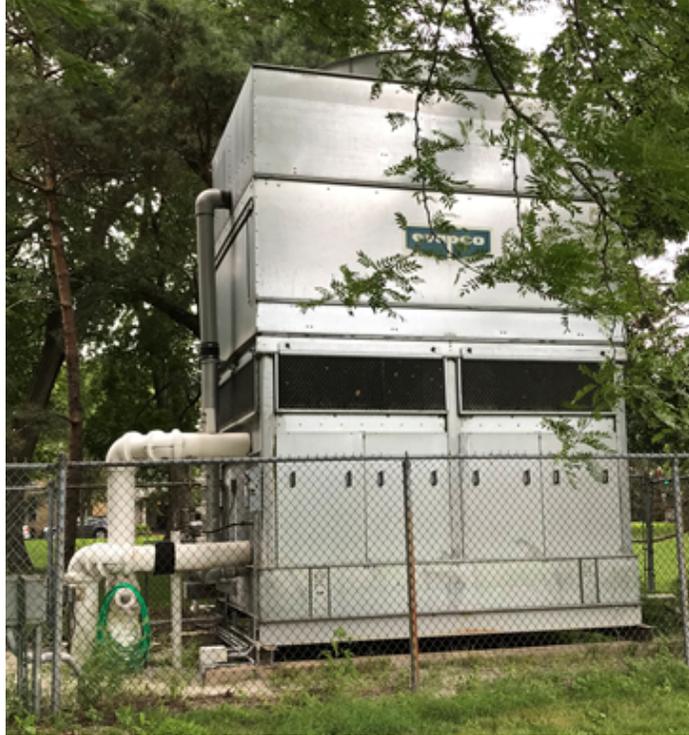
**Figure 6 – Closed Circuit Fluid Cooler**

**Present Condition:** The fluid cooler was installed in 2006. It has been in service for 12 years and appears to be in good condition, with substantial remaining service life. The fill material was replaced in recent years. The operating engineer reports that its capacity has proven adequate under periods of high cooling demand.

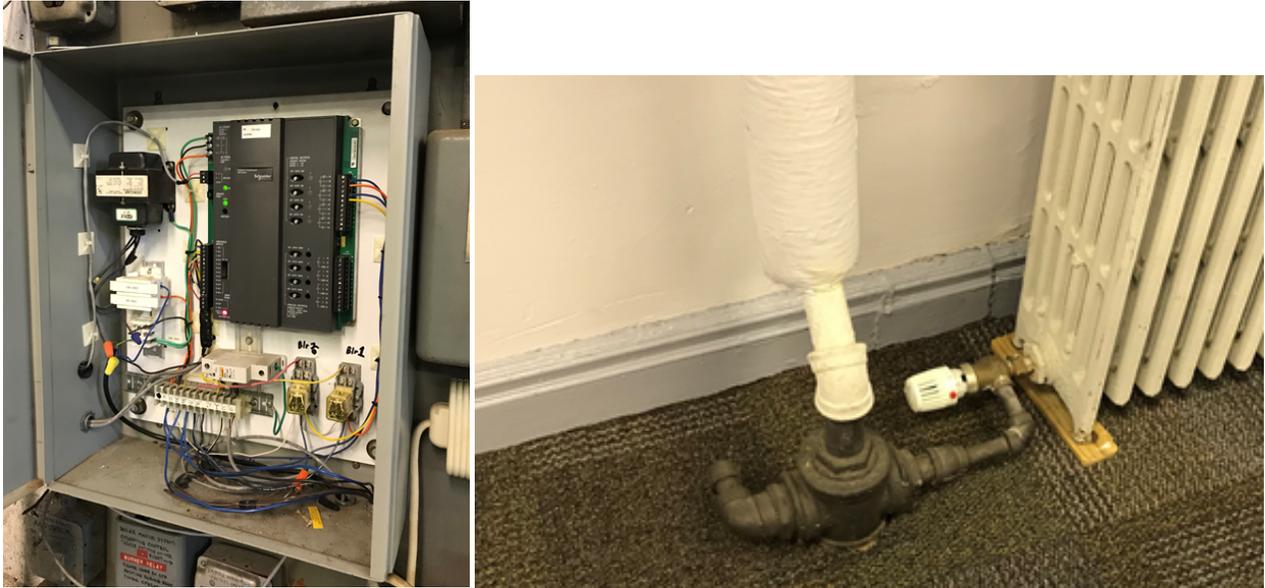
**Figure 8 – DDC boiler controller and thermostatic radiator control valve**

**Present Condition:** The radiator mounted thermostatic control valves have an expected service life of less than 20 years. It appears that many of the valves installed in 1978 have subsequently been replaced.

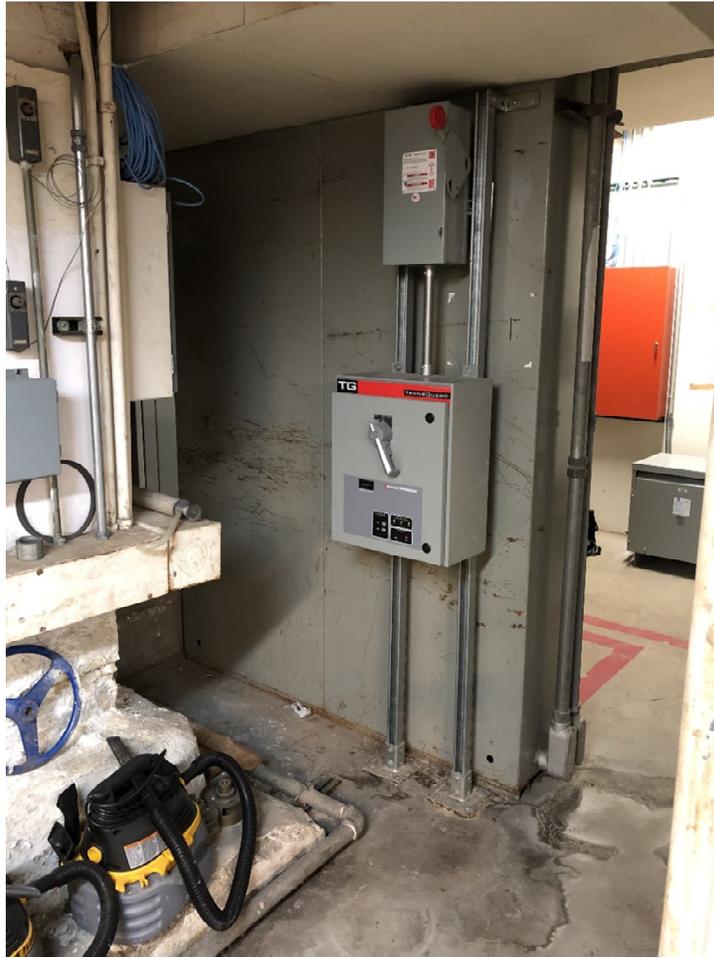
**Description:** The main building has 2 electrical services coming from separate ComEd pad mounted transformers on the South side of the building. The incoming services come in underground to switchboards SWBD-1 and SWBD-2, located on the ground floor electrical room. The switchboard enclosures are showing signs of rust where the paint is scratched. Switch and fuse switchboards can have a long life if properly maintained, but due to the environment and maintenance record, the condition of switchboards is uncertain. Further examination and inspection by a certified testing and service company is required.

**Figure 9 - Back of SWBD-2 shows rust and signs of water damage on the floor**

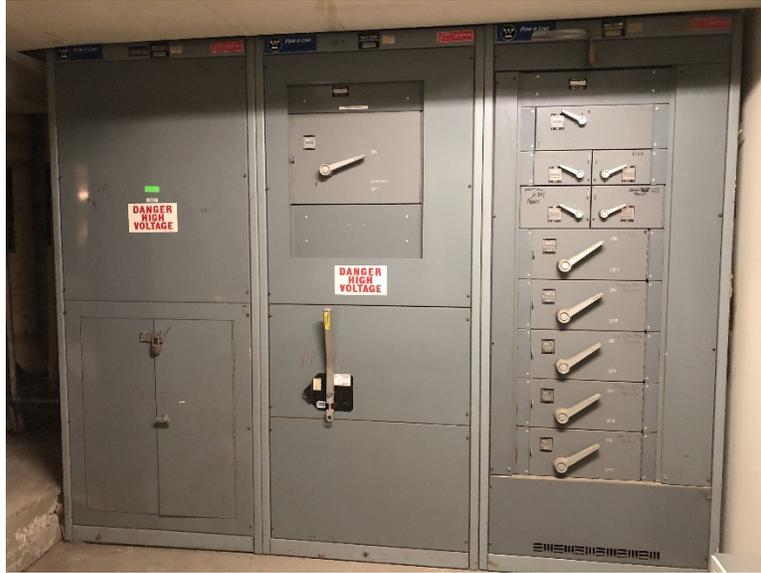
Switchboard SWBD-1 is an 800A, 277/480V-3PH-4W fused switchboard manufactured by Westinghouse. The switchboard nameplate indicate that is was manufactured in 1977. Based on the age, the switchboard may be approaching the end of life, but further testing will be required. Switchboard SWBD-1 serves the fluid cooler, house pumps, elevator, power distribution to the attic, receptacle, and lighting loads throughout the building. Based on utility information, the switchboard has adequate capacity of the loads connected, but does not have any available spare switches or space for expansion.

**Figure 10 - Switchboard SWBD-1**

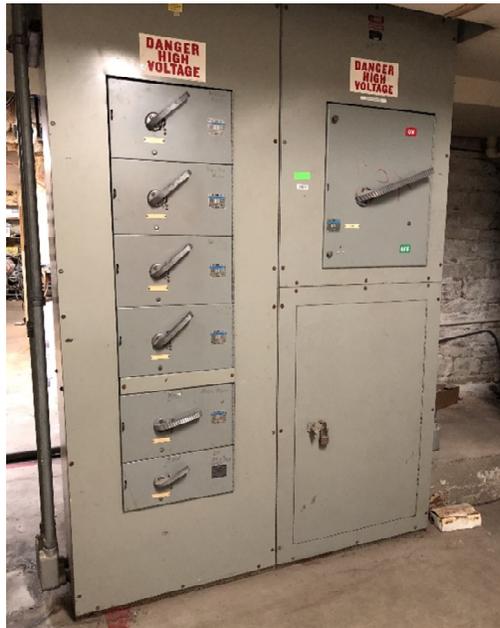
Switchboard SWBD-2 is an 800A, 277/480V-3PH-4W fused switchboard manufactured by Jemison Electric. Switchboard SWBD-2 was likely installed with a service upgrade to serve the heat pump system in 1978. Based on the age, the switchboard may be approaching the end of life, but further testing will be required. The switchboard enclosure does show signs of rust and damage, so special care should be provided to preserve its condition. Switchboard SWBD-2 serves heat pump branch panels throughout the building, emergency lighting and exit signs, basement heating, and the north elevator. Review of historic monthly electric demand readings confirms that the existing electric service is adequate to support all options described in this report. However, the switchboard does not have any available spare switches or space for expansion.

**Figure 11 - Switchboard SWBD-2**

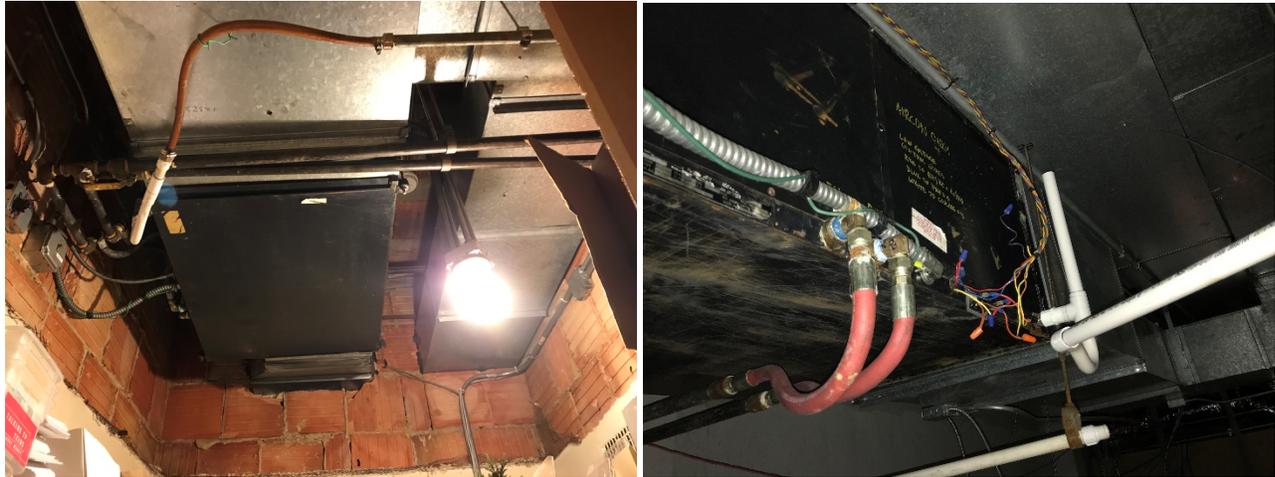
Nevertheless, there are two important reasons why converting to side-access heat pumps would be beneficial. First, it is presumed that pricing for side return units is more competitive because there are multiple manufacturers which produce them. Second, relying on a unit which is only available from a single supplier involves the risk associated with that manufacturer going out of business or discontinuing the product line.

**Figure 12 – Representative Existing Heat Pump Installations**

For the reasons described above, converting to side return configuration heat pump units would likely cost on the order of \$5,000 to \$7,000 per unit to perform the necessary ductwork modifications and relocation of other conflicting ceiling items. This cost is included in the Opinions of Probable Cost which follow for Schemes 1 and 3 below to eliminate the cost and availability risks associated with reliance on a sole source provider.

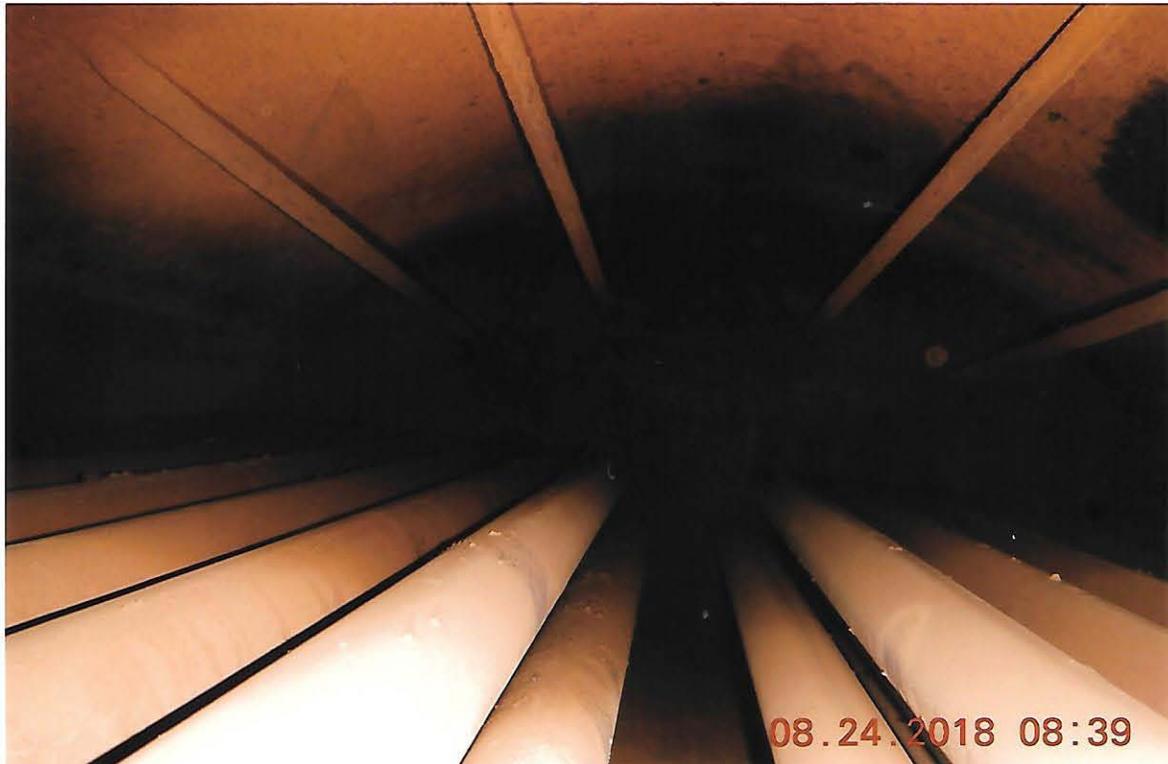
2)

The following ten (10) photos show the condition of the boiler's waterside as viewed from the top manway. Scale and tubercles were observed on the accessible tubes, boiler shell, and furnace sheet. Heavy under deposit pitting and corrosion were observed in the tubes. Light pitting was noted on the accessible furnace sheet.

1. Consideration should be given to completely re-tube Boiler #1 and Boiler #2 due to the present deleterious condition of the tubes prior to the operation of the boilers. At 50% wall loss, the tubes can still theoretically operate at the design pressure of the boilers, however, the State/Jurisdictional authority recommends to start replacing the tubes when the wall loss approaches 50%. A significant portion of tubes in Boiler #1 (49%) and Boiler #2 (63%) have a wall loss of 51% or above, with the remaining tubes nearing 50%. The replacement tubes should be at least equal to or greater than the original material specification. The company that will perform the tube replacement should have a valid "R" stamped from the National Board.

2. The waterside of the boilers should be pressure washed and/or a more aggressive method of scale removal (acid wash) utilized to dislodge and dissolve the heavy build-up of scale. Any accumulation of sediment and debris at the bottom of the boilers should be cleaned out. The build-up of scale or tubercles tends to accelerate corrosion on the shell and tubes by means of oxygen entrapment, as well as decrease the efficiency of the boiler. The potential for overheating of the tubes and furnace sheet also increases due to the insulating effect of the scale. Power washing of the boilers' waterside should be performed annually and incorporated into the boilers' annual maintenance program.

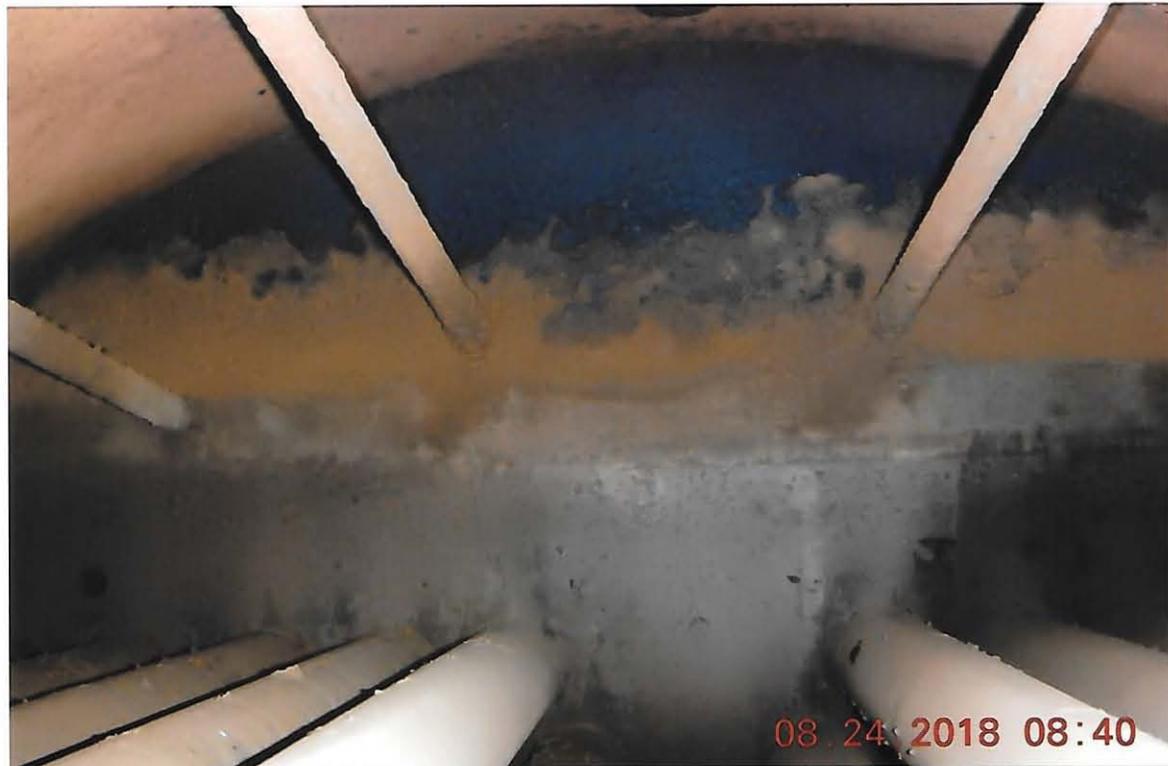
4)

The following ten (10) photos show the condition of the boiler's waterside as viewed from the top manway. Scale and tubercles were observed on the accessible tubes, boiler shell, and furnace sheet. Heavy under deposit pitting and corrosion were observed in the tubes. Light pitting was noted on the accessible furnace sheet.

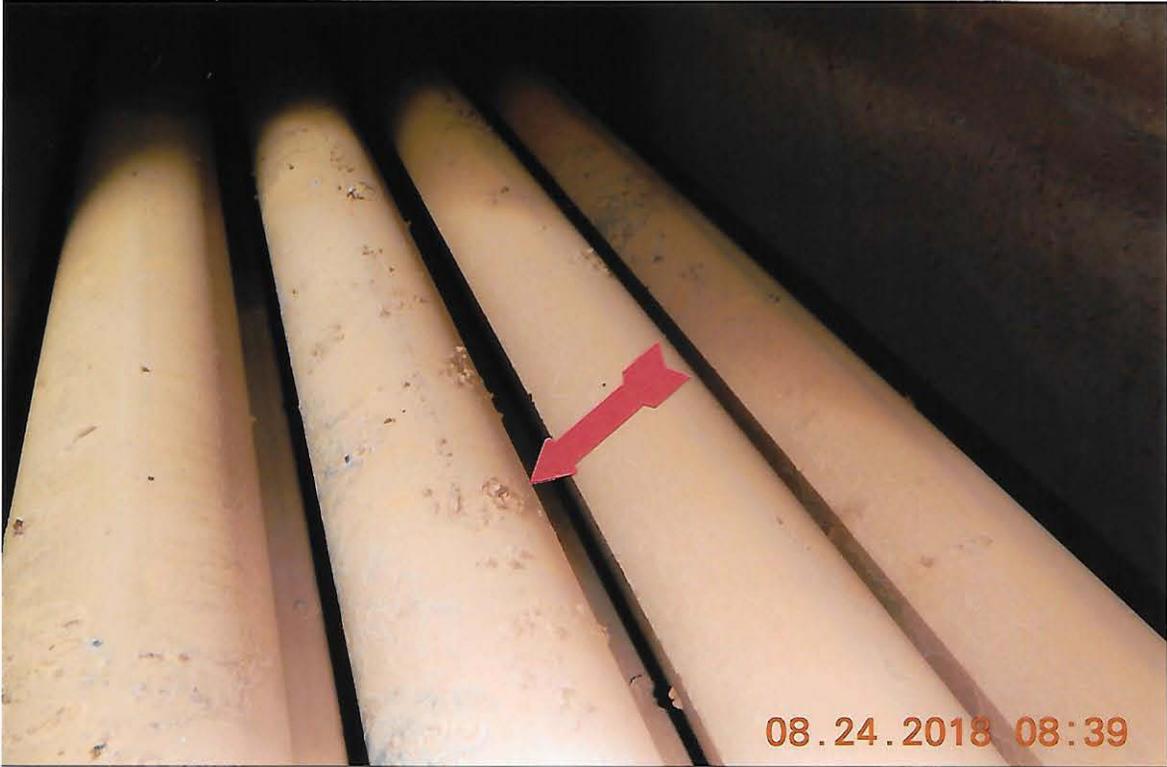
7)

The following ten (10) photos show the condition of the boiler's waterside as viewed from the top manway. Scale and tubercles were observed on the accessible tubes, boiler shell, and furnace sheet. Heavy under deposit pitting and corrosion were observed in the tubes. Light pitting was noted on the accessible furnace sheet.

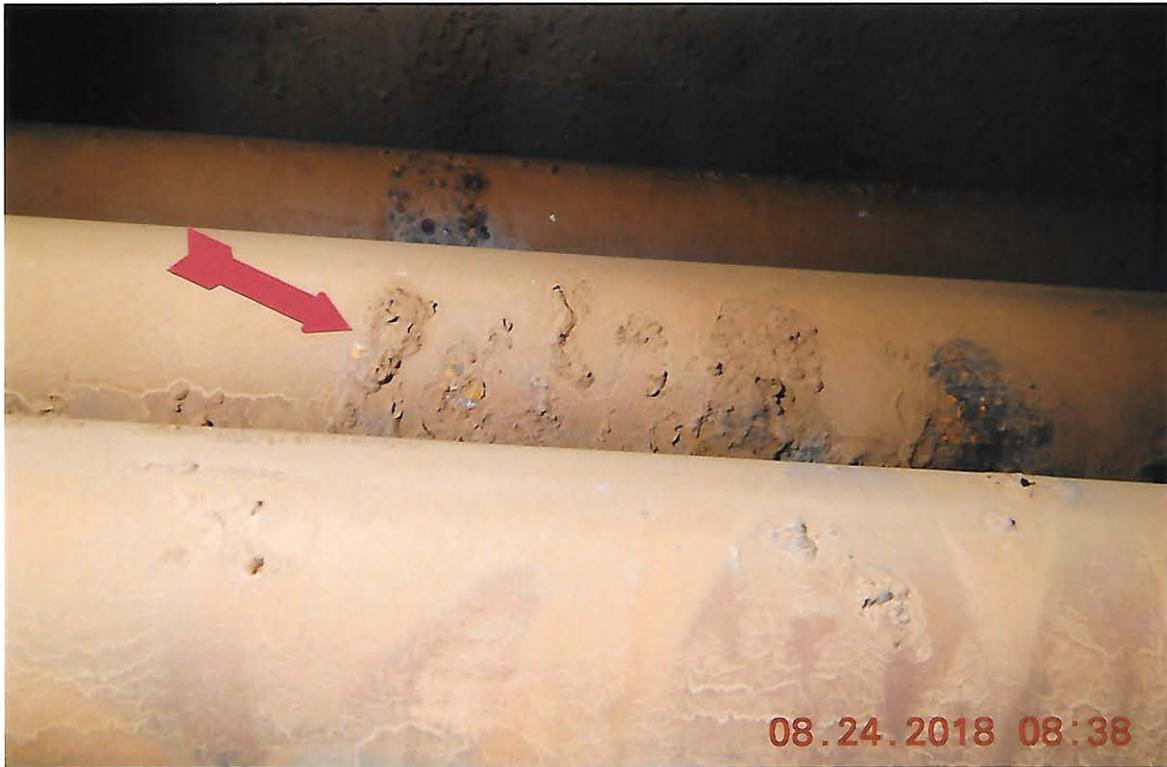
8)

The following ten (10) photos show the condition of the boiler's waterside as viewed from the top manway. Scale and tubercles were observed on the accessible tubes, boiler shell, and furnace sheet. Heavy under deposit pitting and corrosion were observed in the tubes. Light pitting was noted on the accessible furnace sheet.

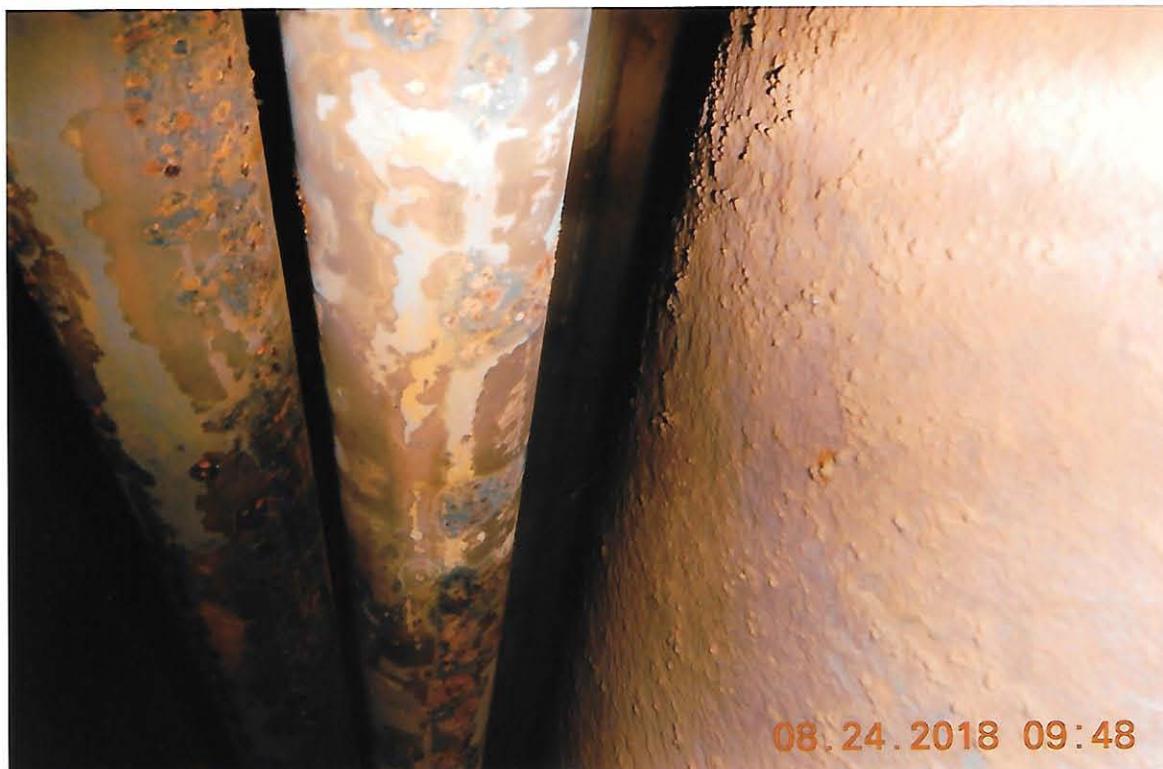
5)

The following ten (10) photos show the condition of the boiler's waterside as viewed from the lower handholes. Scale and tubercles were observed on the accessible tubes, boiler shell, and furnace sheet. An old cut-out tube was noted at the bottom of the shell. A moderate accumulation of sediment and debris was observed at the bottom of the shell.

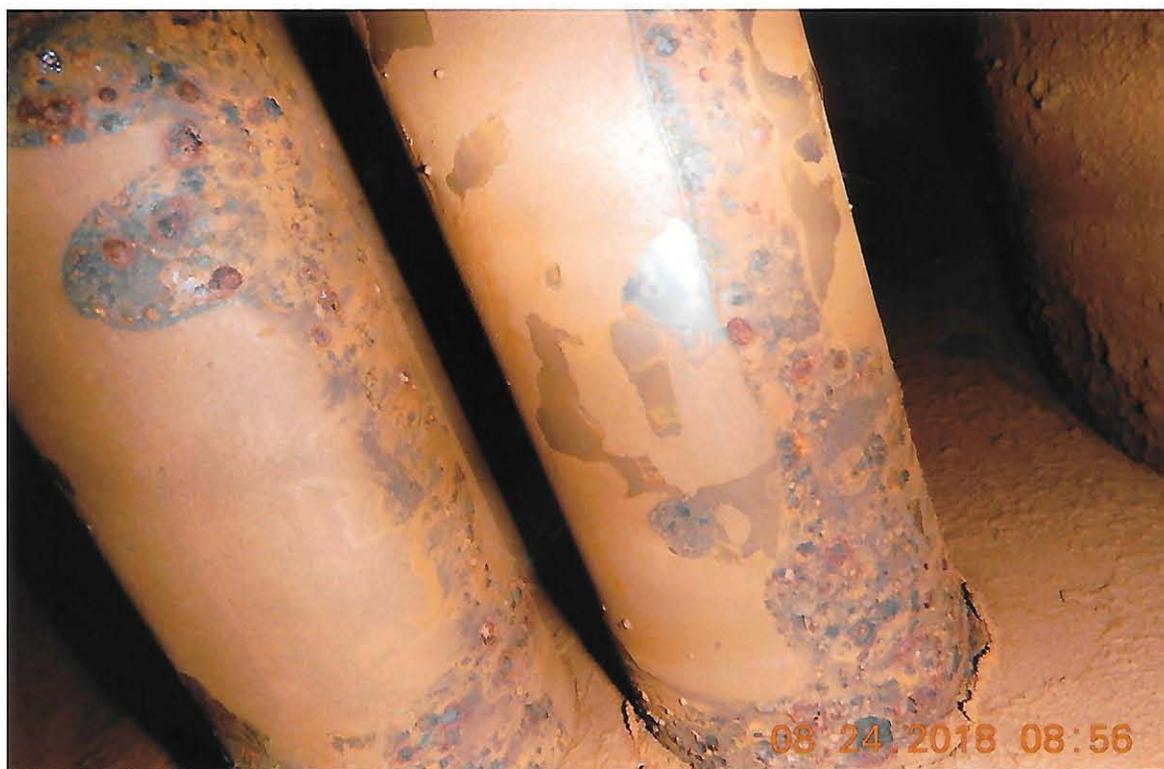
6)

The following ten (10) photos show the condition of the boiler's waterside as viewed from the lower handholes. Scale and tubercles were observed on the accessible tubes, boiler shell, and furnace sheet. An old cut-out tube was noted at the bottom of the shell. A moderate accumulation of sediment and debris was observed at the bottom of the shell.

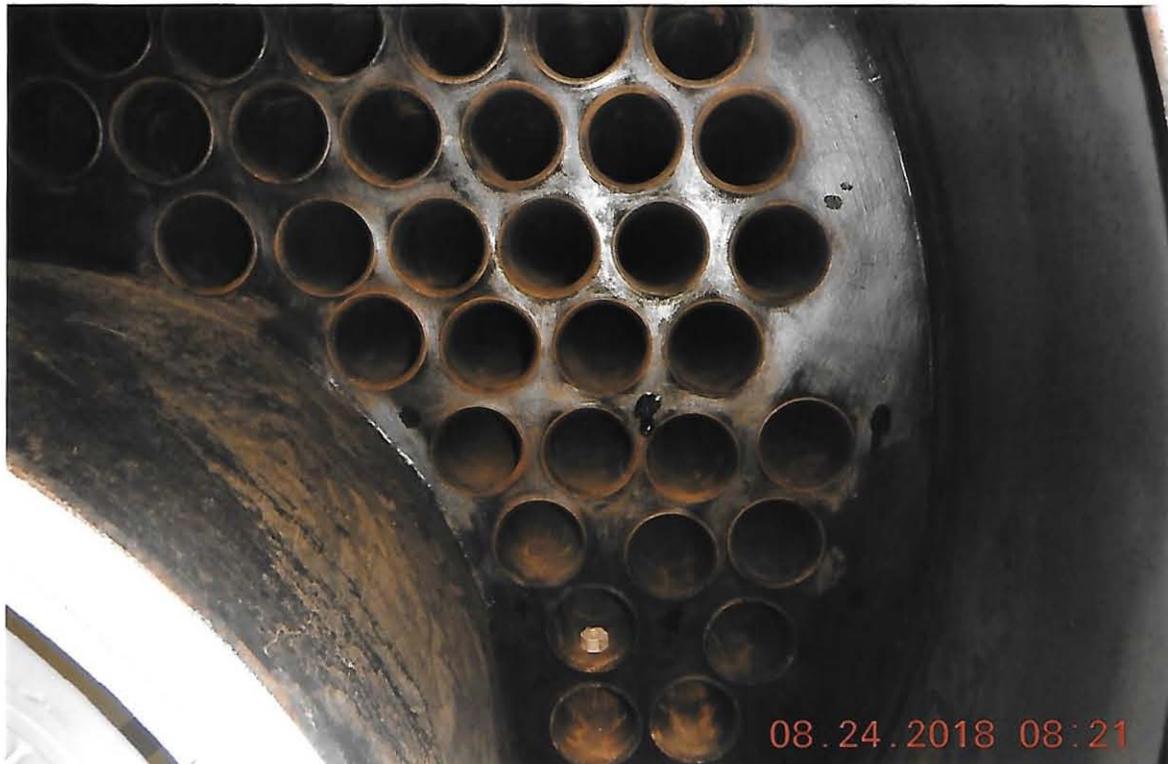
2)

The following six (6) photos show the condition of the front tubesheet and associated smokebox. A light layer of black soot was observed on the front tubesheet, smokebox walls, and ID of the tubes. No indication of pitting was noted. The accessible welds and tubesheet ligaments appeared to be in satisfactory condition.

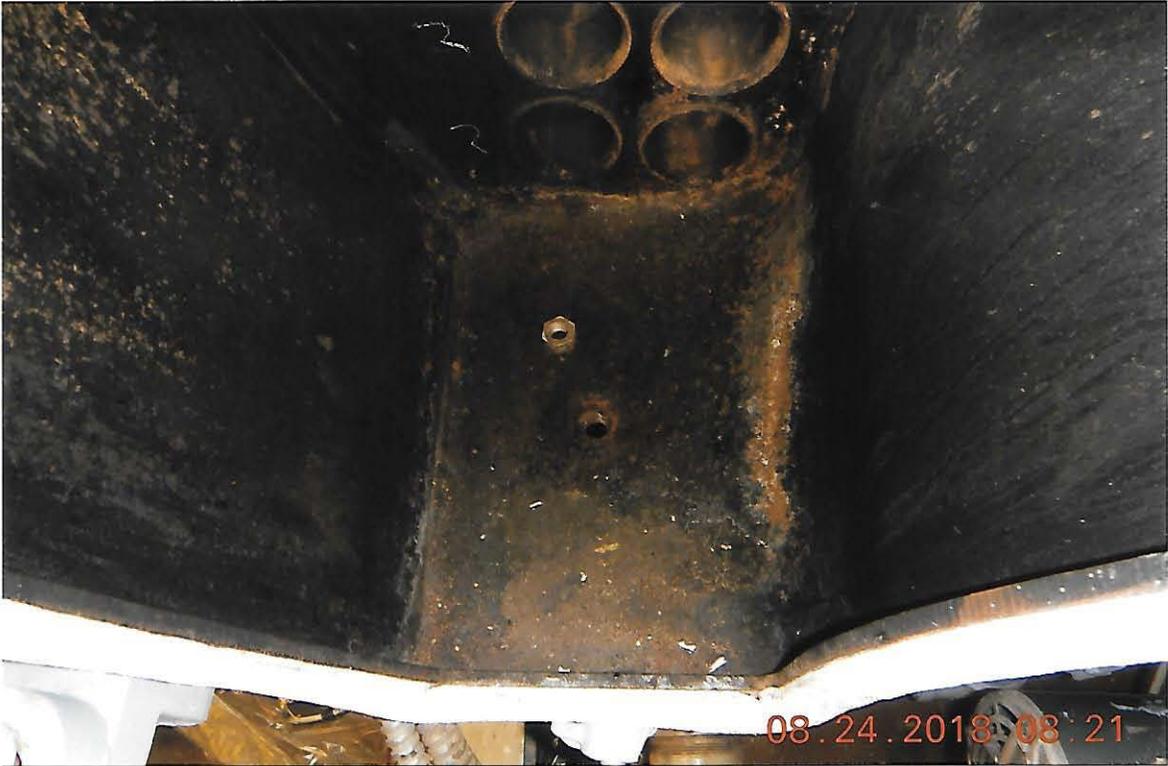
4)

The following six (6) photos show the condition of the front tubesheet and associated smokebox. A light layer of black soot was observed on the front tubesheet, smokebox walls, and ID of the tubes. No indication of pitting was noted. The accessible welds and tubesheet ligaments appeared to be in satisfactory condition.

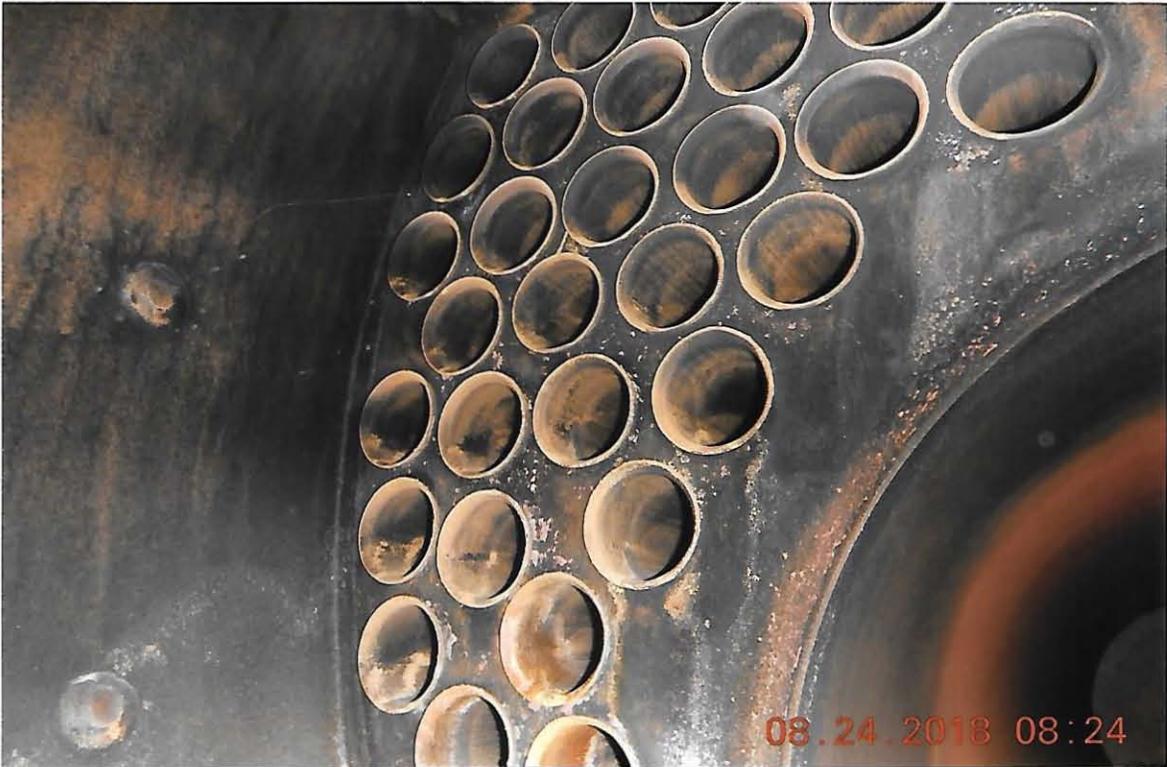
1)

The following six (6) photos show the condition of the inner rear tubesheet and combustion chamber. A light layer of black soot was noted on the rear tubesheet, combustion chamber walls, and ID of the tubes. No indication of pitting was observed. Watermark discoloration was noted on the tubesheet and at the bottom of the combustion chamber. Accumulation of debris was observed at the bottom of the combustion chamber. The accessible welds and tubesheet ligaments appeared to be in satisfactory condition.

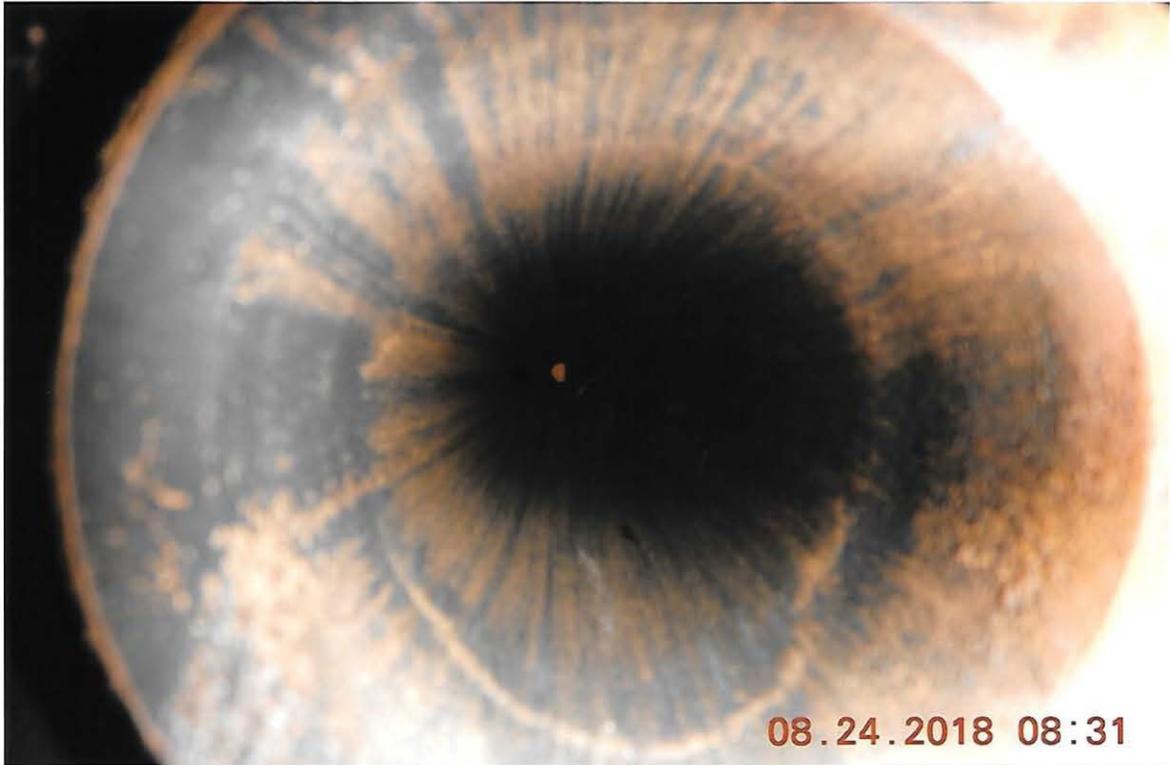
3)

The following six (6) photos show the condition of the inner rear tubesheet and combustion chamber. A light layer of black soot was noted on the rear tubesheet, combustion chamber walls, and ID of the tubes. No indication of pitting was observed. Watermark discoloration was noted on the tubesheet and at the bottom of the combustion chamber. Accumulation of debris was observed at the bottom of the combustion chamber. The accessible welds and tubesheet ligaments appeared to be in satisfactory condition.

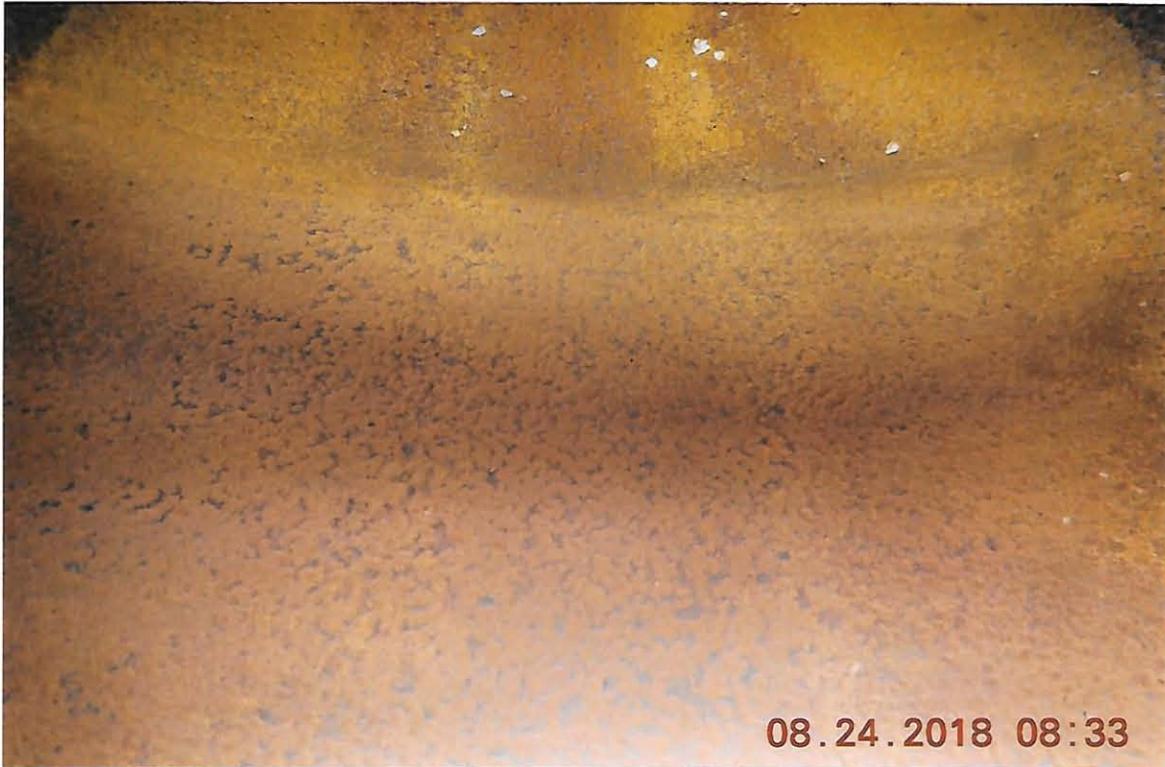
3)

The following six (6) photos show the condition of the furnace sheet and burner. Light corrosion and pitting were observed on the furnace sheet. Soot build-up was noted near the burner. Watermark discoloration and accumulation of debris were noted at the bottom of the furnace sheet. Cracks in the burner refractory were observed. The longitudinal weld appeared to be in satisfactory condition.

3. The fireside of the boilers (furnace sheet, and tubesheets) should be cleaned and free of fireside scale and deposits to prevent masking of surface defects and improve the efficiency and fuel consumption of the boiler.

5. The cracks in the burner refractory in both boilers should be repaired prior to the operation of the boilers. The boilers' refractory should be monitored and repaired as needed every shutdown.

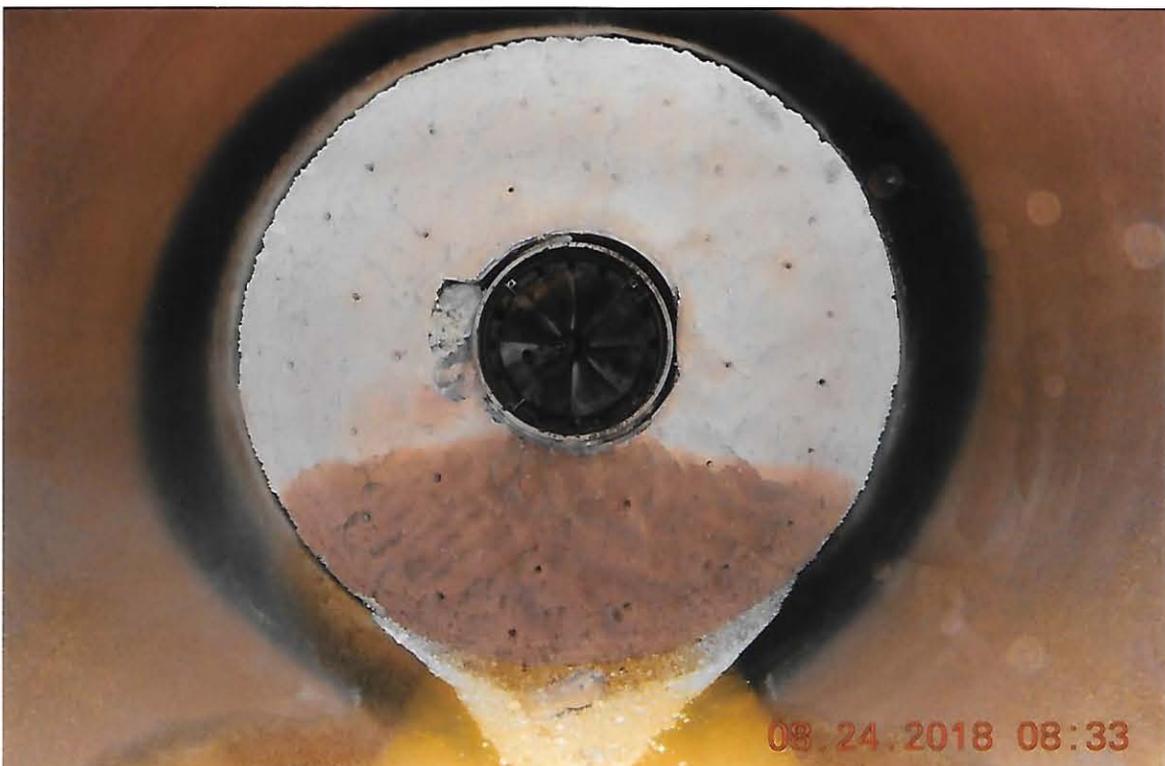
4)

The following six (6) photos show the condition of the furnace sheet and burner. Light corrosion and pitting were observed on the furnace sheet. Soot build-up was noted near the burner. Watermark discoloration and accumulation of debris were noted at the bottom of the furnace sheet. Cracks in the burner refractory were observed. The longitudinal weld appeared to be in satisfactory condition.

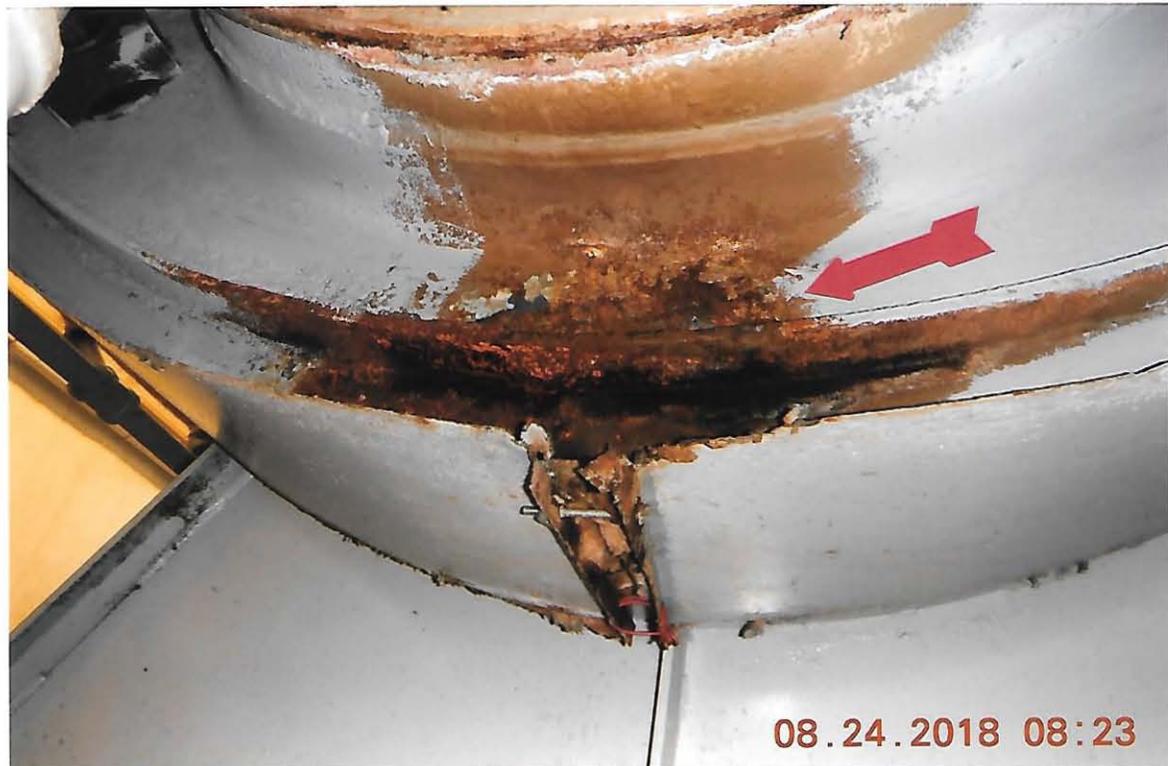
4)

The following eight (8) photos show the external condition of the boiler. Gaps in the casing seams were noted. Staining, corrosion, and deterioration were observed on the casing beneath the boiler. Corrosion around the handholes was noted. The support structure appeared to be in satisfactory condition.

9. The insulation and casing on the boilers should be repaired at the next available boiler opportunity and continuously monitored for moisture entrapment to prevent external corrosion of the boiler's shell.

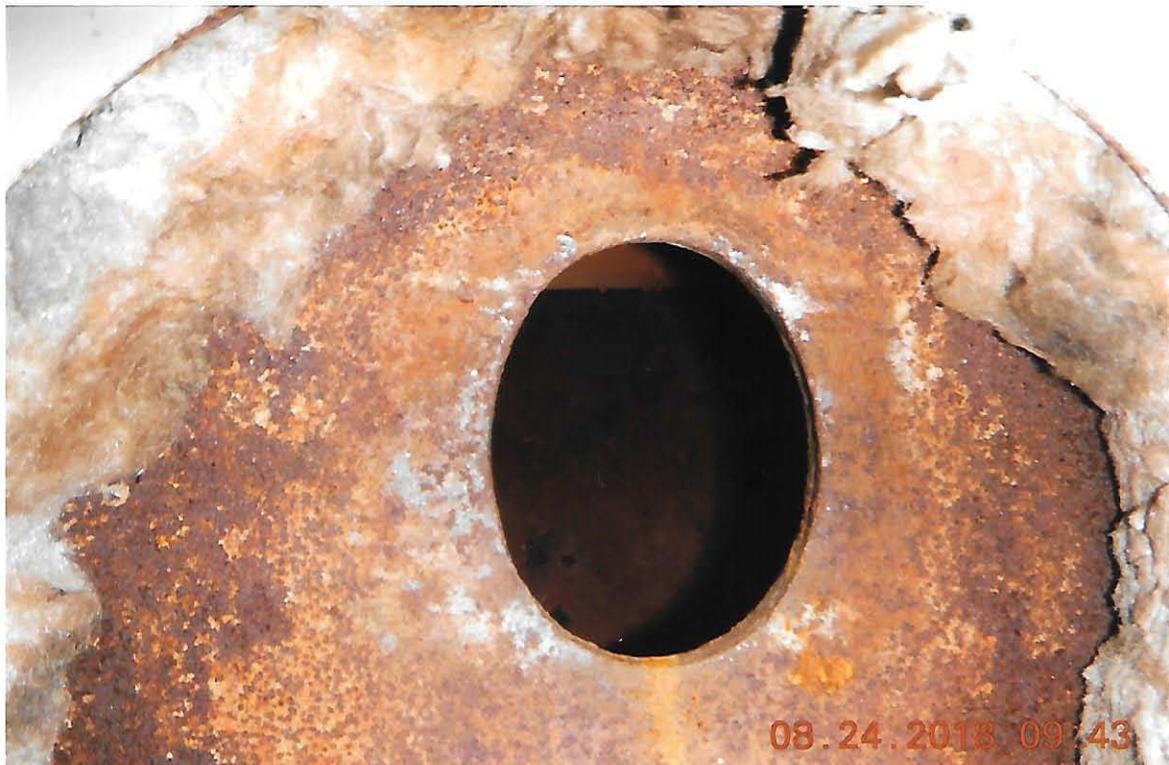
6)

The following eight (8) photos show the external condition of the boiler. Gaps in the casing seams were noted. Staining, corrosion, and deterioration were observed on the casing beneath the boiler. Corrosion around the handholes was noted. The support structure appeared to be in satisfactory condition.

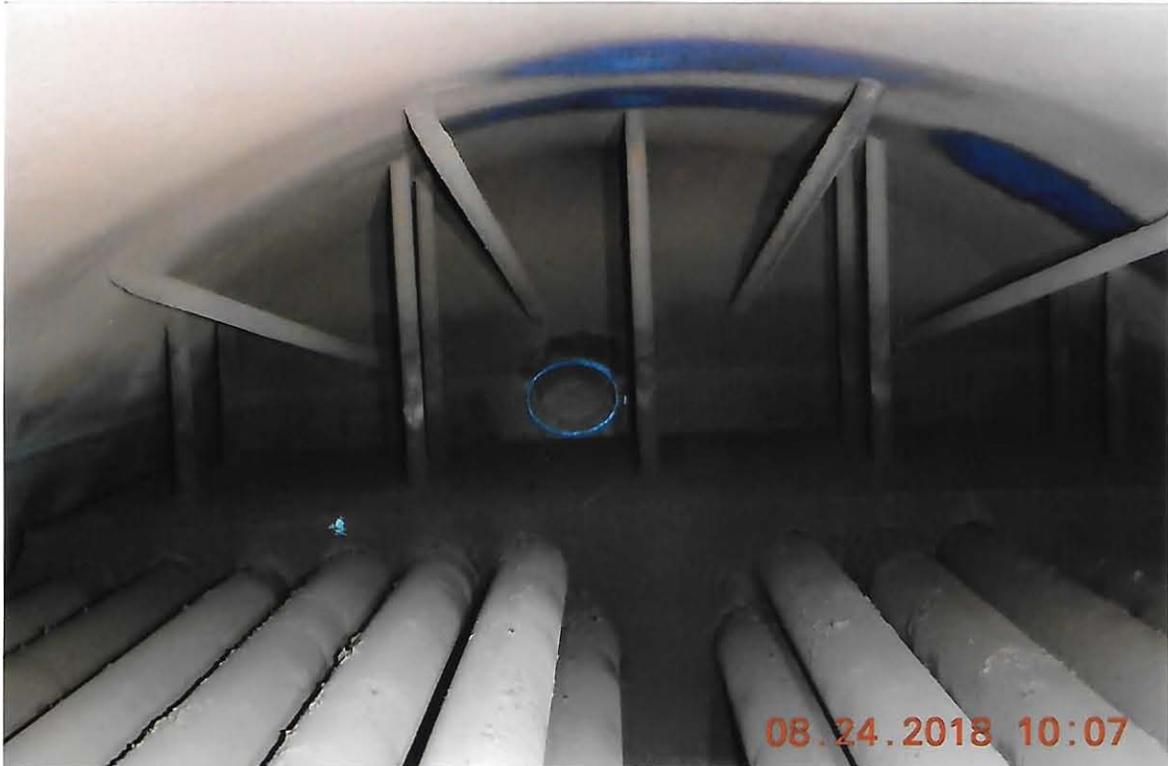
3)

The following ten (10) photos show the condition of the boiler's waterside as viewed from the top manway. Scale and tubercles were observed on the accessible tubes, boiler shell, and furnace sheet. Heavy under deposit pitting and corrosion were observed in the tubes. Light pitting was noted on the accessible furnace sheet.
