# Mechanical Systems Assessment

## Lorraine H. Morton Civic Center

### August 26, 2019

MECHANICAL SYSTEMS ASSESSMENT AND  
REVIEW OF UPGRADE ALTERNATIVES

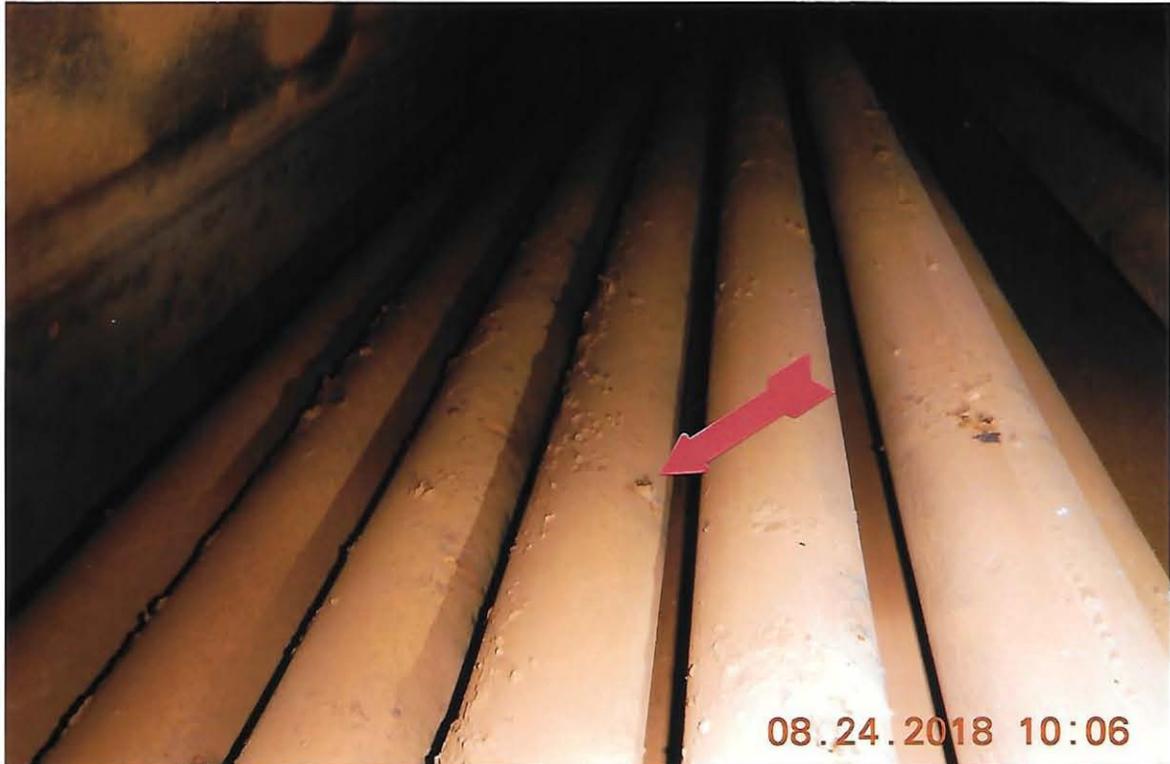
5)

The following ten (10) photos show the condition of the boiler's waterside as viewed from the top manway. Scale and tubercles were observed on the accessible tubes, boiler shell, and furnace sheet. Heavy under deposit pitting and corrosion were observed in the tubes. Light pitting was noted on the accessible furnace sheet.

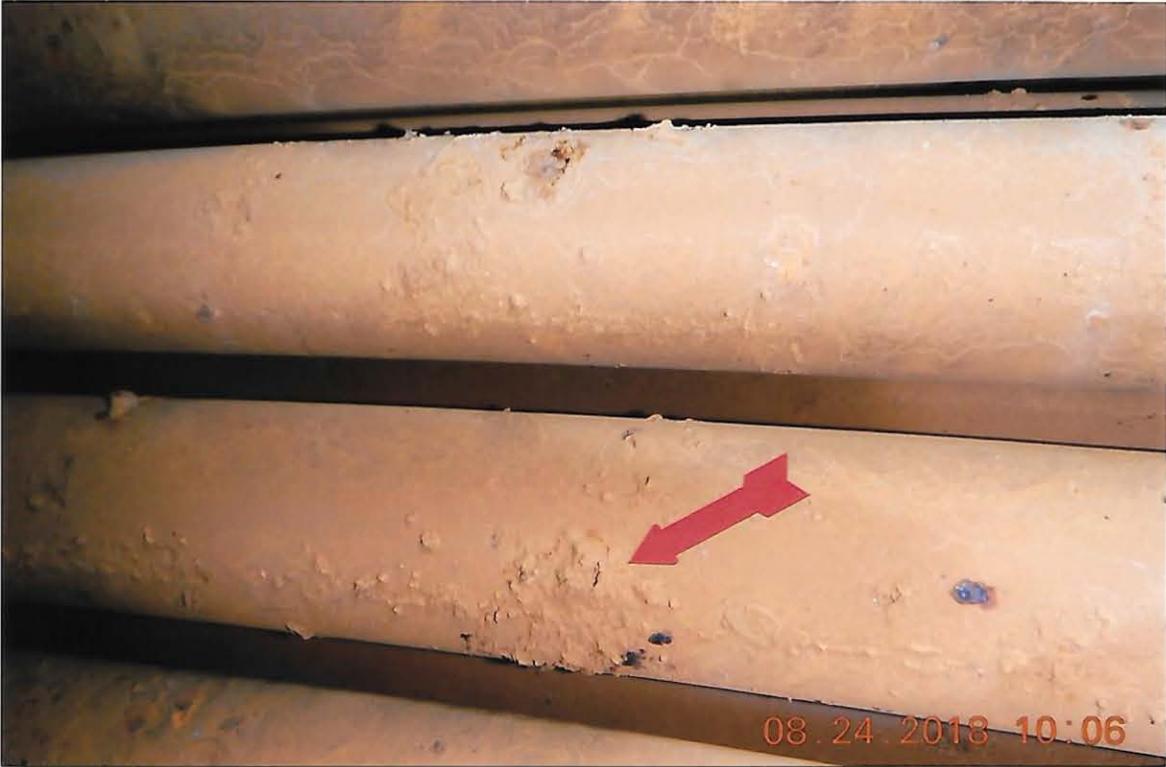
9)

The following ten (10) photos show the condition of the boiler's waterside as viewed from the top manway. Scale and tubercles were observed on the accessible tubes, boiler shell, and furnace sheet. Heavy under deposit pitting and corrosion were observed in the tubes. Light pitting was noted on the accessible furnace sheet.

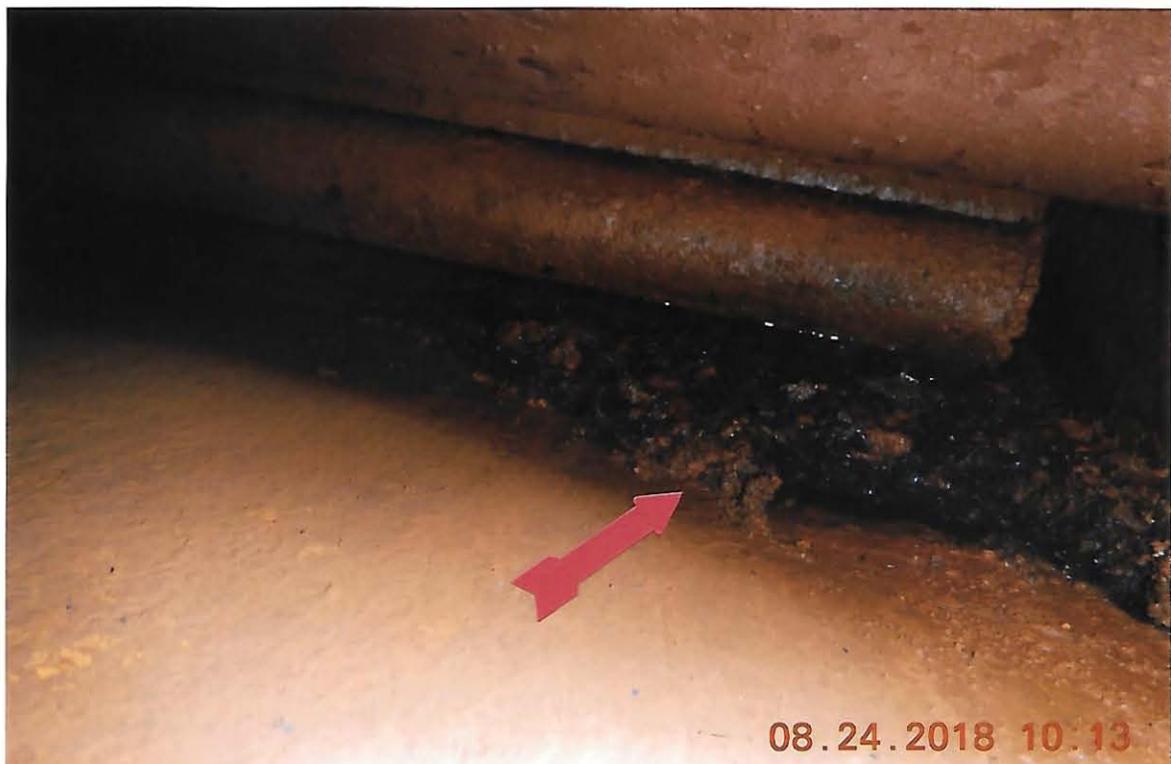
8)

The following eight (8) photos show the condition of the boiler's waterside as viewed from the lower handholes. Scale and tubercles were observed on the accessible tubes, boiler shell, and furnace sheet. Two old cut-out tubes were noted at the bottom of the shell. A moderate accumulation of sediment and debris was observed at the bottom of the shell.

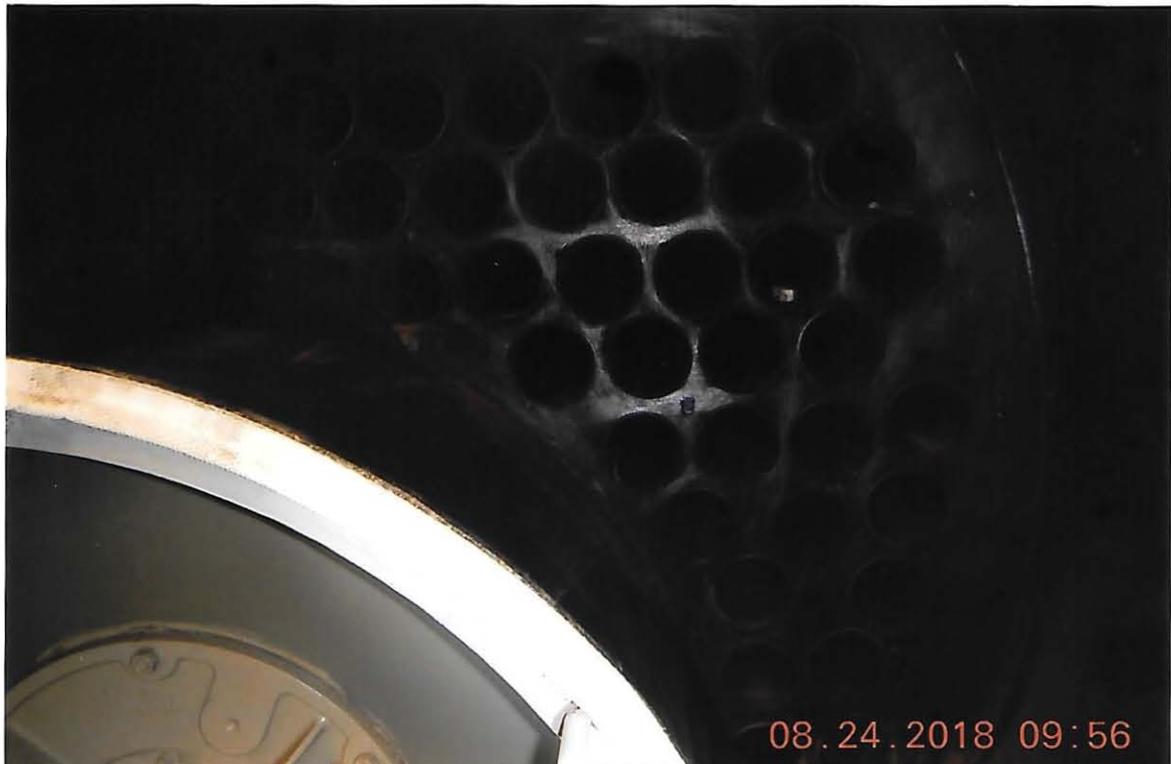
2)

The following six (6) photos show the condition of the front tubesheet and associated smokebox. A light layer of black soot was observed on the front tubesheet, smokebox walls, and ID of the tubes. No indication of pitting was noted. The accessible welds and tubesheet ligaments appeared to be in satisfactory condition.

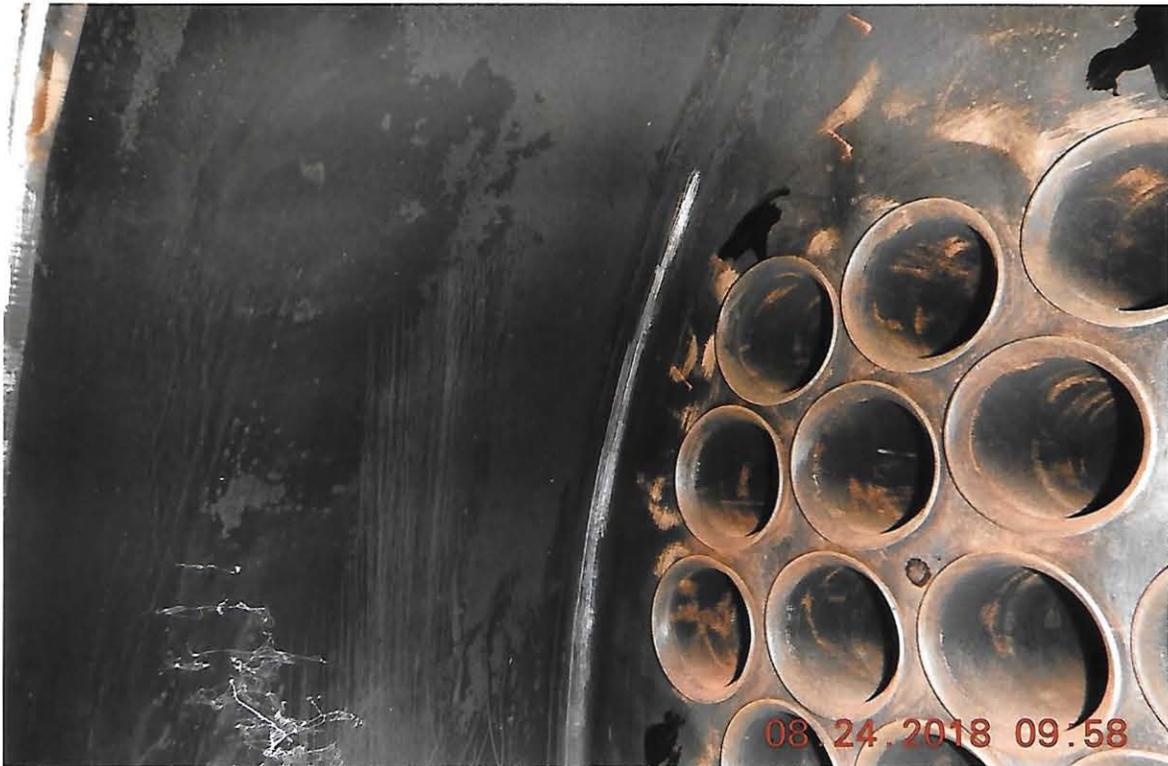
6)

The following six (6) photos show the condition of the front tubesheet and associated smokebox. A light layer of black soot was observed on the front tubesheet, smokebox walls, and ID of the tubes. No indication of pitting was noted. The accessible welds and tubesheet ligaments appeared to be in satisfactory condition.

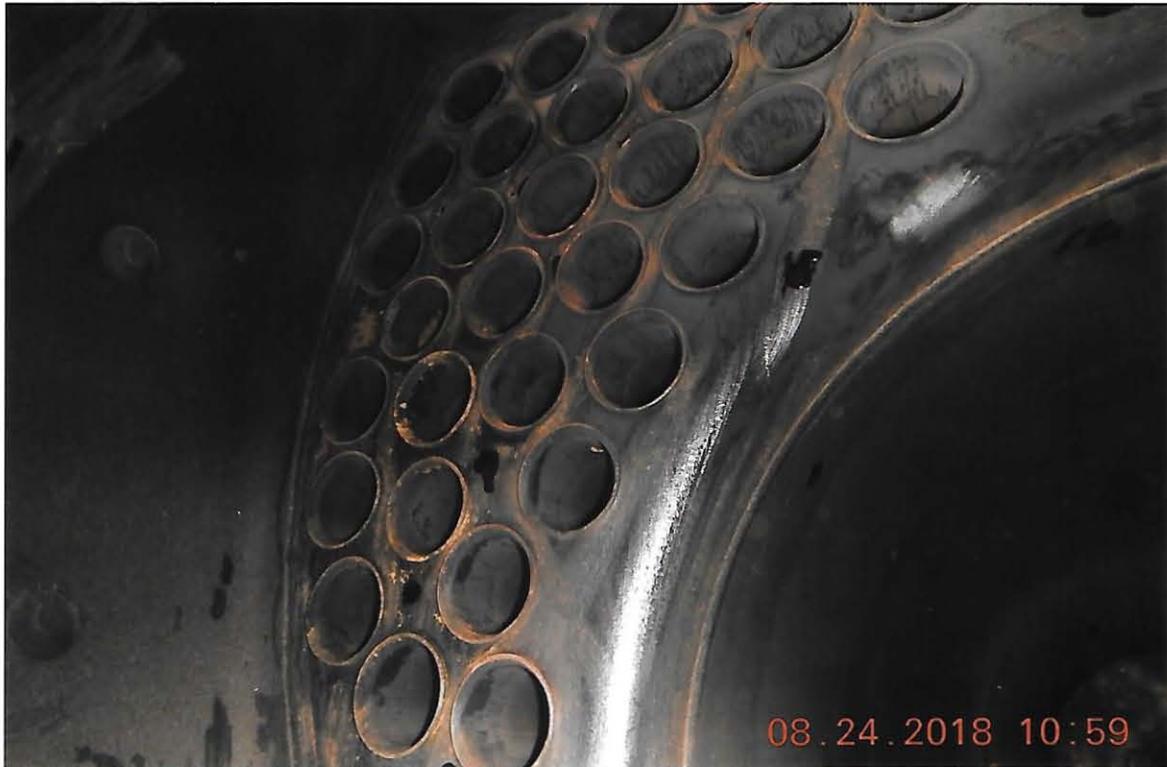
1)

The following eight (8) photos show the condition of the inner rear tubesheet and combustion chamber. A light layer of black soot was noted on the rear tubesheet, combustion chamber walls, and ID of the tubes. No indication of pitting was observed. Watermark discoloration was noted on the tubesheet and at the bottom of the combustion chamber. Accumulation of debris was observed at the bottom of the combustion chamber. The accessible welds and tubesheet ligaments appeared to be in satisfactory condition.

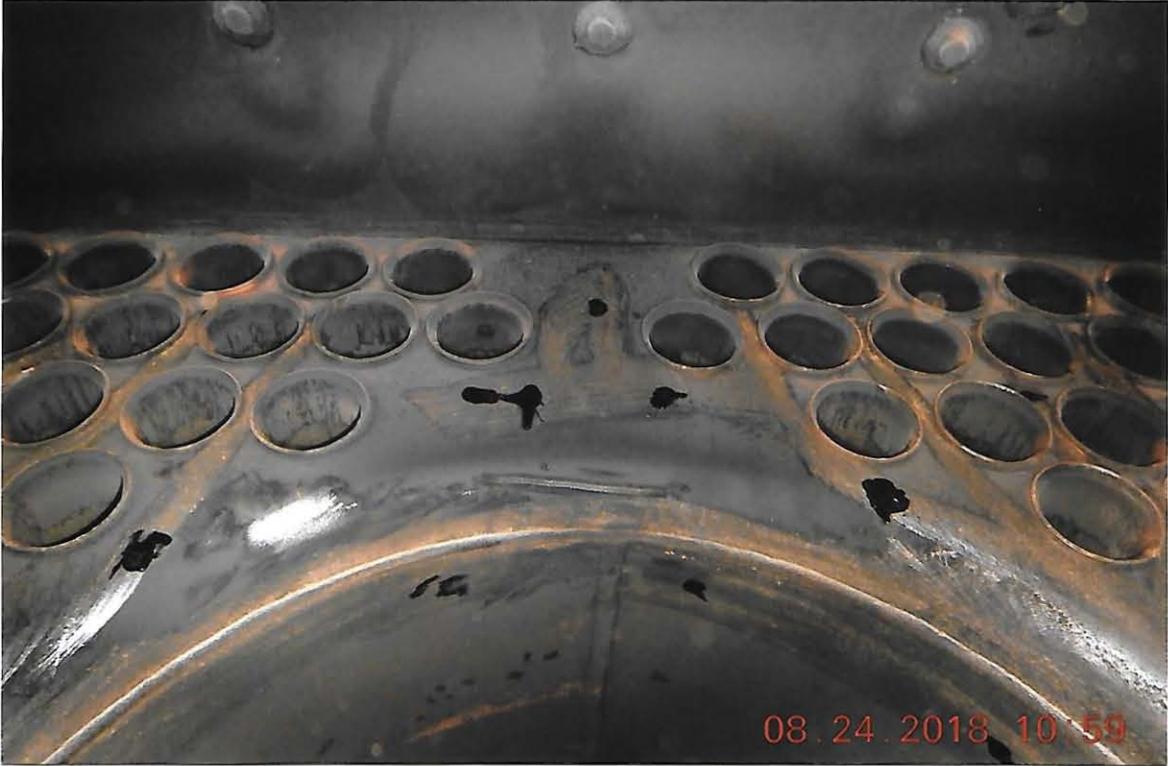
3)

The following eight (8) photos show the condition of the inner rear tubesheet and combustion chamber. A light layer of black soot was noted on the rear tubesheet, combustion chamber walls, and ID of the tubes. No indication of pitting was observed. Watermark discoloration was noted on the tubesheet and at the bottom of the combustion chamber. Accumulation of debris was observed at the bottom of the combustion chamber. The accessible welds and tubesheet ligaments appeared to be in satisfactory condition.

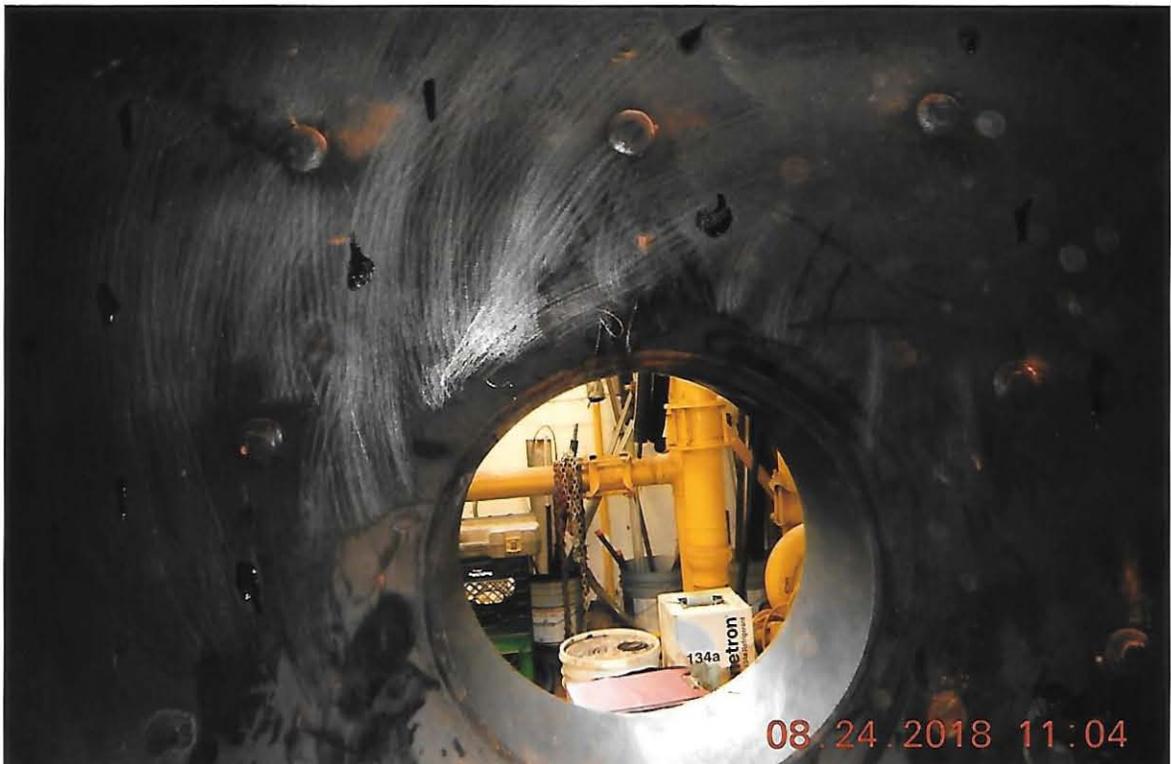
8)

The following eight (8) photos show the condition of the inner rear tubesheet and combustion chamber. A light layer of black soot was noted on the rear tubesheet, combustion chamber walls, and ID of the tubes. No indication of pitting was observed. Watermark discoloration was noted on the tubesheet and at the bottom of the combustion chamber. Accumulation of debris was observed at the bottom of the combustion chamber. The accessible welds and tubesheet ligaments appeared to be in satisfactory condition.

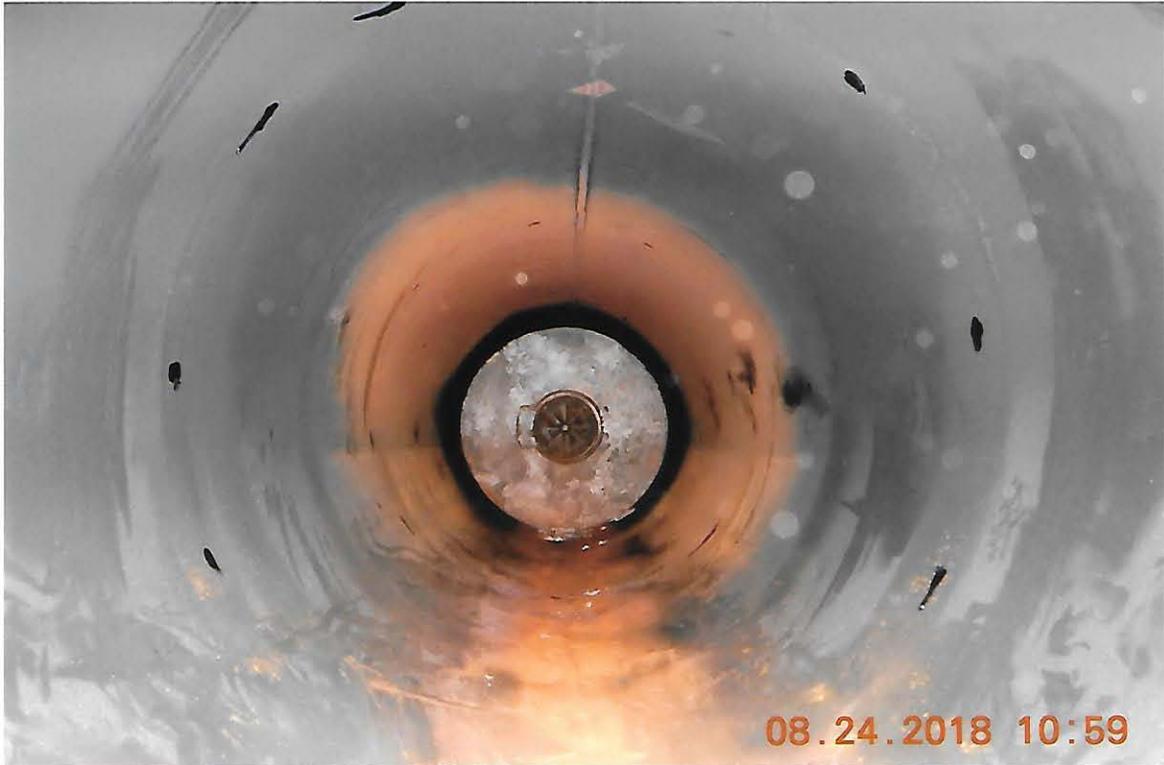
1)

The following six (6) photos show the condition of the furnace sheet and burner. Light corrosion and pitting were observed on the furnace sheet. Soot build-up was noted near the burner. Watermark discoloration and accumulation of debris were noted at the bottom of the furnace sheet. Corrosion and warping of the burner barrels were noted. Cracks in the burner refractory were observed. The longitudinal weld appeared to be in satisfactory condition.

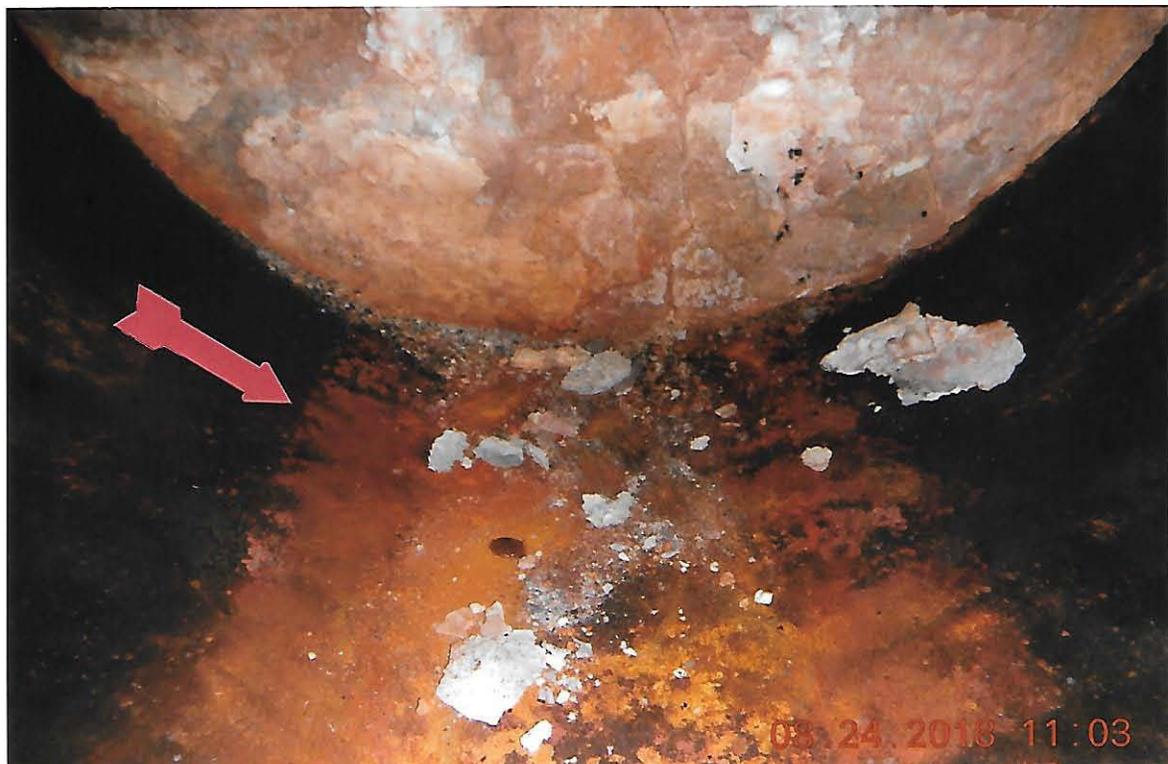
6)

The following six (6) photos show the condition of the furnace sheet and burner. Light corrosion and pitting were observed on the furnace sheet. Soot build-up was noted near the burner. Watermark discoloration and accumulation of debris were noted at the bottom of the furnace sheet. Corrosion and warping of the burner barrels were noted. Cracks in the burner refractory were observed. The longitudinal weld appeared to be in satisfactory condition.

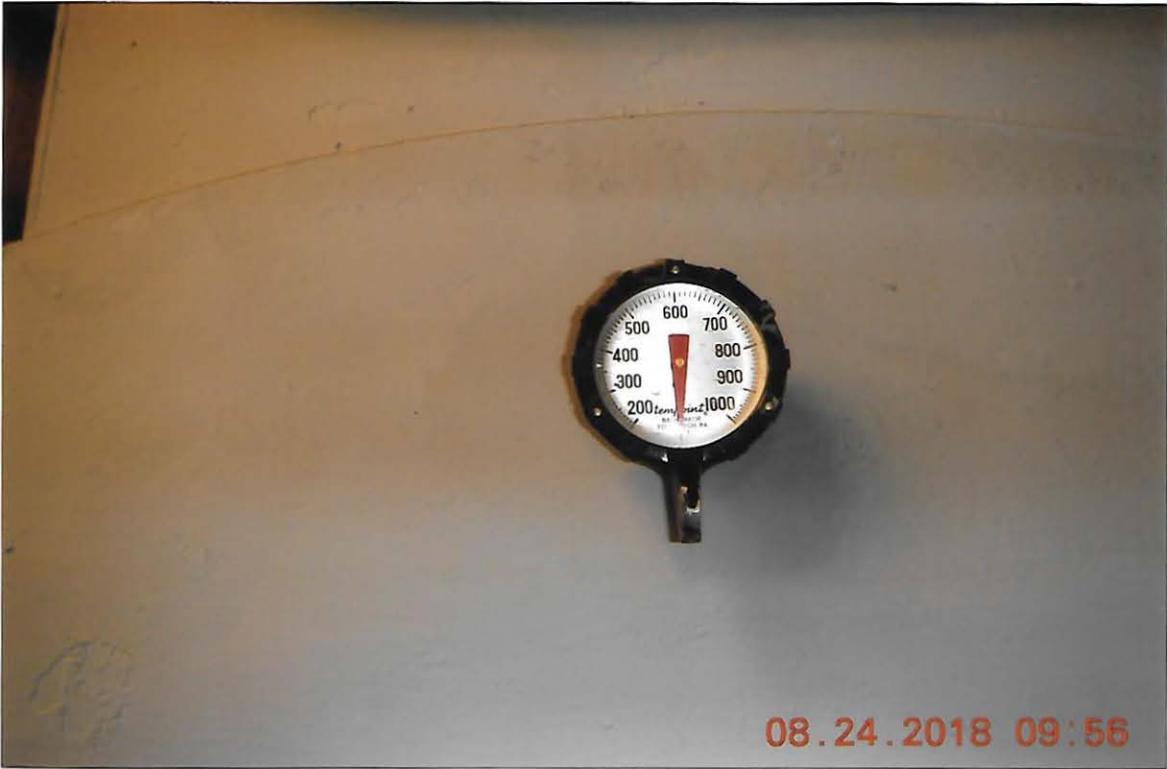
1)

The following five (5) photos show the condition of the various safety appurtenances. No indication of up-to-date calibration was observed on the pressure/temperature gauges and pressure relief valves. The low water fuel cut-off devices were newly installed. The water level sight glass appeared to be in satisfactory condition.

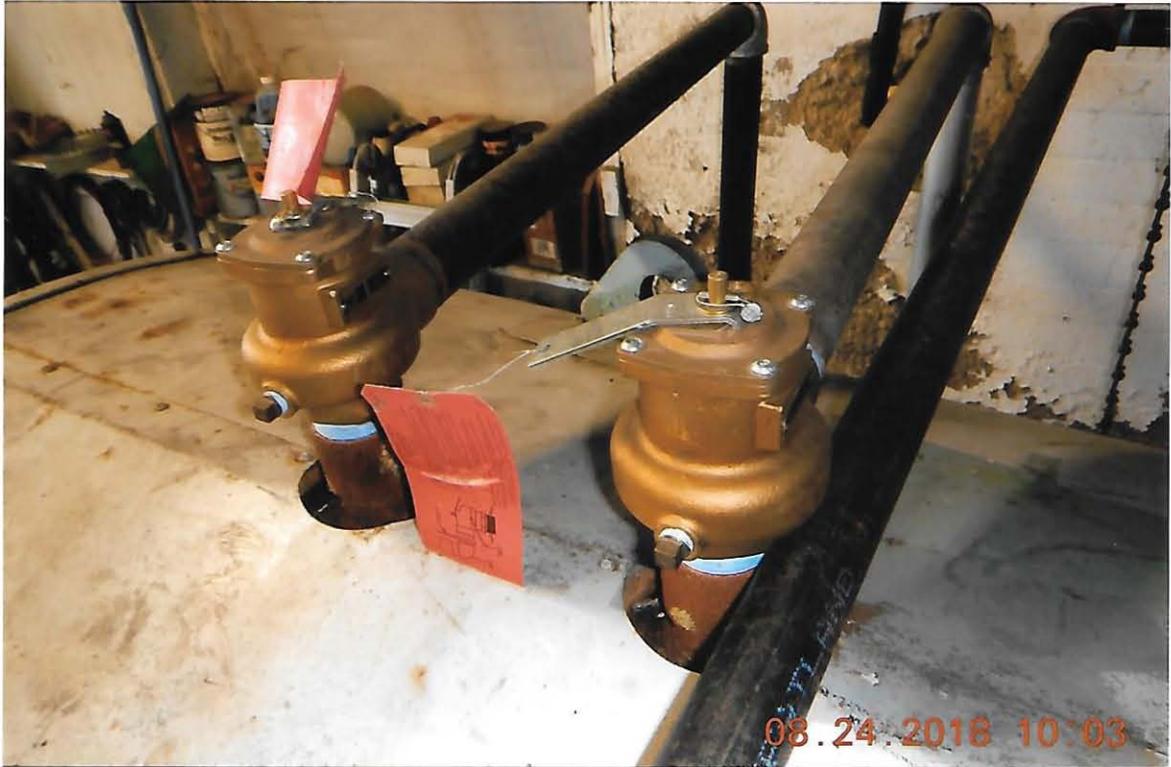
3)

The following five (5) photos show the condition of the various safety appurtenances. No indication of up-to-date calibration was observed on the pressure/temperature gauges and pressure relief valves. The low water fuel cut-off devices were newly installed. The water level sight glass appeared to be in satisfactory condition.

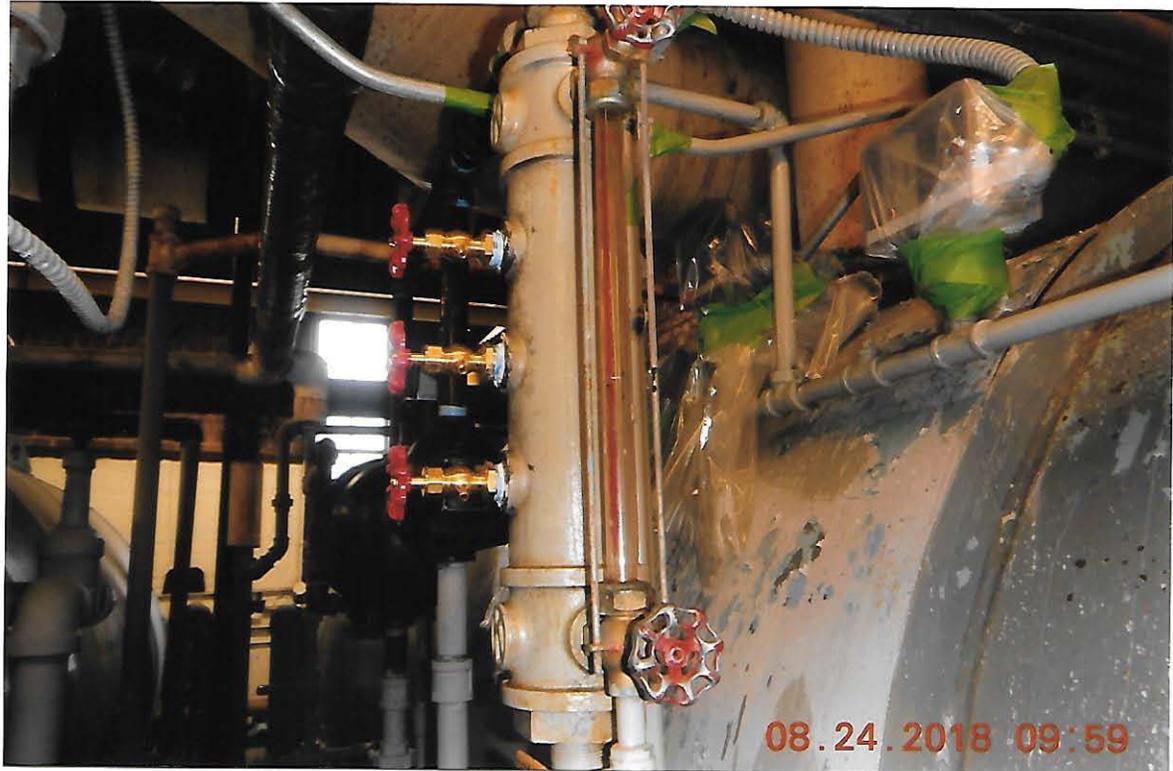
5)

The following five (5) photos show the condition of the various safety appurtenances. No indication of up-to-date calibration was observed on the pressure/temperature gauges and pressure relief valves. The low water fuel cut-off devices were newly installed. The water level sight glass appeared to be in satisfactory condition.

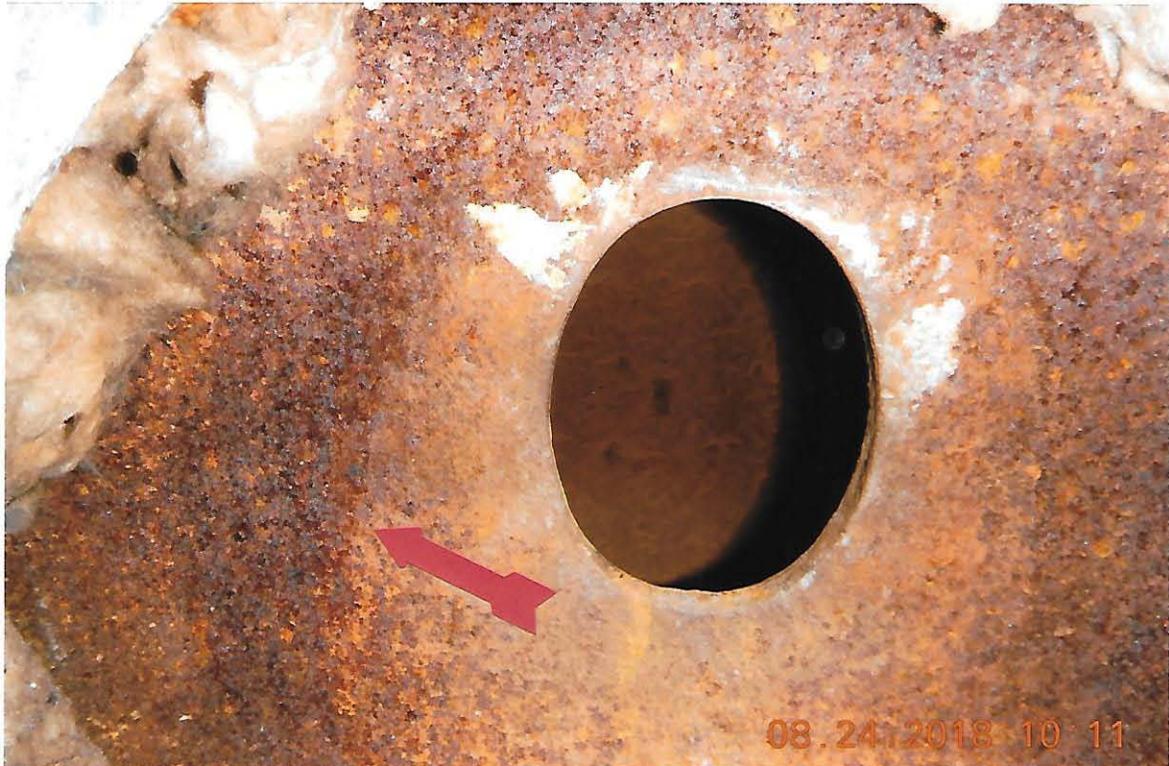
5)

The following eight (8) photos show the external condition of the boiler. Gaps in the casing seams were noted. Staining, corrosion, and deterioration were observed on the casing beneath the boiler. Corrosion around the handholes was noted. The support structure appeared to be in satisfactory condition.

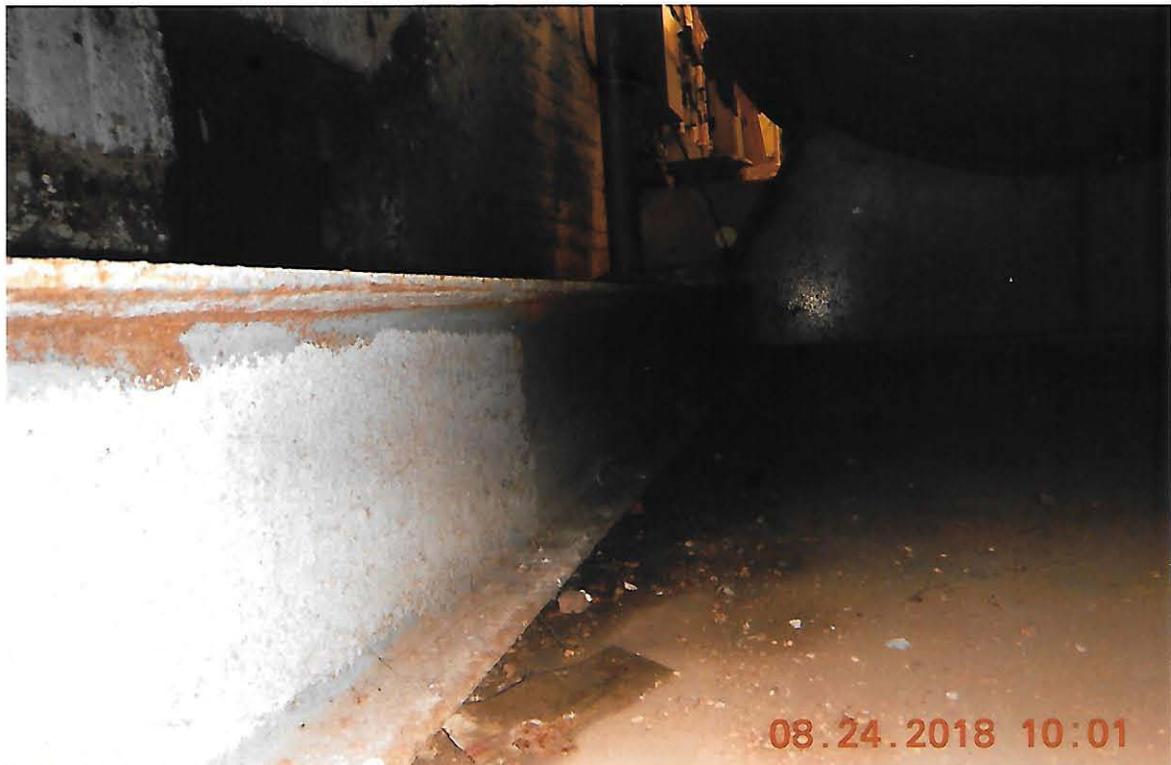
8)

The following eight (8) photos show the external condition of the boiler. Gaps in the casing seams were noted. Staining, corrosion, and deterioration were observed on the casing beneath the boiler. Corrosion around the handholes was noted. The support structure appeared to be in satisfactory condition.

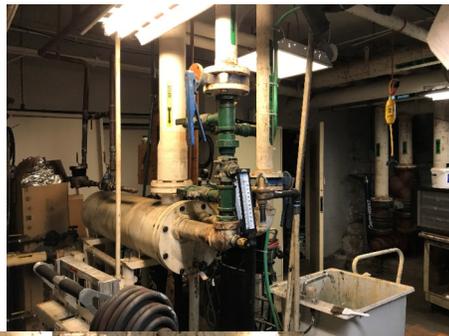
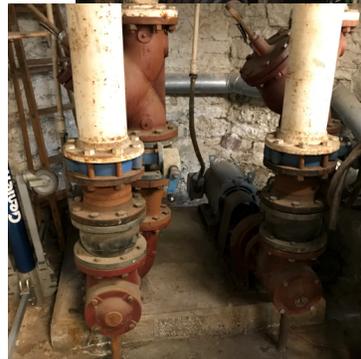
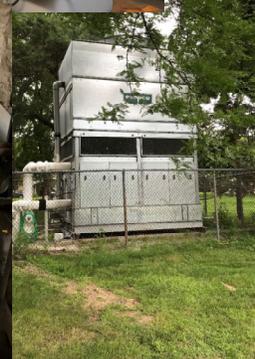
The circulation pumps were installed in 1979. They are beyond their expected service life.
