# Evanston Ecology Center

Existing Conditions Report

March 22, 2023

**HPZS**

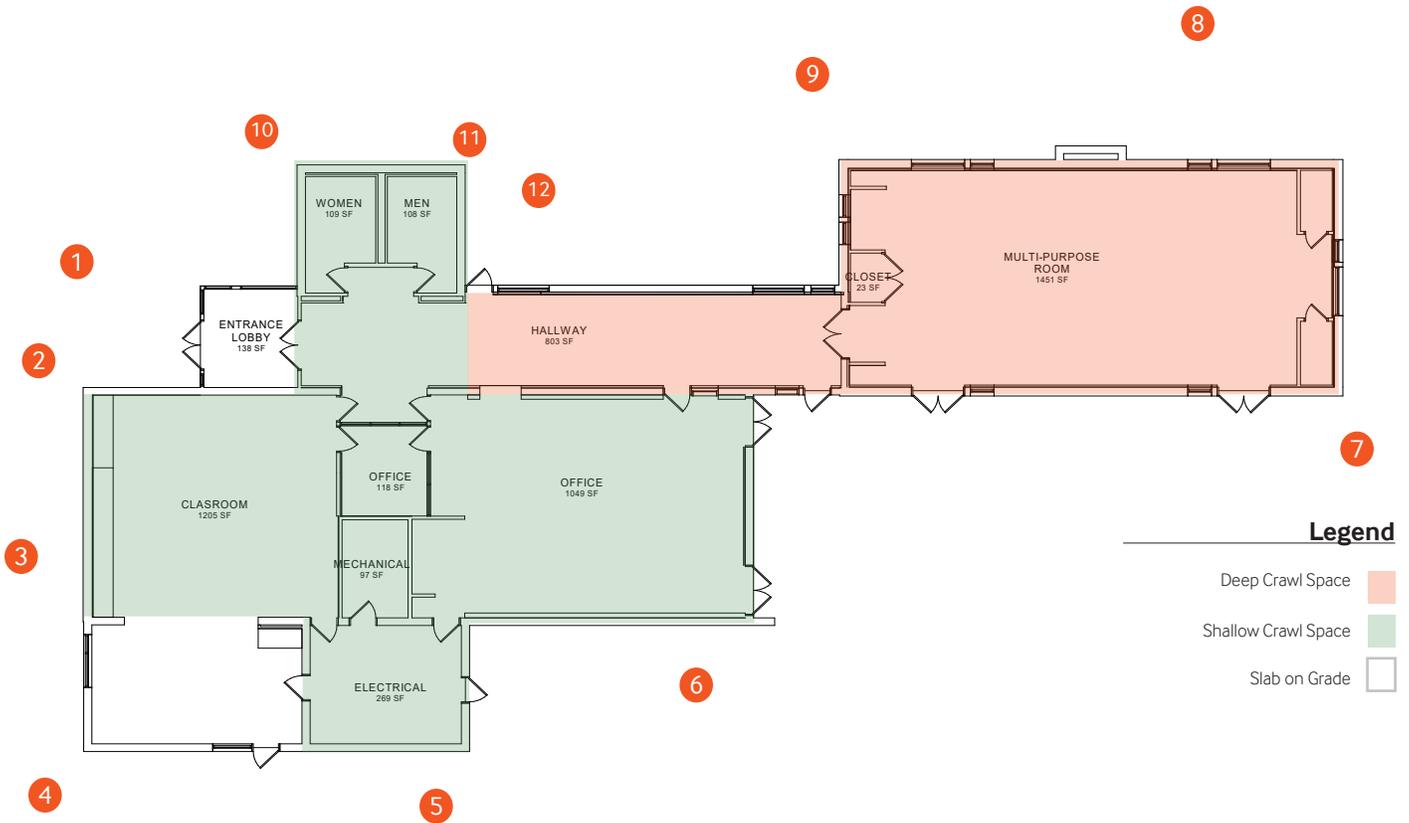
Figure 3. Existing Overall Plan

There are two types of crawl spaces under the building. (See Figure 3. Existing Overall Plan) For reference purposes in this section of the report, these are designated as shallow and deep. The shallow crawl spaces occur under the original portions of the building. These are not truly crawl spaces, but are more appropriately referenced as pipe chases. They have dirt floors. The chase under the toilet rooms contained approximately 2" of water. There does not appear to be any insulation either on the foundation walls or between the joist spaces.

The deep crawl spaces are located under the Hallway and Multi-Purpose rooms. They have gravel floors. No vapor barrier was observed under the gravel. Batt insulation has been installed between the floor joists. The foundations were covered with a rigid insulation board (+/- 1") although the installation leaves many gaps between the pieces of insulation. Where the foundations are exposed, moisture (likely condensation) can be seen coating the walls. It is unclear why both the foundation and the floor joists were insulated.

There is a sump pump located near the access hatch in the Multi-Purpose Room suggesting that the newer construction has footing drain tiles. The pump discharges to the exterior on the west side and immediately adjacent to the foundation. No sump pump was found at the shallow crawl space areas, suggesting that those footings have no drain tile. None of the crawl space areas are ventilated.

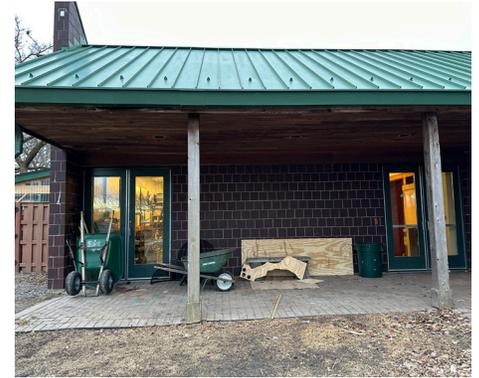
6 Office Exterior Patio

north side of the toilet room wing. The drain pipe runs through the masonry wall and presumably connects to the toilet room drain line. The brick at the pipe penetration is broken, and may be a source of water infiltration. The downspouts around the building typically discharge into a hub buried in the ground. There is a gap between the downspout and the leader that may permit water to escape. Several downspouts discharge directly on the ground. The exterior at the south side of the Multi-Purpose Room and the east side of the Office has a brick paved patio. The pavers are uneven, and several areas pitch back toward the building.

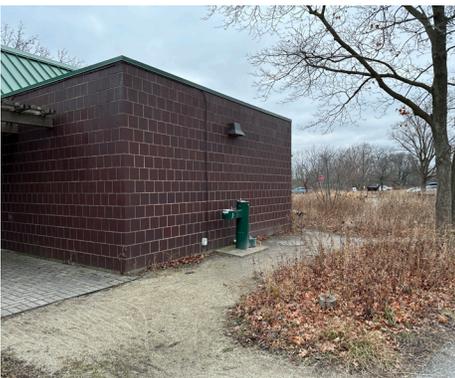
10 Water Fountain, Exterior

**Exterior Observations.** There is a drinking fountain located on the exterior at the

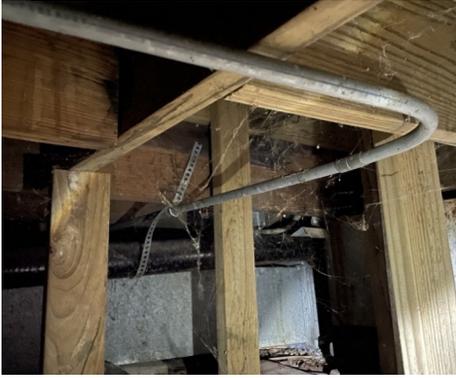
25 Existing Joists

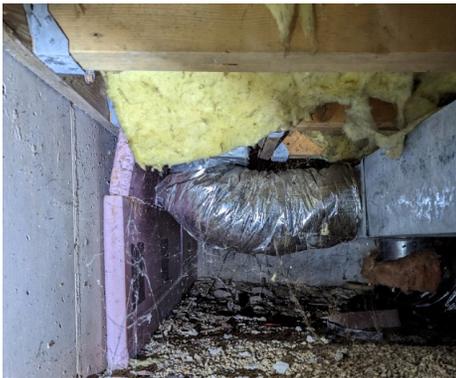
28 Existing Foundation Wall

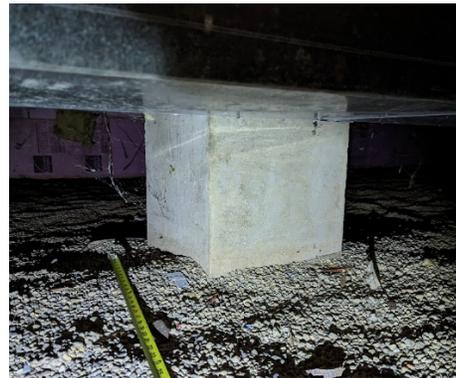
29 Existing Foundation Pier

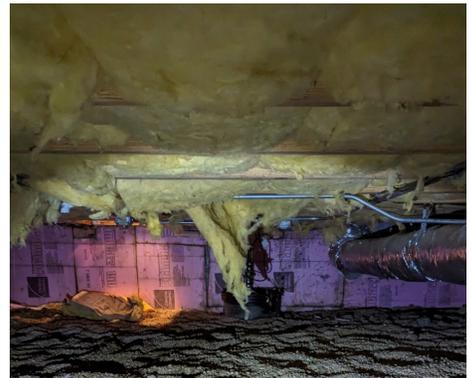
30 Existing Foundation and Wood Structural Members

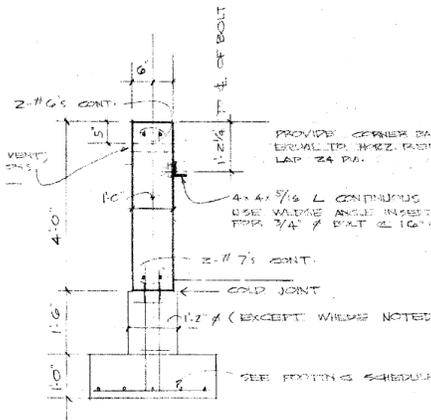
Figure 8. Section through Grade Beam, Pier and Footing from 1973 Construction Documents

The Evanston Ecology Center was originally constructed in 1973, which included the areas that are now restrooms, classroom, offices, mechanical, and electrical rooms (see Figure 5. Existing Overall Phasing Plan). Based on the existing construction drawings, 1'-0" thick, 4'-0" tall concrete grade beams extend along the entire perimeter of the building, as well as at intersecting walls (see Figure 8. Section through Grade Beam, Pier and Footing from 1973 Construction Documents). Openings were created in the grade

beams to allow for mechanical and plumbing to run through. Concrete piers located at corners, wall intersection, and mid-points between provide a transfer point between the frost walls and the isolated footings below. The piers are typically 1'-6" tall. Isolated concrete footings, 1'-0" in thickness, range from 4'-0" x 4'-0" to 6'-6" x 6'-6", depending on the loading supported. Based on the existing drawings, it is assumed the isolated footings are located approximately 6'-6" below the exterior grade.

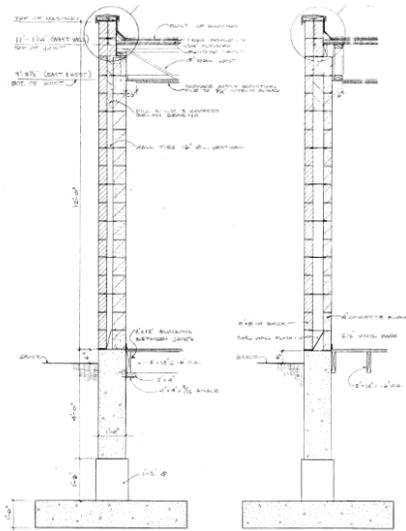
Figure 12. Wall Section from Existing Construction Documents

Around the perimeter, 6" thick CMU block walls were provided. At the mechanical room and bathrooms, a 4" thick CMU block wall was provided. The block wall is always the interior facing wall, while the exterior comprised of 8"x8"x4" brick (see Figure 12. Wall Section from Existing Construction Documents) It is assumed that these walls not only act as the gravity-supporting system of the building, but also the lateral resisting system.

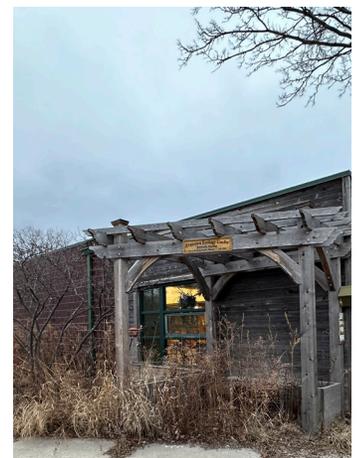
Figure 21. Southwest Exterior Corner of Classroom Extension

Like the rest of the building, 8" thick CMU block was used around the perimeter of the addition. The exterior is clad in wood instead of brick (see Figure 21. Southwest Exterior Corner of Classroom Extension). Based on the addition drawings, the roof of the classroom addition is supported (5) W8x13 steel beams, spanning in the north/south direction. Two of the beams were designed to support mechanical units. 1-1/2" deep metal roof deck spans perpendicular to the beams.

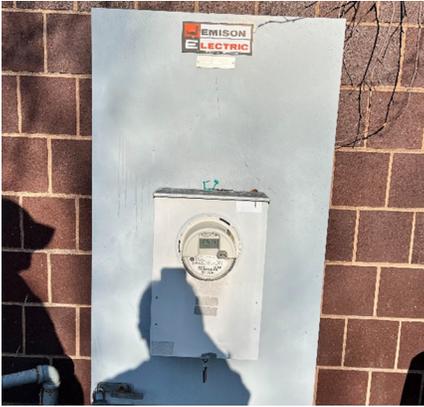
Figure 25. ComEd meter and C/T section outside

Electrical service (600A, 120/240V, 1ph, 3W) is entering the building from east side of the Storage room via ComEd meter and C/T cabinet. (See Figure 25. ComEd meter and C/T section outside). The two (2) 4" conduits then routed to junction box inside to feed 400A distribution panel in Storage room and 200A power panel in Mechanical room.

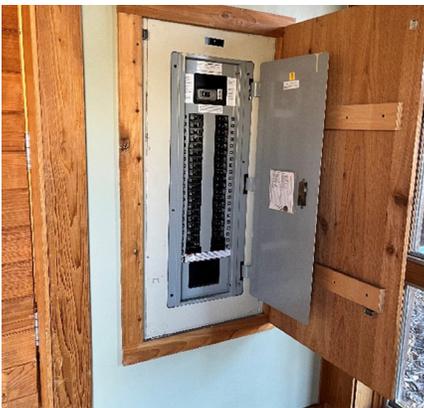
Figure 26. 200A panel in Multi-Purpose room

The 200A panel located in Mechanical room is not shown on City's permit document and it appears to be double tapped from service entrance cabinet. (See Figure 26. 200A panel in Multi-Purpose room). The panel is outdated model and located near the water sources such as mop basin and water heater. It is recommended to be relocated and replaced after verification of feeder routing.

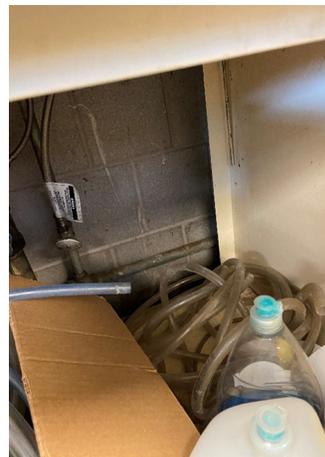
Figure 32. Galvanized piping below classroom sink

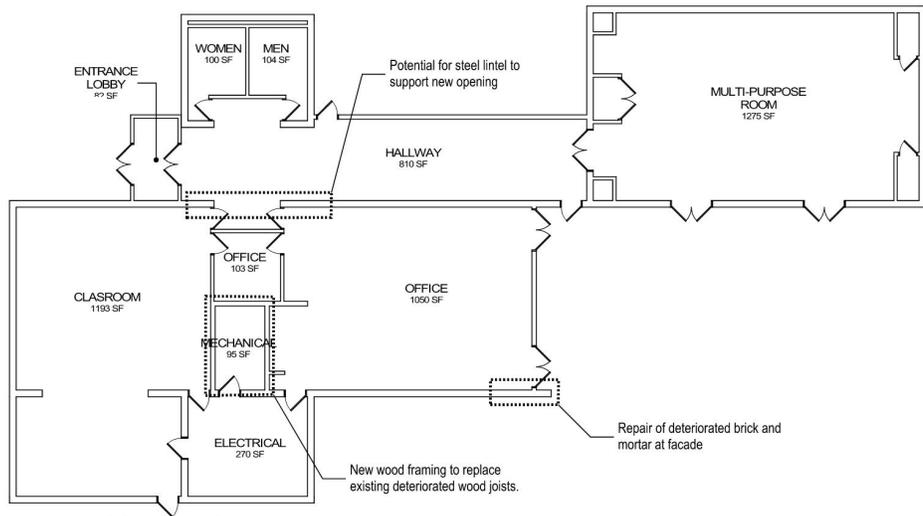
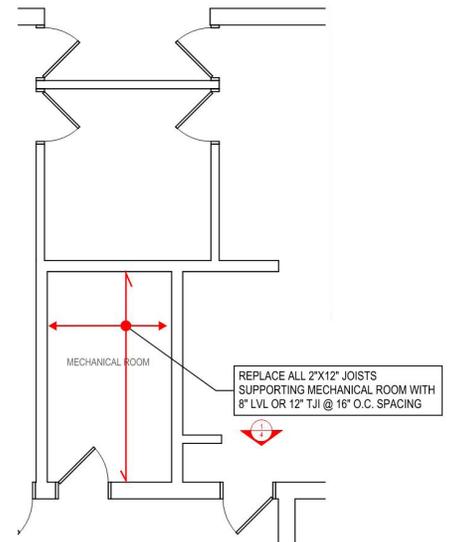
Figure 48. EEC Structural Scoping Plans

We have attached a plan diagram (See Figure 48. EEC Structural Scoping Plans) which indicates structural repair scope based on what we were able to visually observe. These attachments are for reference only and not intended to represent the specific sizing or approach of this structure. Additional structural scope may be required to support mechanical, electrical, or plumbing scope. This could include reinforcement at a new opening in an existing foundation wall, dunnage for mechanical equipment, or penetrations through existing wood joists. The required structural scope for this work is currently pending coordination with these trades.
